12338 Mona Blvd., Compton 90220 | <http://bms-compton-ca.schoolloop.com>

A. EXISTING SITE INFORMATION

B. OVERVIEW

C. ASSESSMENT OF SITE

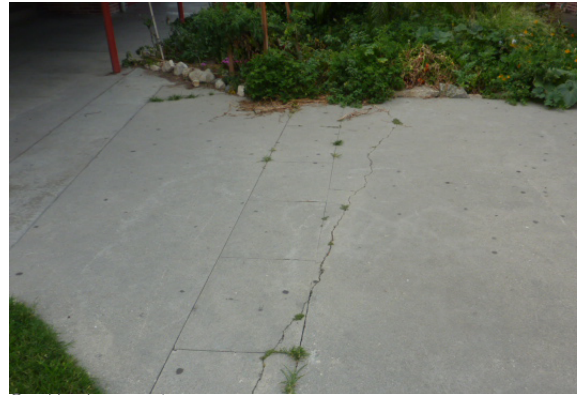
Degrade asphalt on playground

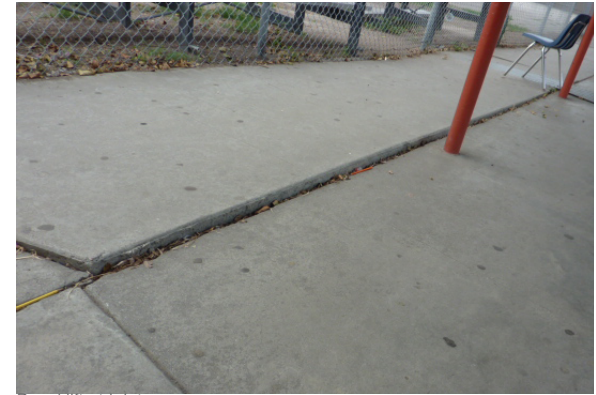
Cracking in concrete

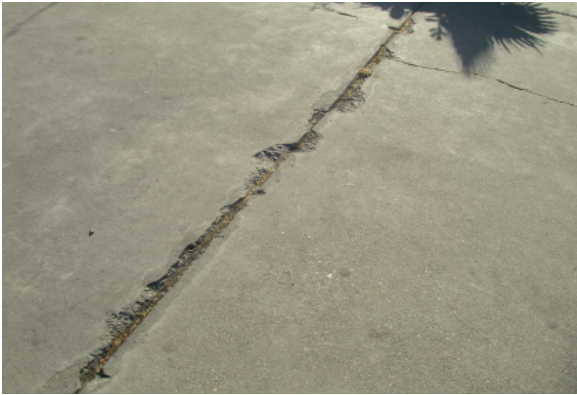
Large chips in concrete paving

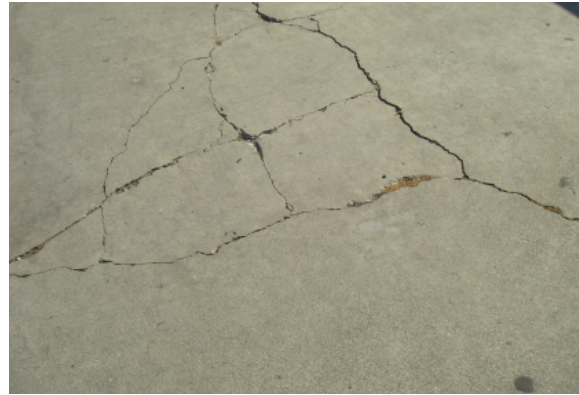
Large cracks in concrete paving

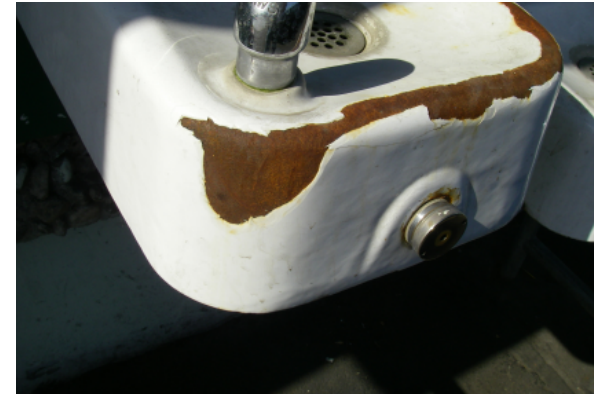
Rusted drinking fountains

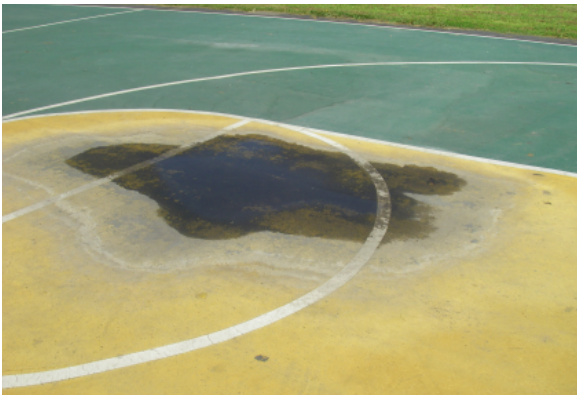
Poor drainage in asphalt paving

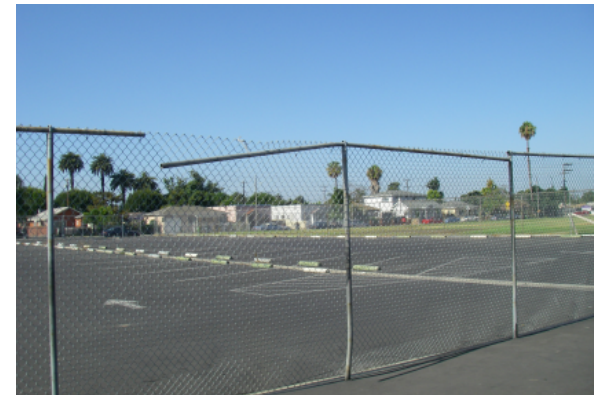
Broken chain link fencing

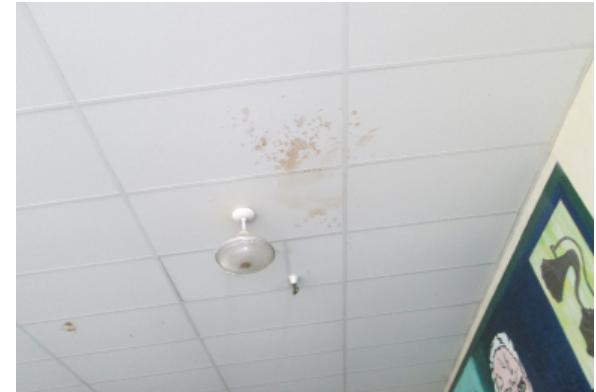
Damage/stains to ACT

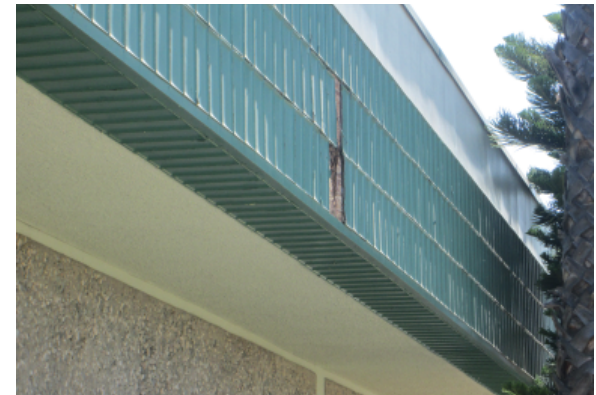
Metal pieces at fascia are missing which can result in water infiltration

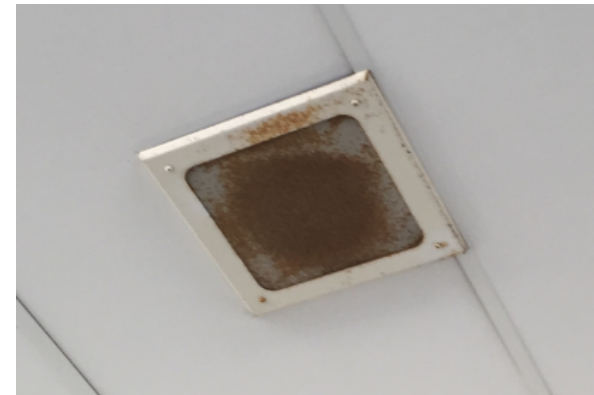
Light fixture is rusting and inoperable

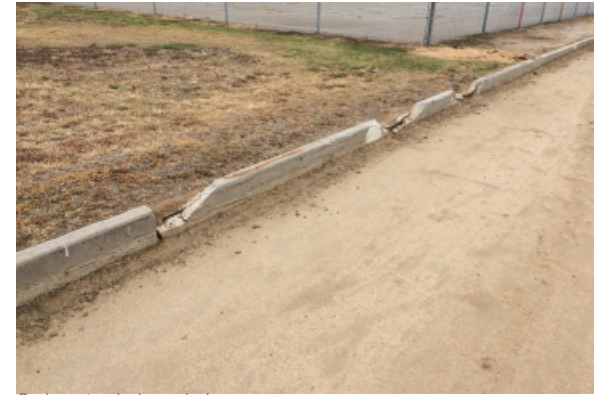
Curb on track degraded

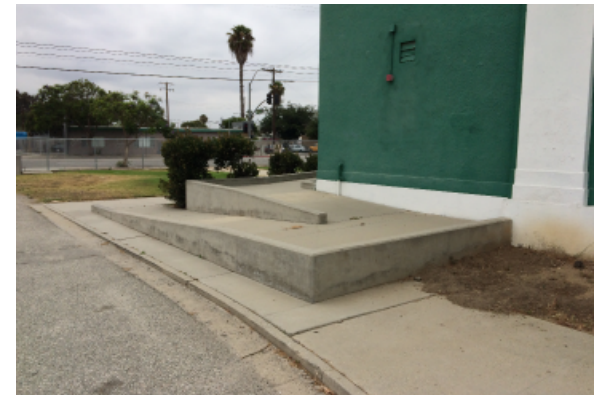
Handrails missing

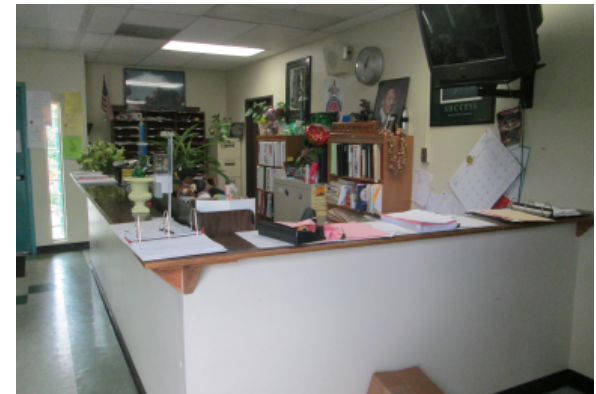
Non accessible front office counter

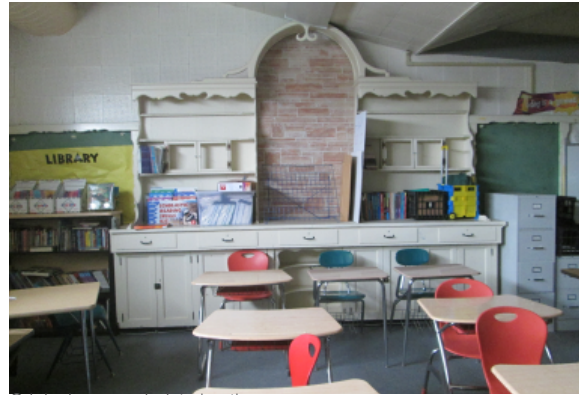
Original casework deteriorating

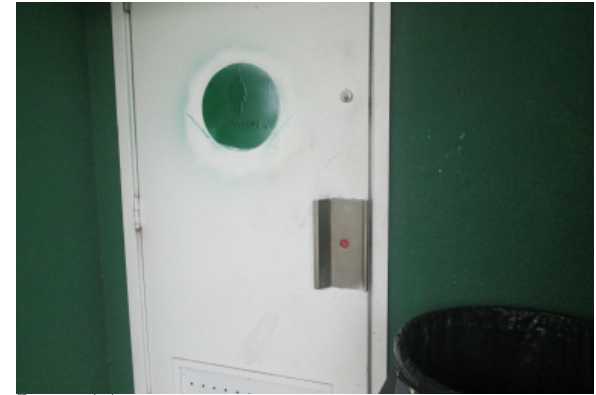
Damaged signage

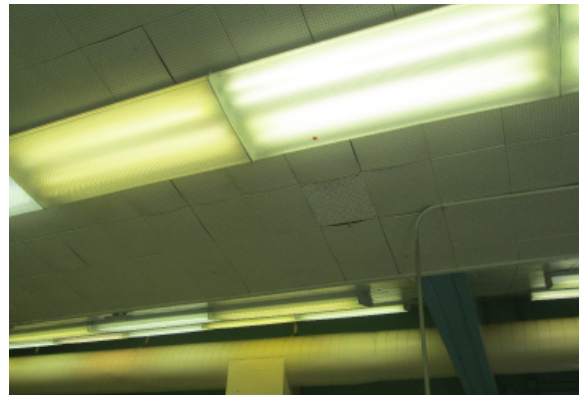
Deteriorating lights

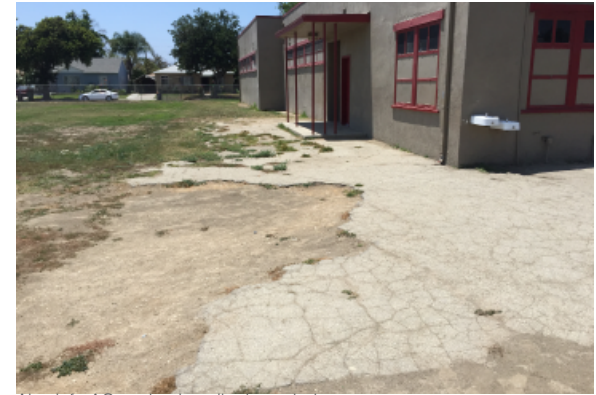
Abcdefg AC paving heavily degraded

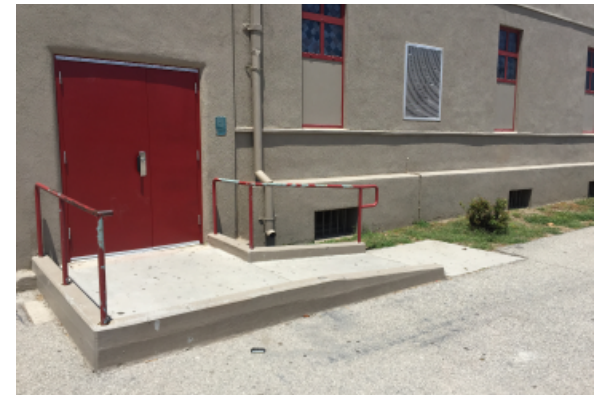
Handrails are missing

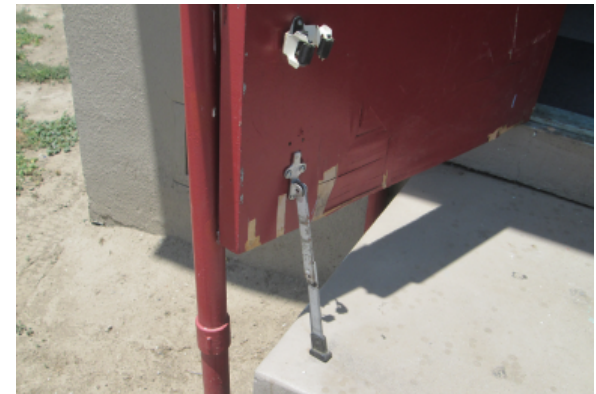
Door damaged and not accessible

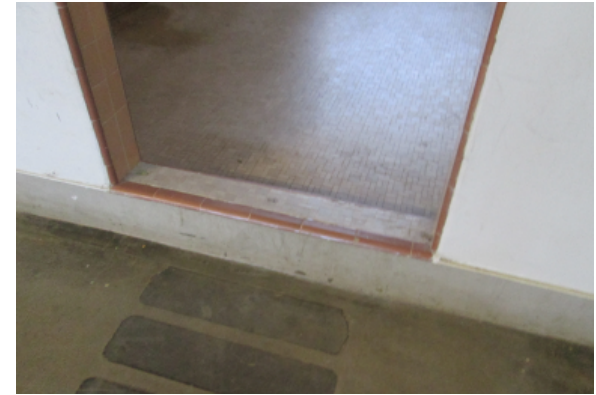
Non accessible threshold

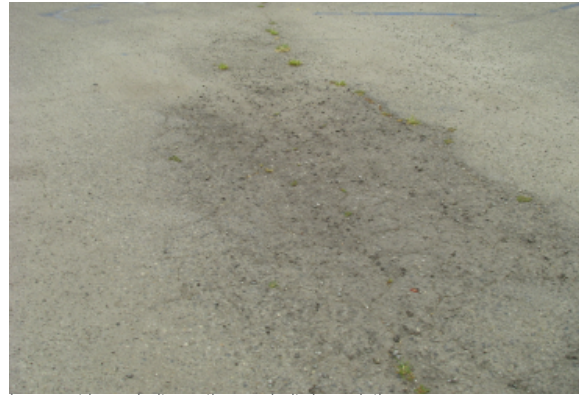
Low spot in asphalt creating asphalt degradation

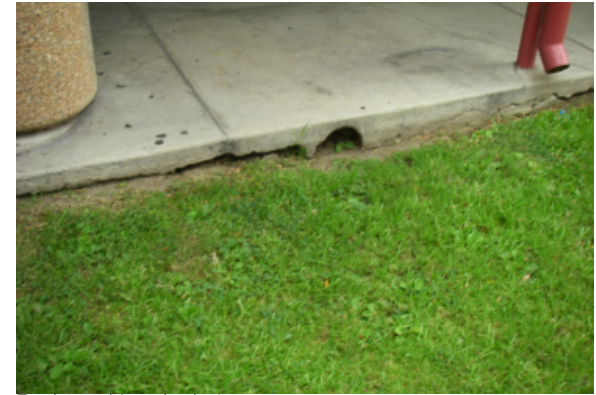
Erosion problems in planter

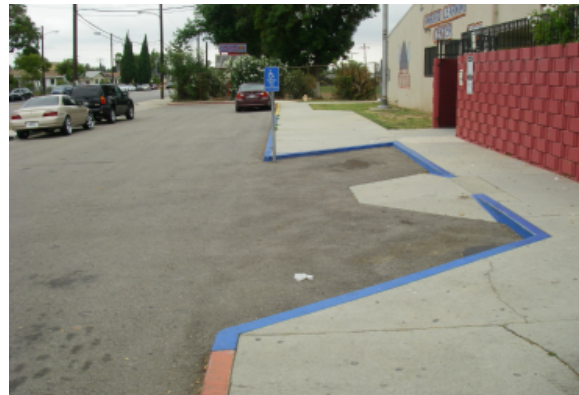
Missing proper drop-off width/length/signage/marking

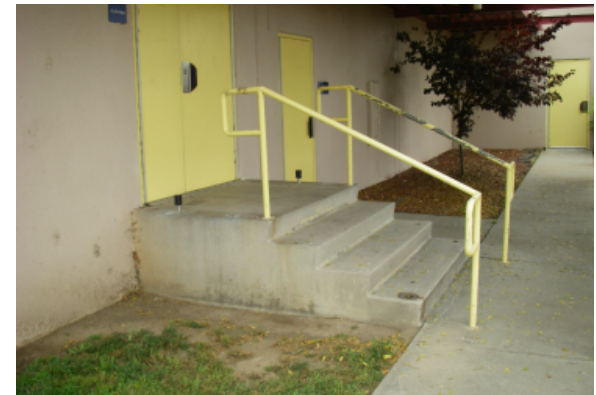
Nosings & landing is non-compliant

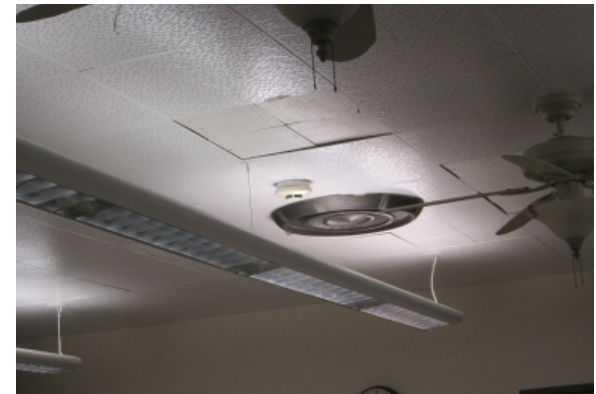
Damaged ceiling tiles

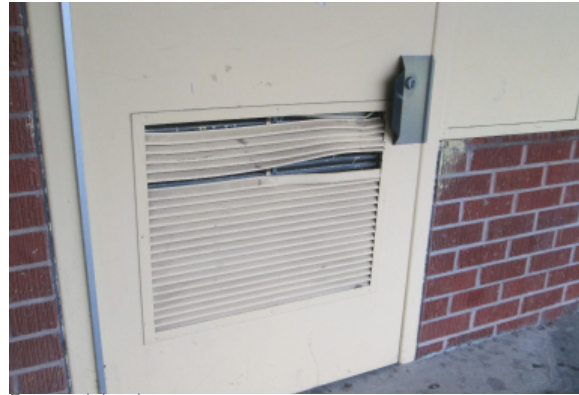
Damaged door louver

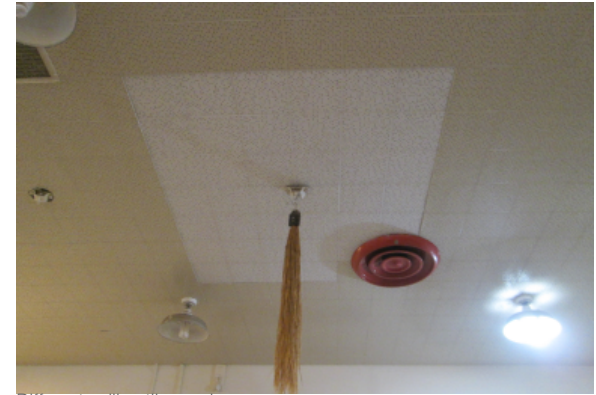
Different ceiling tile repair

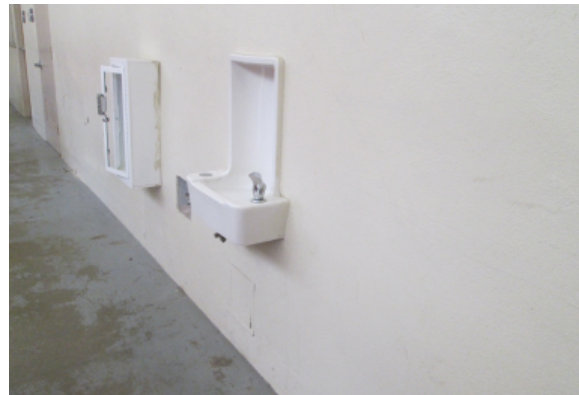
Non accessible drinking fountain

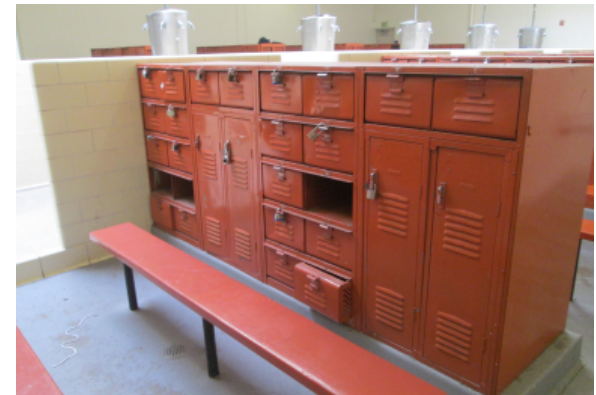
Original lockers deteriorating

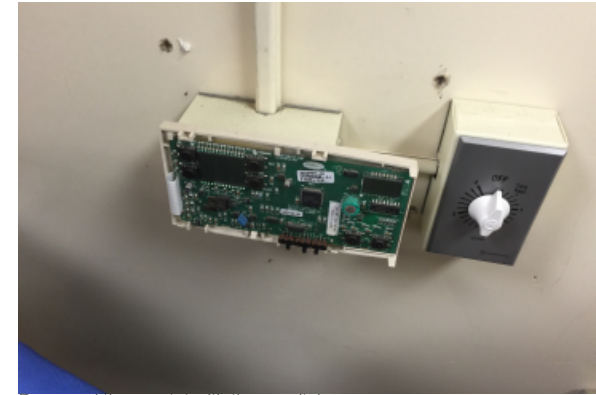
Damaged thermostat with timer switch

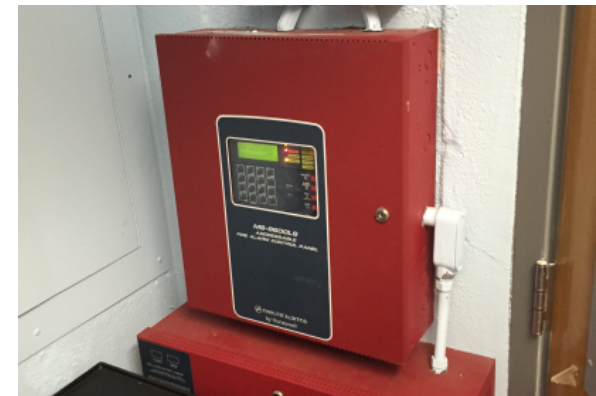
Fire alarm control panel is not up to standards

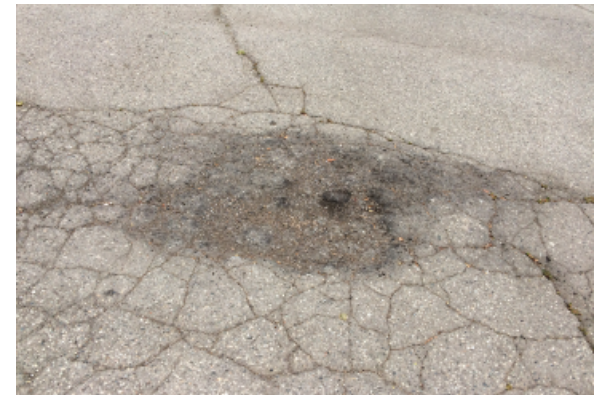
Eroded/cracked asphalt paving

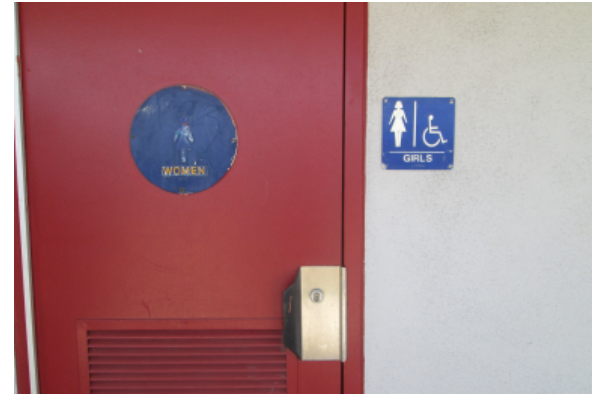
Door signage deteriorating

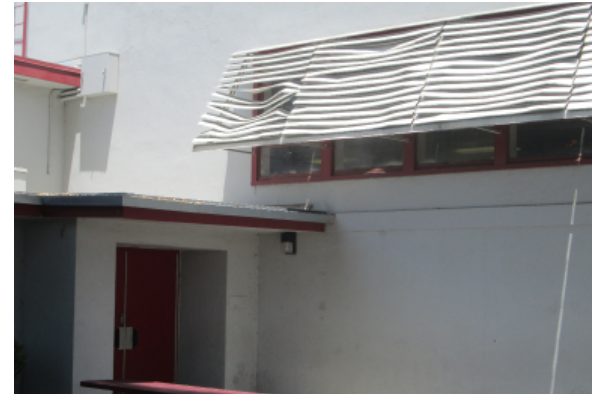
Exterior metal shade damaged

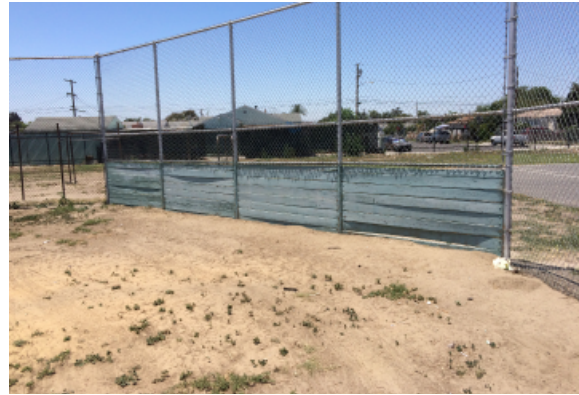
Backstop is broken/rusted, no landscape

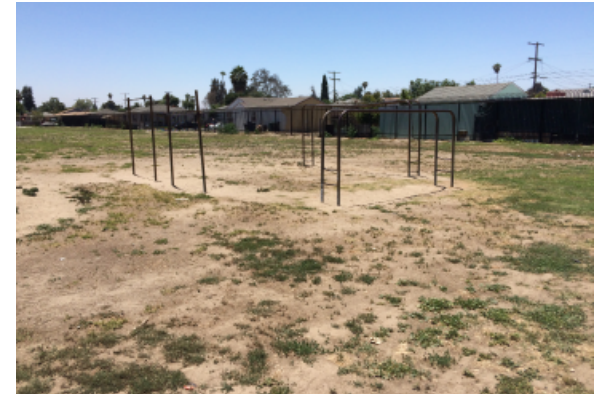
Play equipment is outdated and deemed unsafe

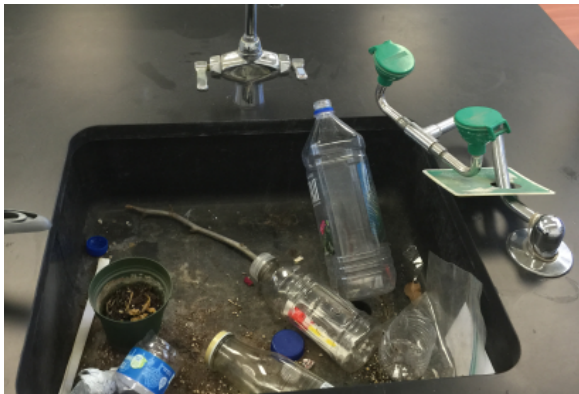
Nonfunctional science room teachers sink

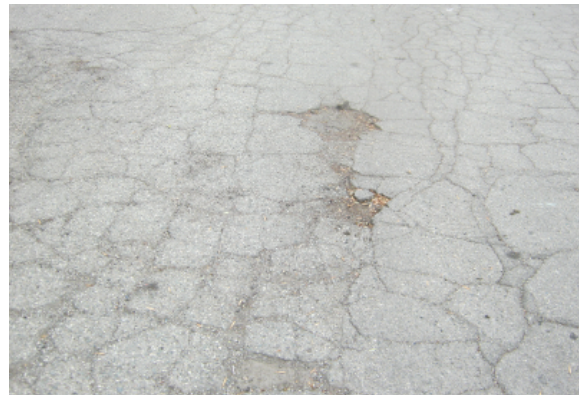
Asphalt cracking allowing for water intrusion

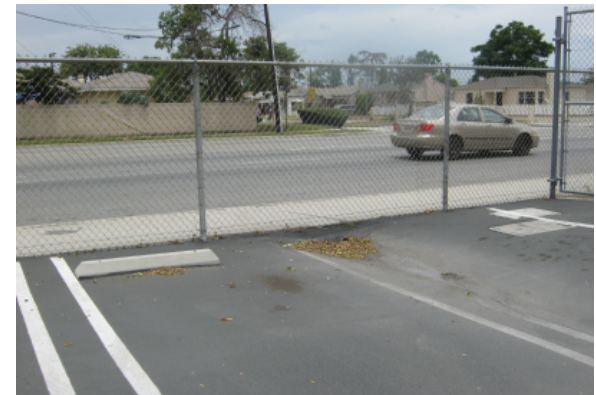
Abcdefg Drain inlet blocked with debris

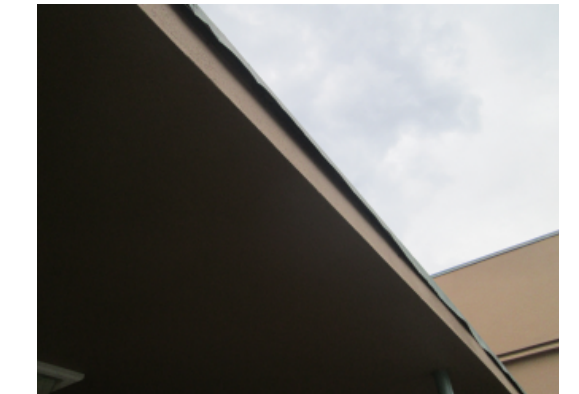
Deteriorating flashing / coping

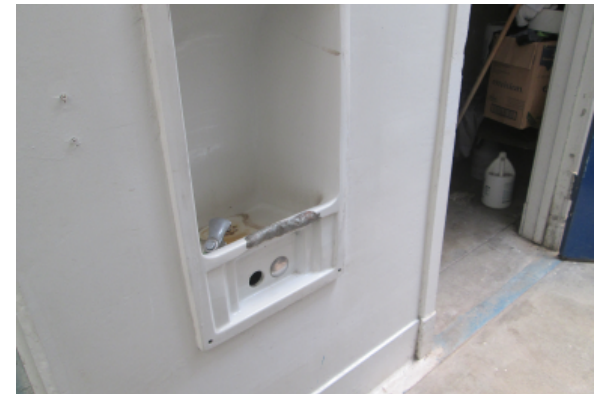
Non Accessible drinking fountain

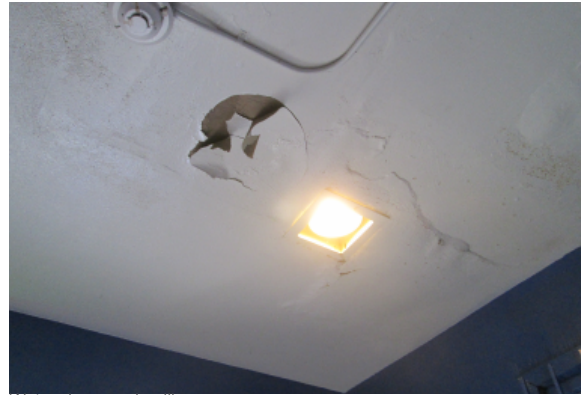
Water damaged ceiling

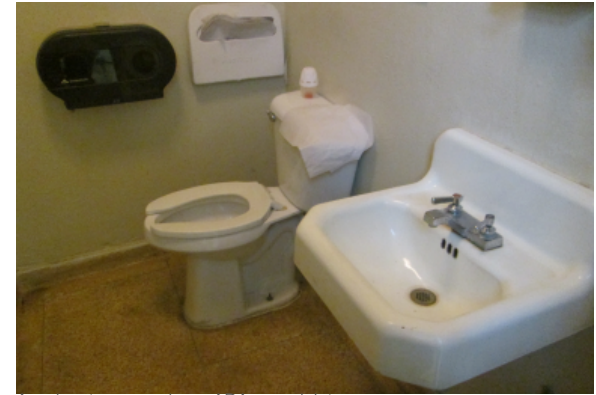
Aged restroom and non ADA complaint

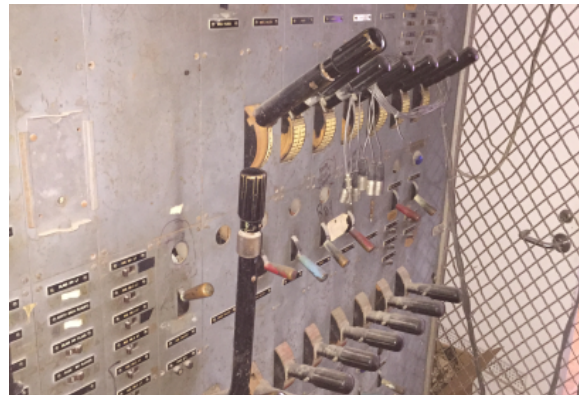
Old distribution equipment needs replacement

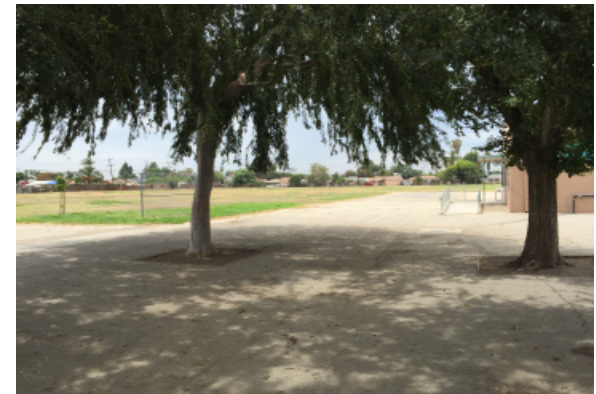
Inadequate site lighting coverage
