COMPTON UNIFIED SCHOOL DISTRICT

COMPTON HIGH SCHOOL CAMPUS WIDE & WEST COCOA STREET PROPERTIES

HISTORICAL RESOURCE ANALYSIS

June 2, 2018

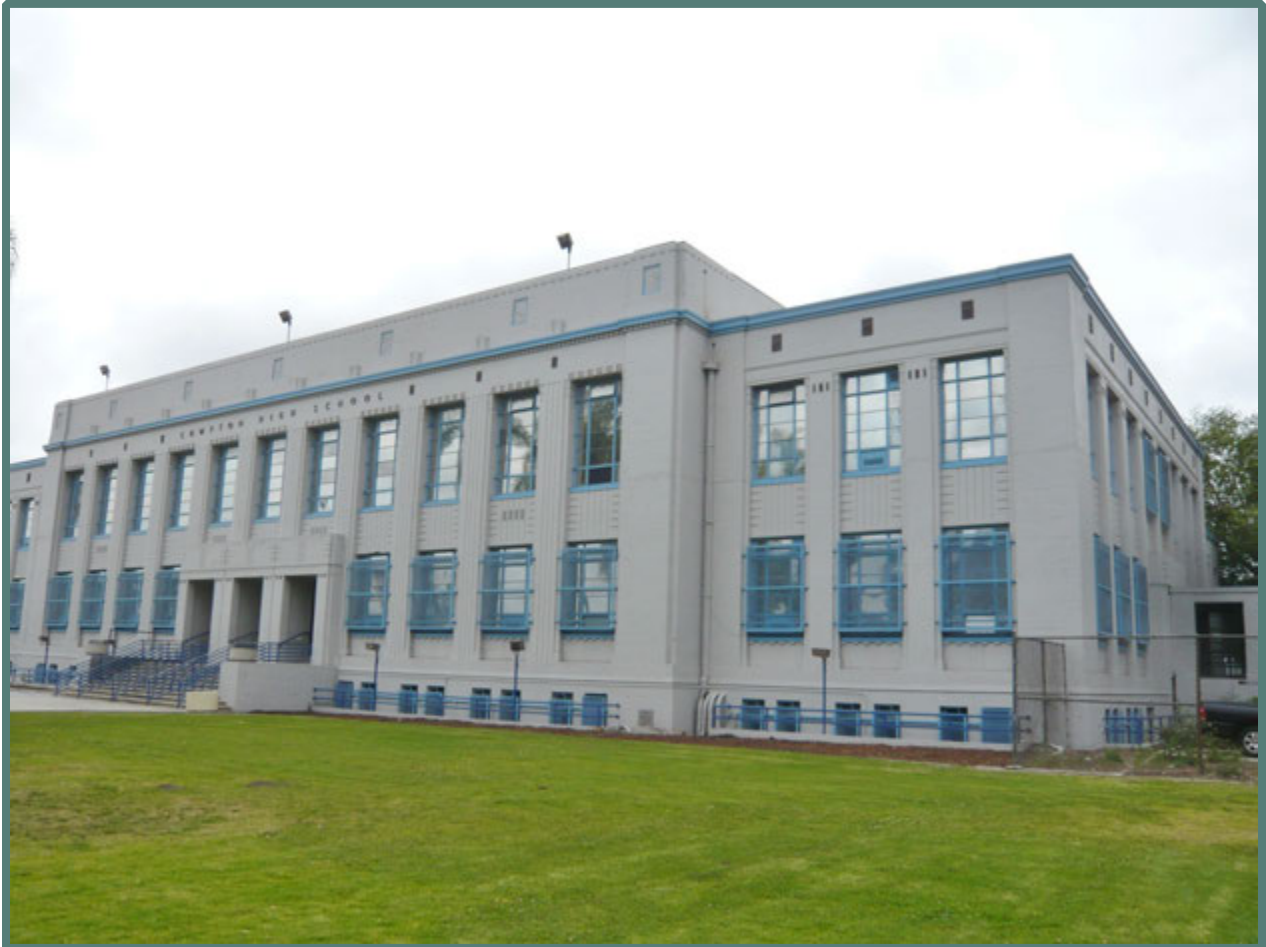
BUILDING "A"
AUDITORIUM AND ADMINISTRATION

INCOMPATIBLE LIGHT FIXTURES AND MULTIPLE UTILITY CONDUITS
HAVE BEEN ADDED TO THE STREET FAÇADE . FENCING AND STEEL SECURITY
SCREENS ALSO COMPROMISE THE FRONT FAÇADE.

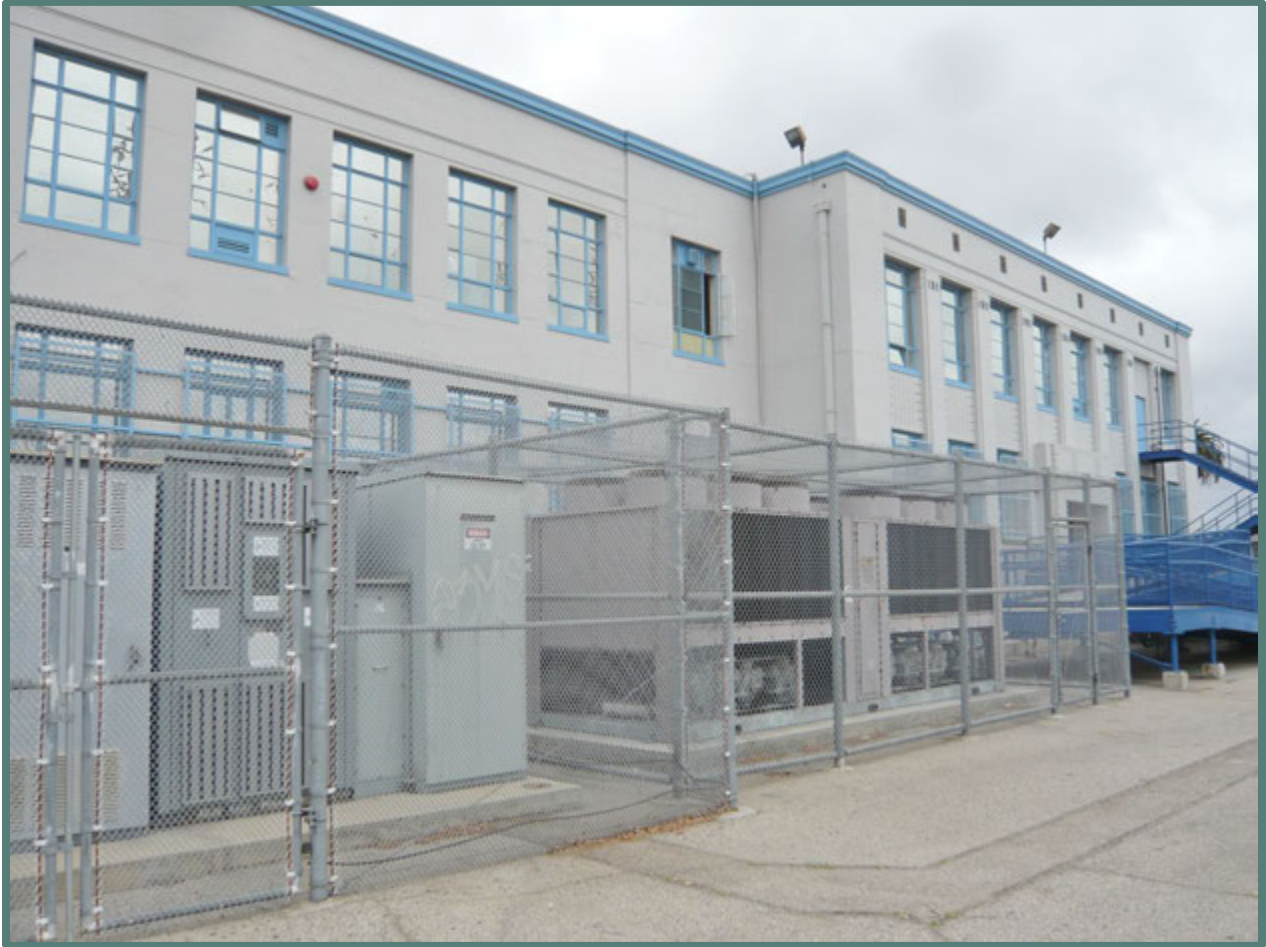
BUILDING "A"
AUDITORIUM AND ADMINISTRATION

DETERIORATING ELECTRICAL SWITCHGEAR AND OBSOLETE
MECHANICAL EQUIPMENT ADJACENT TO THE SOUTH SIDE OF BUILDING "A"

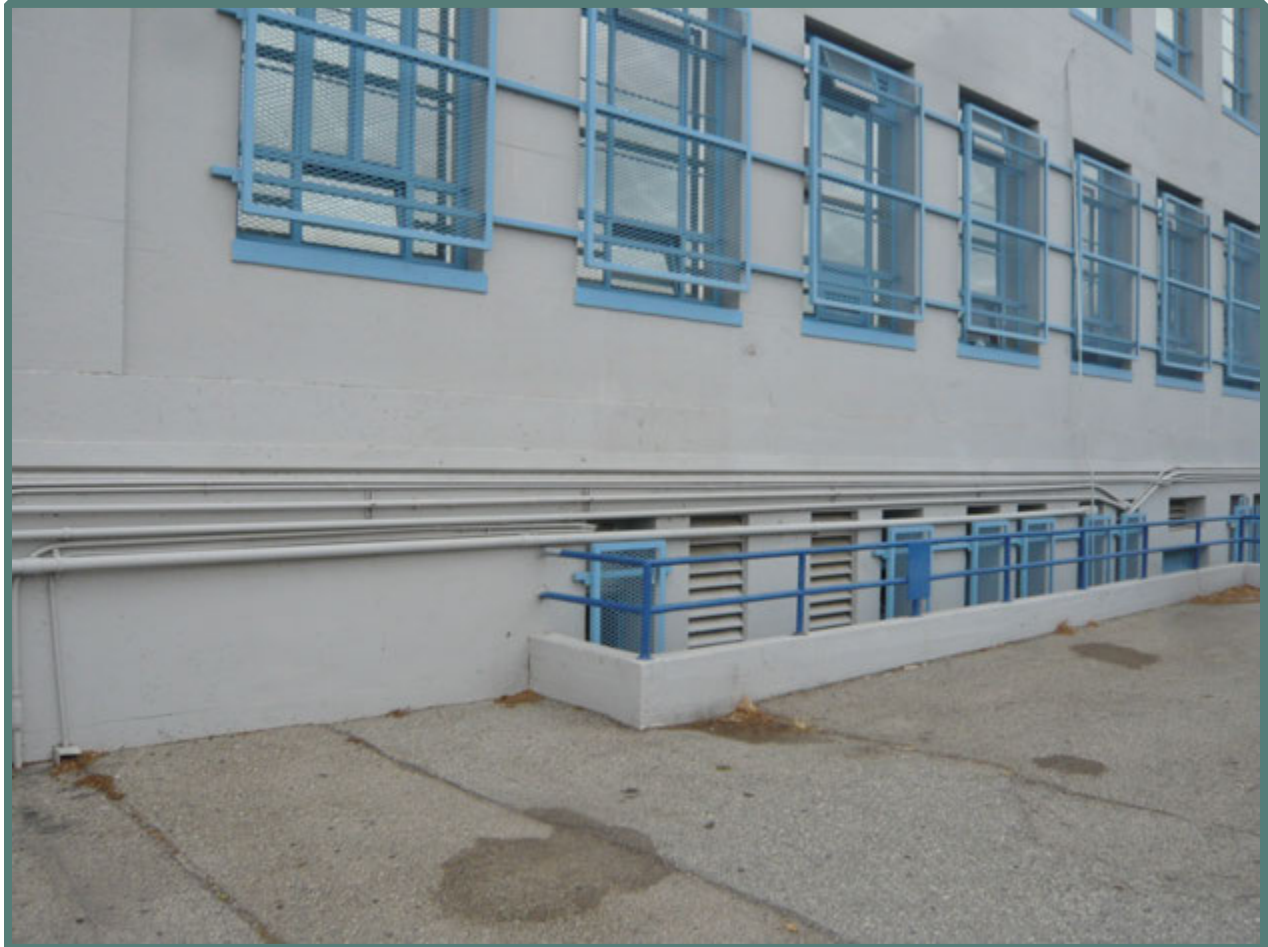
BUILDING "A"
AUDITORIUM AND ADMINISTRATION

ELECTRICAL CONDUIT AND PLUMBING PIPING ADDED TO
THE FAÇADE OF BUILDING "A" OVER THE YEARS.
SECURITY SCREENS ADDED TO ALL FIRST FLOOR WINDOWS
IN MORE RECENT YEARS.

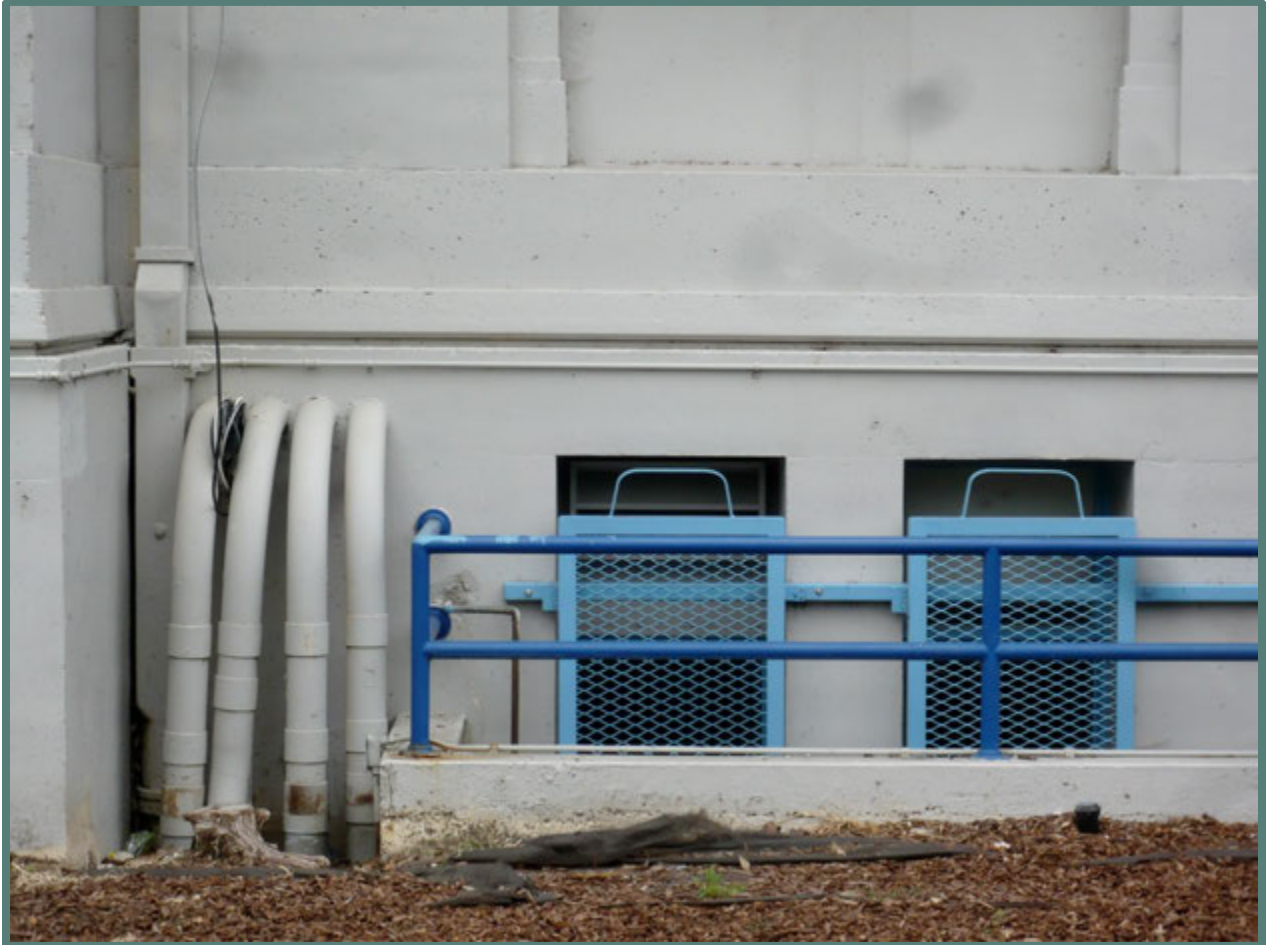
BUILDING "A"
AUDITORIUM AND ADMINISTRATION

ELECTRICAL CONDUIT AND PLUMBING PIPING ADDED
AT FRONT FAÇADE FACING THE PUBLIC STREET

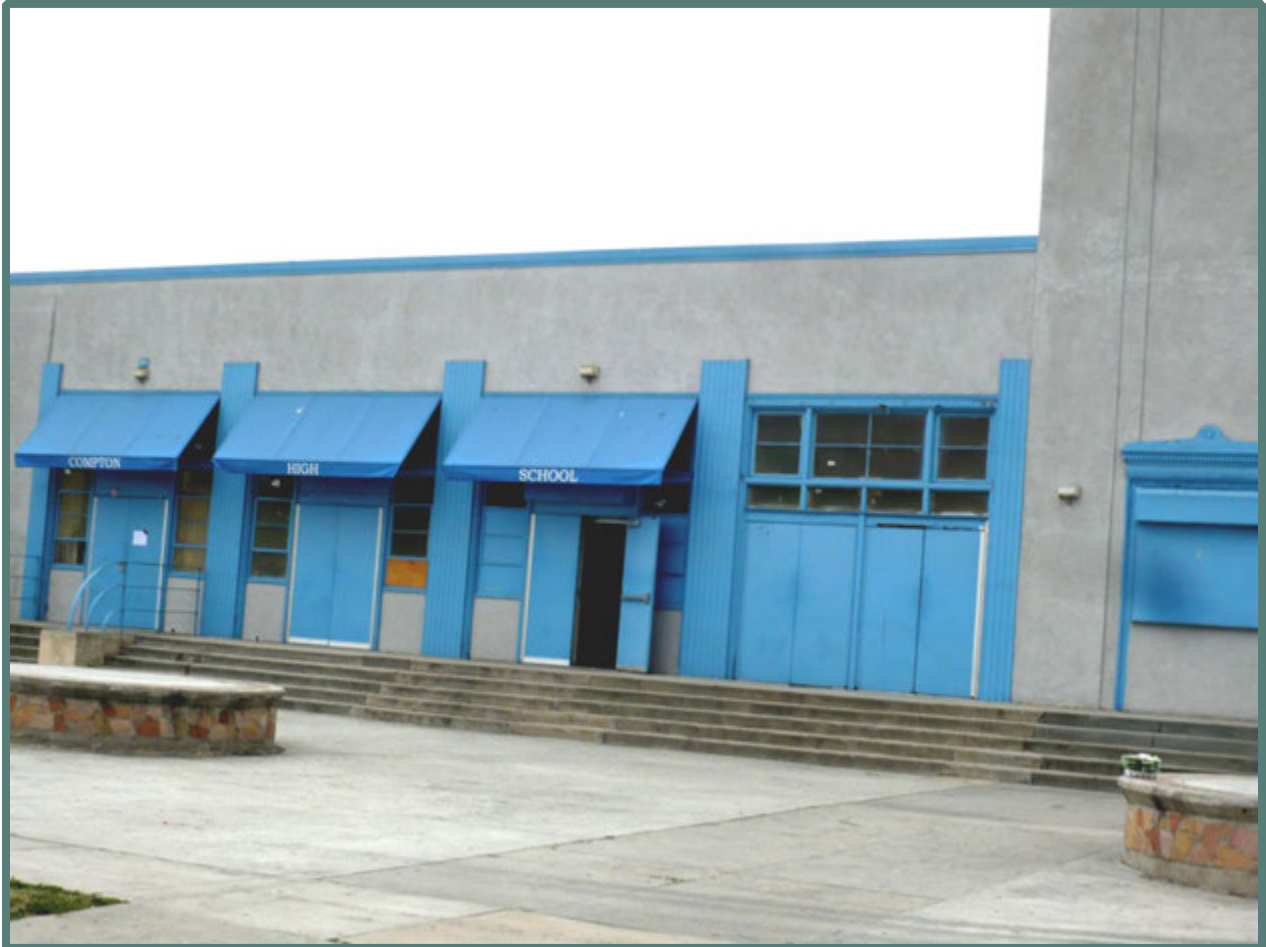
BUILDING "B"
CAFETERIA

ORIGINAL DOORS HAVE BEEN RETROFITTED WITH CONTEMPORARY SOLID SLAB DOORS.
MODERN STYLE AWNINGS HAVE BEEN ADDED. STREAMLINE MODERNE ELEMENTS ARE MINIMAL.

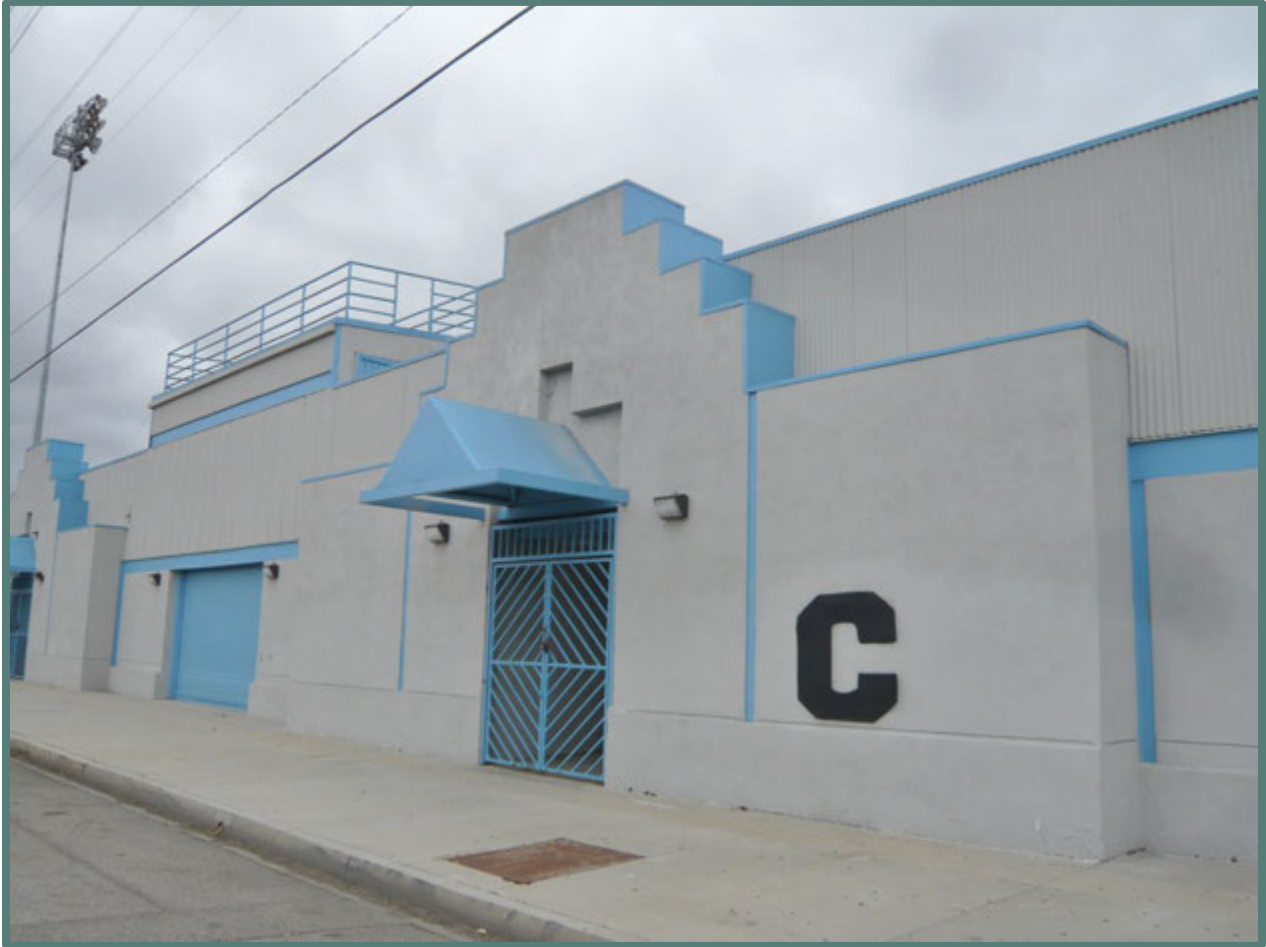
THE FAÇADE OF THE ORIGINAL 1938 ATHLETIC FIELD GRANDSTAND
WAS GIVEN A STREAMLINE MODERNE STYLE FACELIFT – CIRCA 1960'S.

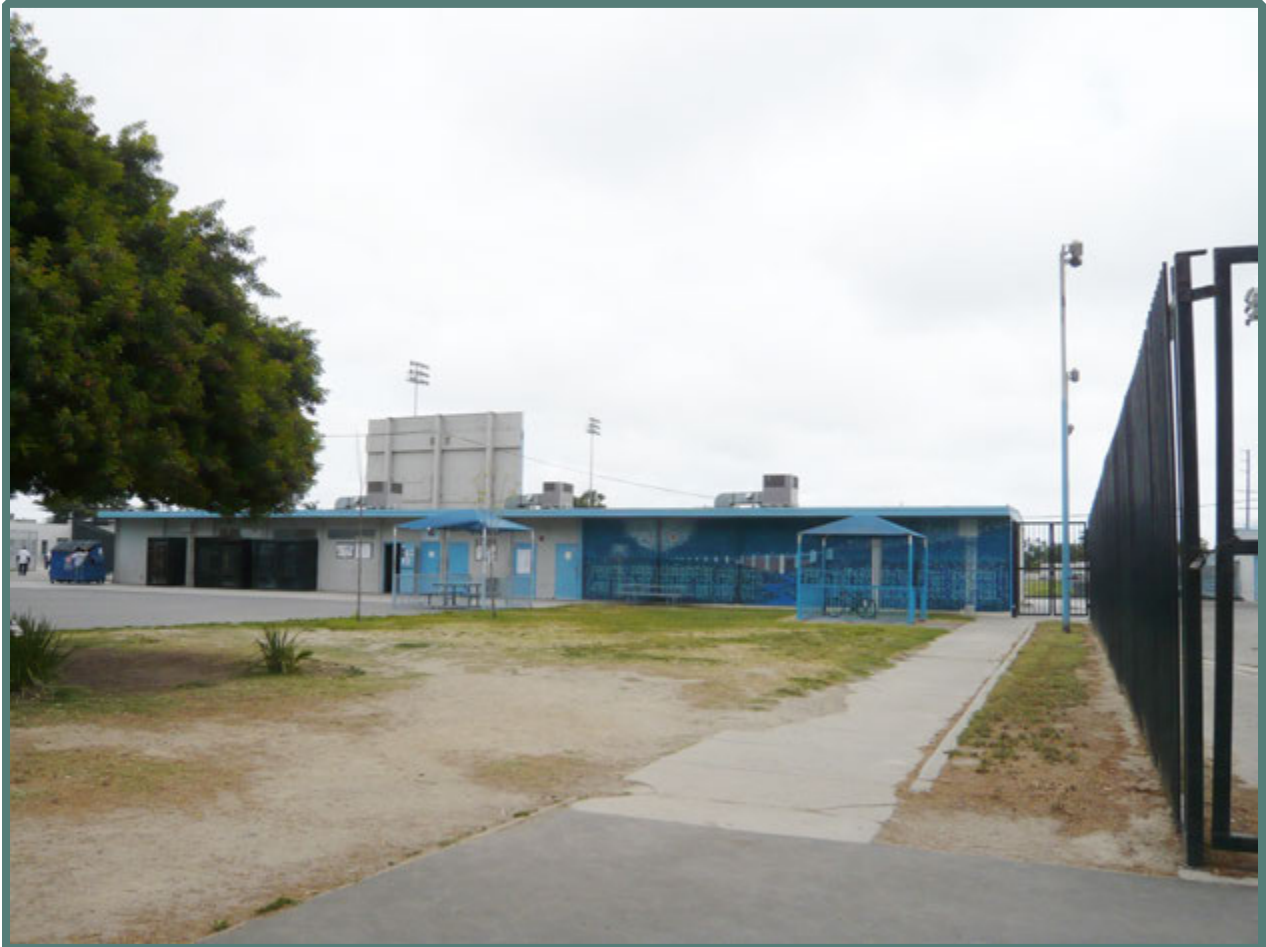
ATHLETIC FIELD
NORTH ENTRY

CRACKED CONCRETE, FAILING ASPHALT, STUNTED GRASS AND BARE DIRT
ARE TYPICAL THROUGHOUT THE CAMPUS GROUNDS. PLANTINGS ARE MINIMAL

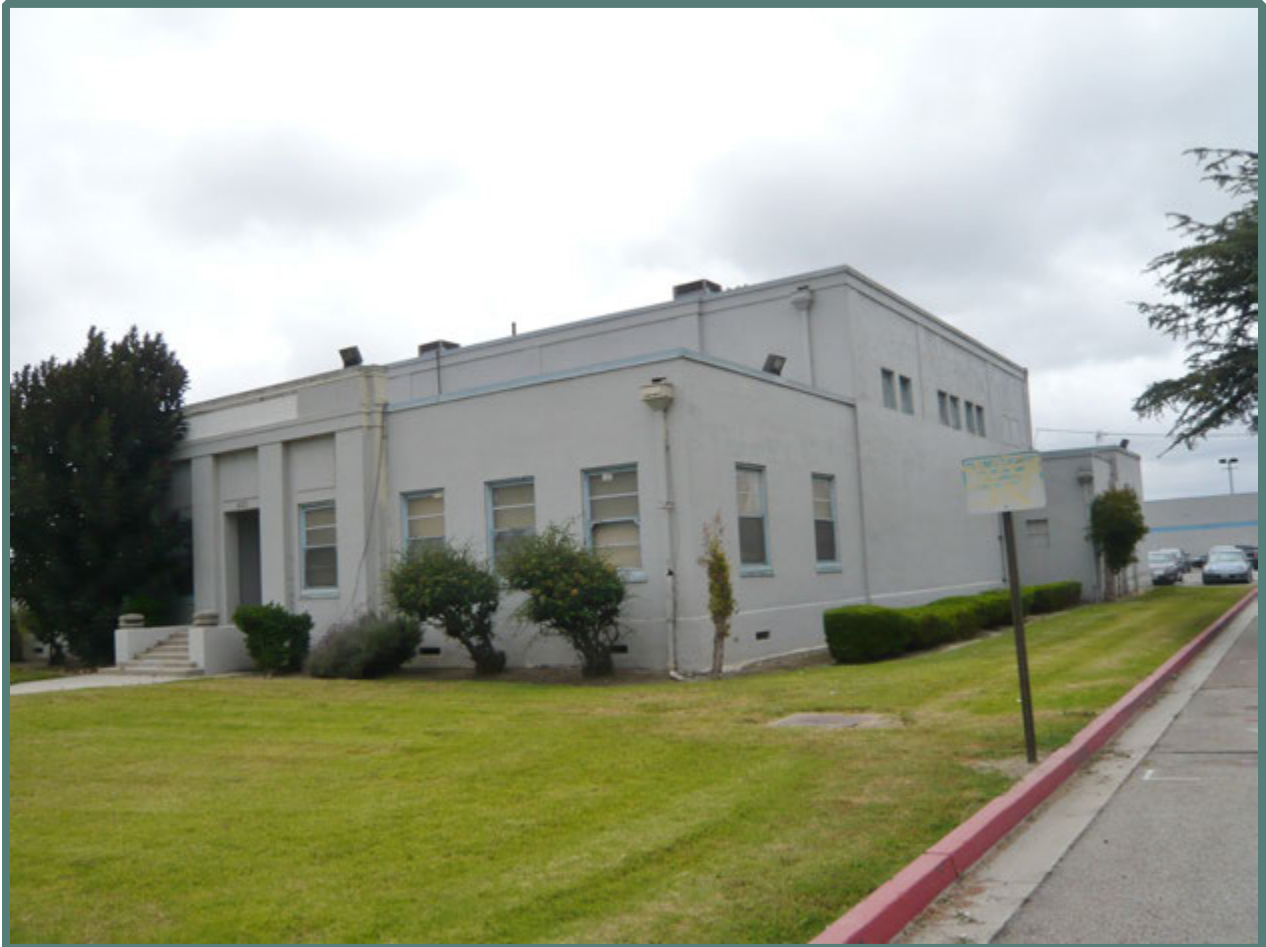
BUILDING "D"
MEDIA CENTER

DESIGN ELEMENTS AND ARCHITECTURAL DETAILS ARE MISSING OR MINIMAL
ON THE STREET FACING FAÇADE OF ONE OF THE POST-EARTHQUAKE PERIOD BUILDINGS.

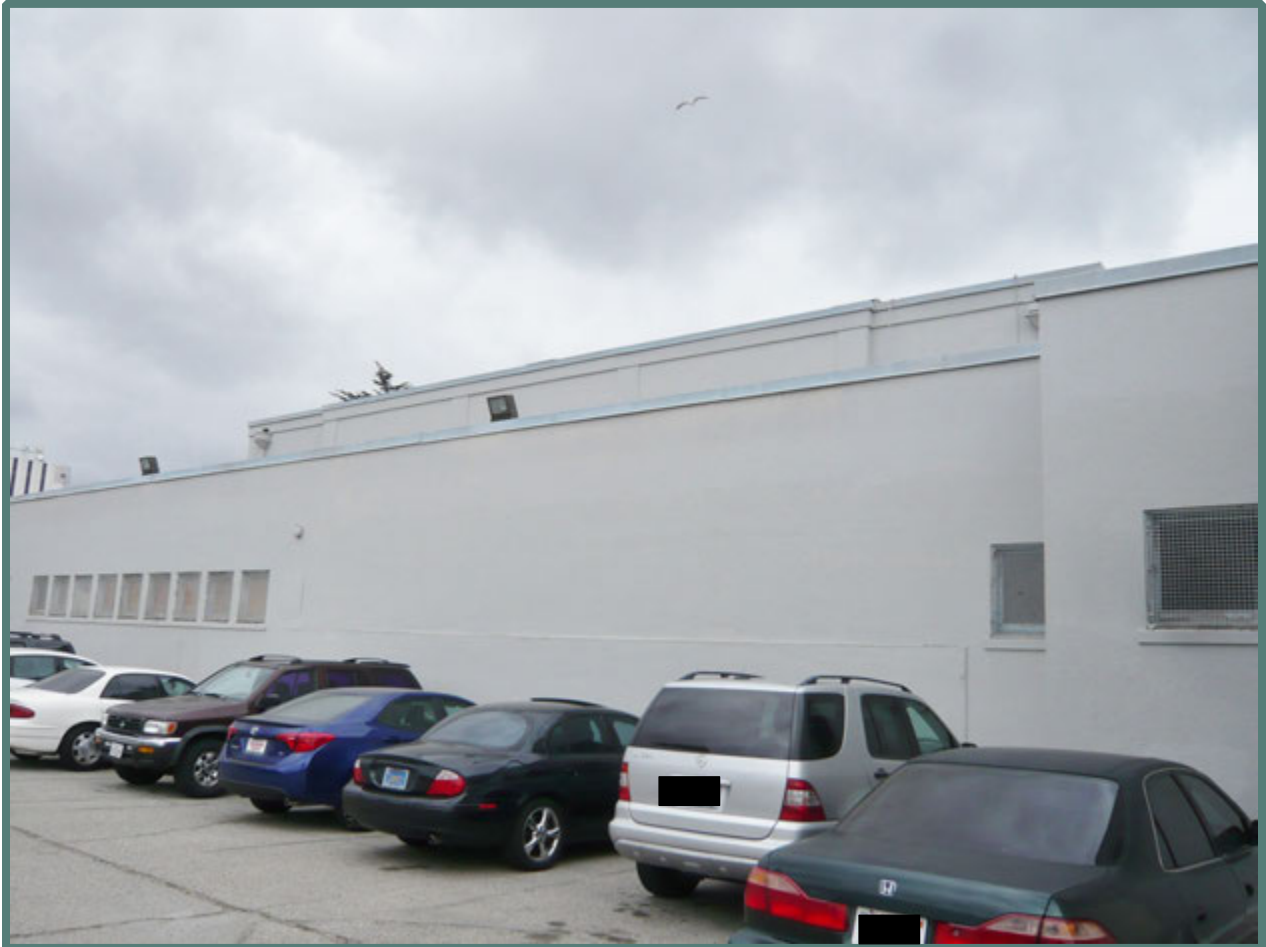
BUILDING “D”
MEDIA CENTER

THE WEST SIDE OF BUILDING “D” IS VOID OF ANY ARCHITECTURAL DETAILS.
RUSTING WINDOWS AND FAILING PAINT ARE TYPICAL THROUGHOUT.

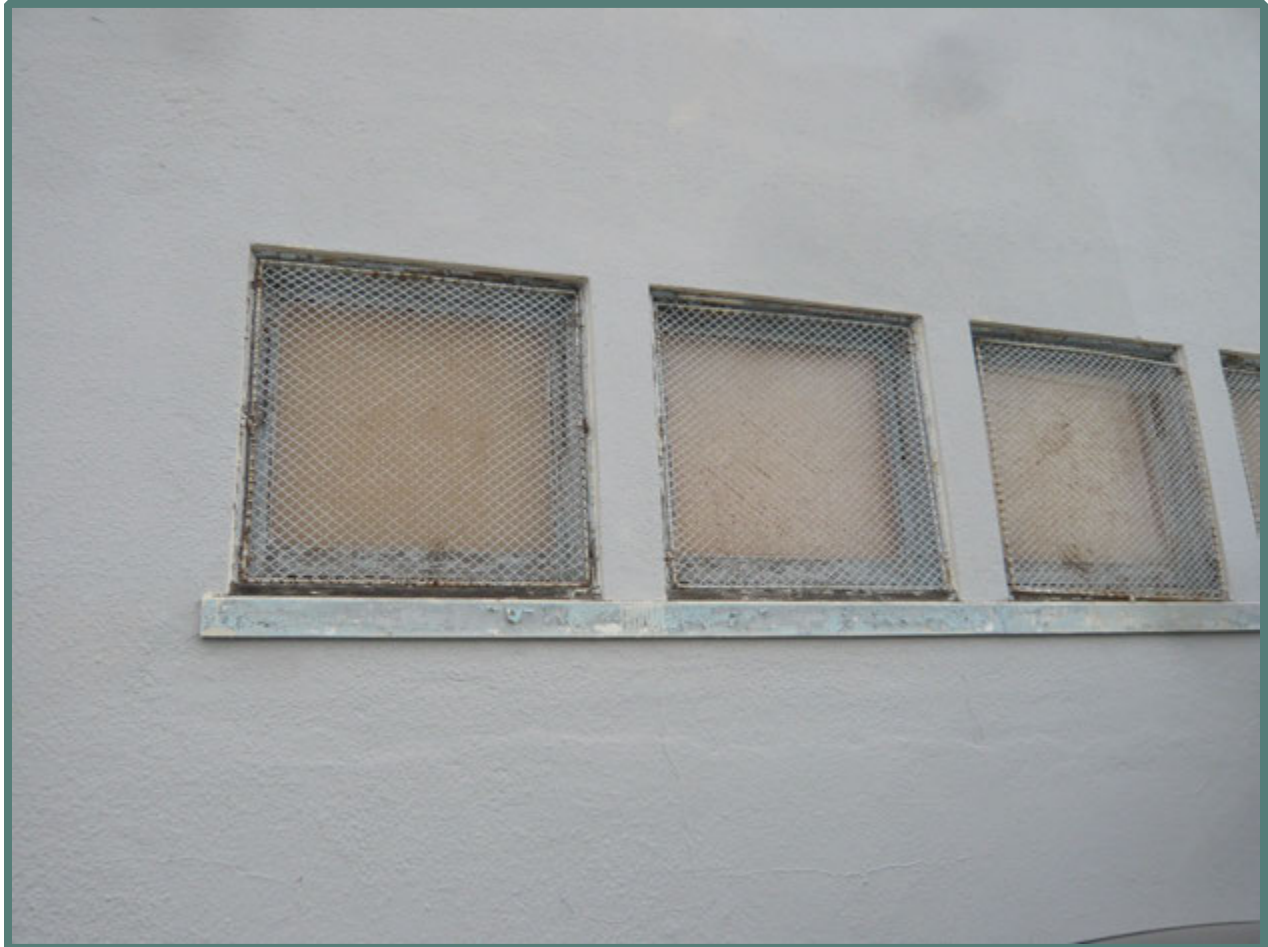
**BUILDING “D”
MEDIA CENTER**

**RUSTING WINDOW SCREENS, INOPERABLE WINDOWS
AND PEELING PAINT ARE TYPICAL THROUGHOUT.**

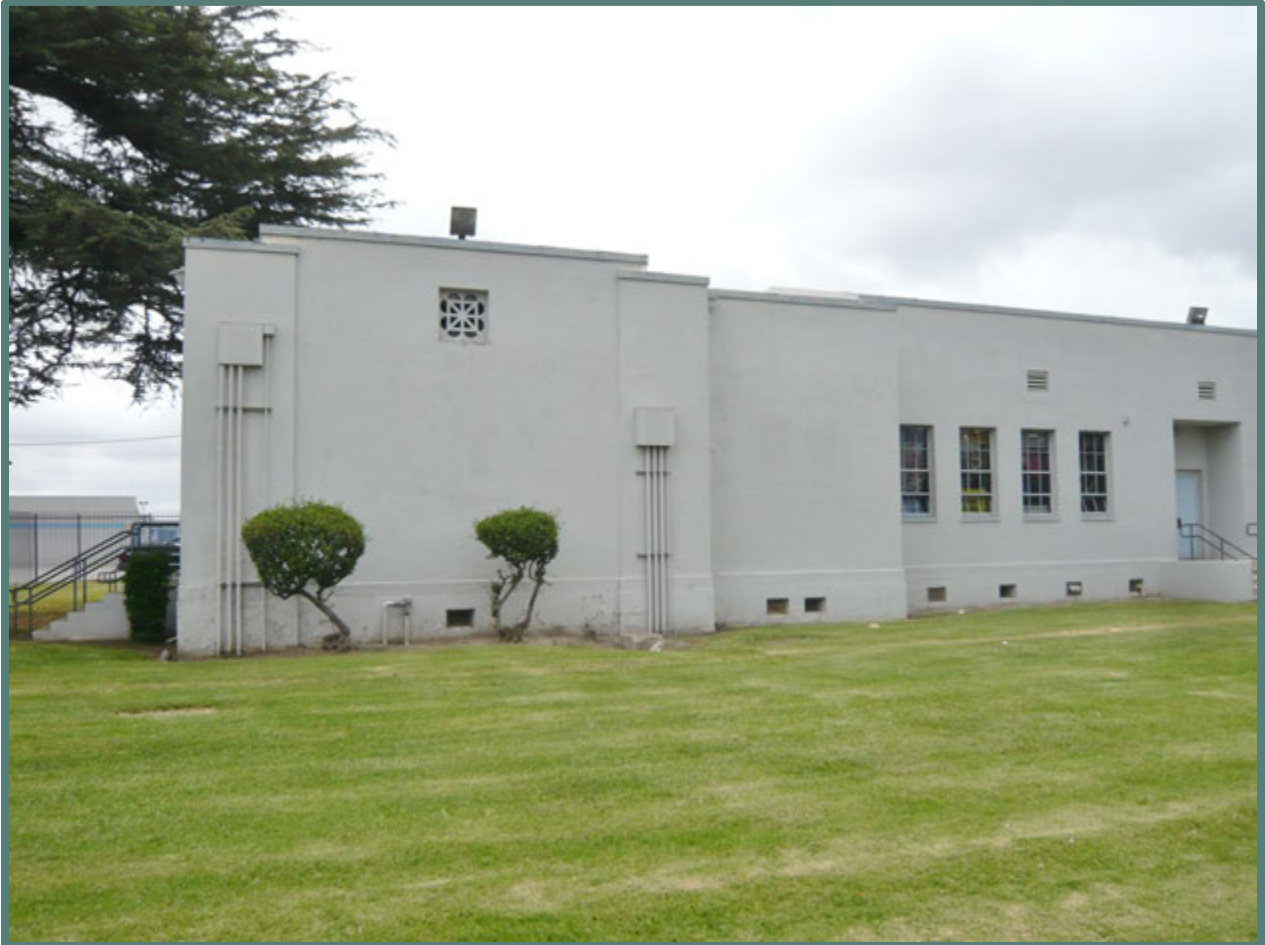
BUILDING “E”
SOCIAL ARTS

ELECTRICAL CONDUIT, LARGE PULL BOXES AND MODERN LIGHT FIXTURES MOUNTED ON THE ORIGINAL NORTH FAÇADE OF THIS PRE-EARTHQUAKE DESIGNED BUILDING. THE ONLY SIGNIFICANT ARCHITECTURAL DETAIL IS THE ONE ATTIC VENT.

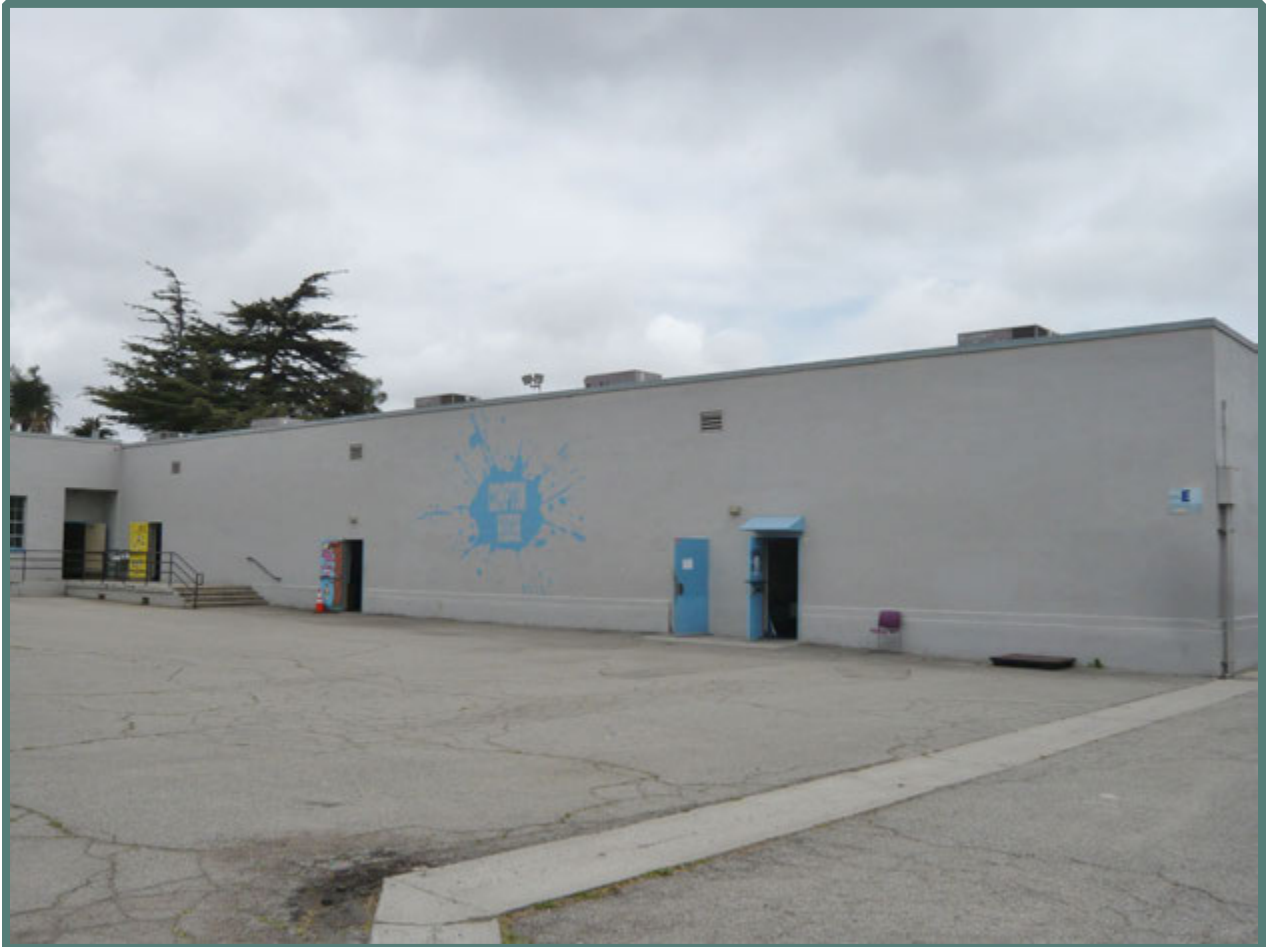
BUILDING “E”
SOCIAL ARTS

ONE OF THE REMAINING TWO ORIGINAL PRE-EARTHQUAKE DESIGNED BUILDINGS.
THE FAÇADES ARE VOID OF ANY DESIGN FEATURES OR ARCHITECTURAL DETAILS.
THE ASPHALT COURTYARD IS COMPLETELY FAILED.

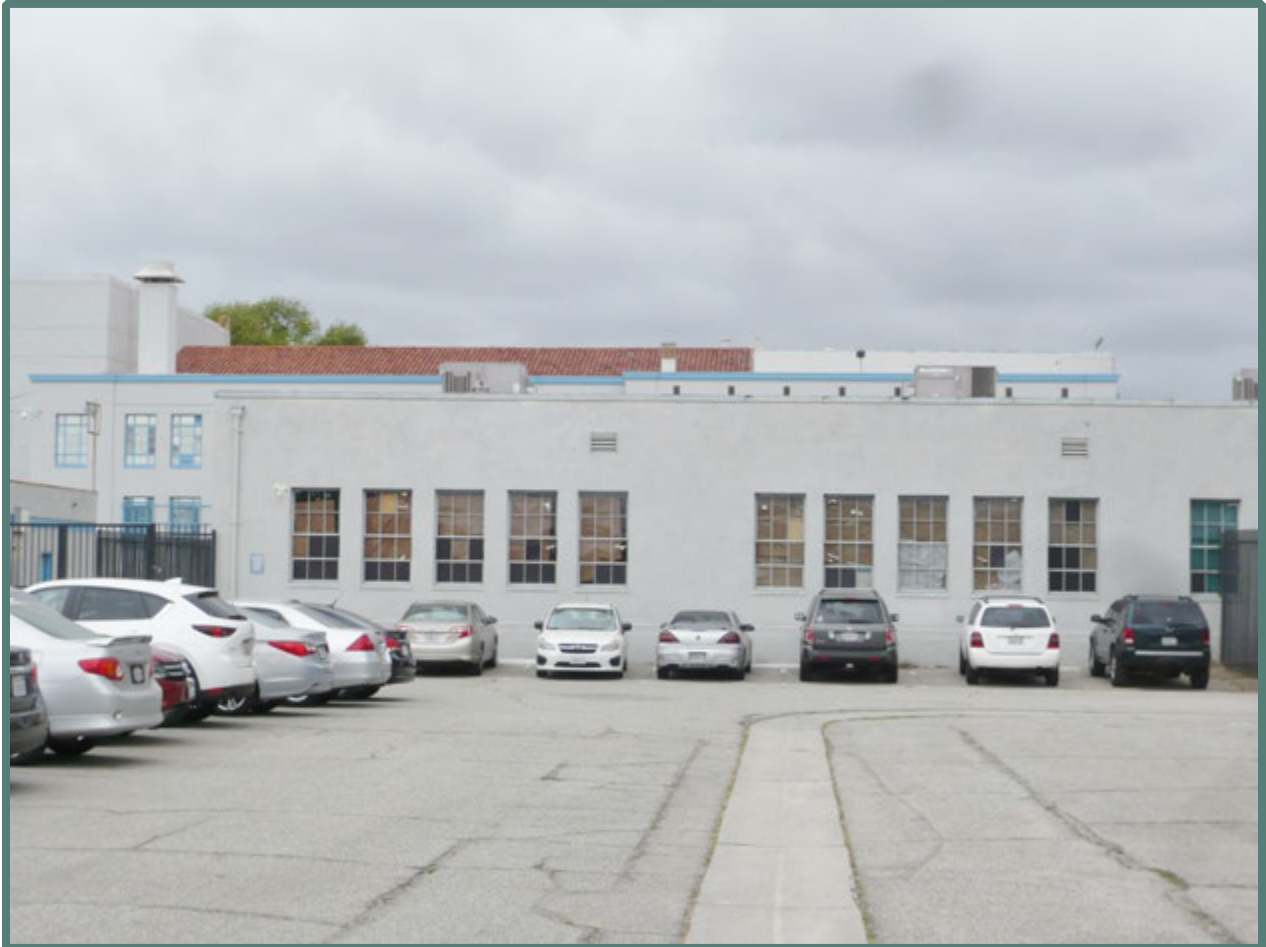
BUILDING “E”
SOUTH FAÇADE

THE FAÇADE IS TYPICAL OF ALL SIDES OF THIS BUILDING – VOID OF ANY DESIGN FEATURES OR ARCHITECTURAL DETAILS. WINDOW SASHES ARE TYPICAL INDUSTRIAL DESIGN. MOST WINDOWS ARE NOT OPENABLE.

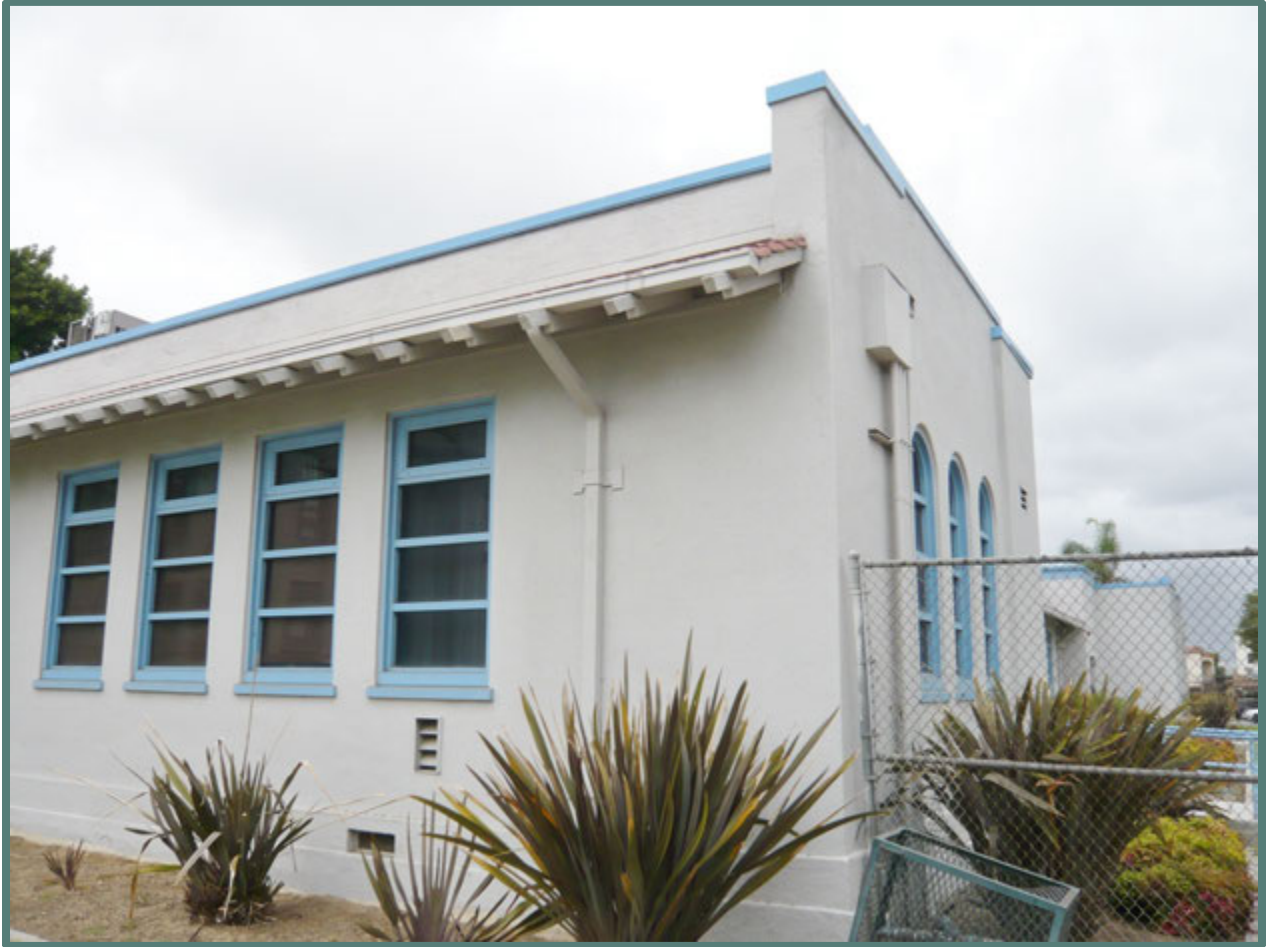
BUILDING “F”
HOME ECONOMICS

TERRA-COTTA TILE EYEBROW AWNINGS AND ARCHTOP WINDOWS AT FRONT FAÇADE SUGGEST THE SPANISH REVIVAL STYLE OF ARCHITECTURE. THE APPEARANCE OF THE FAÇADES IS VERY PLAIN AND MINIMALISTIC. LARGE ELECTRICAL CONDUITS AND PULL BOXES ARE MOUNTED ON THE WEST STREET FACING FAÇADE.

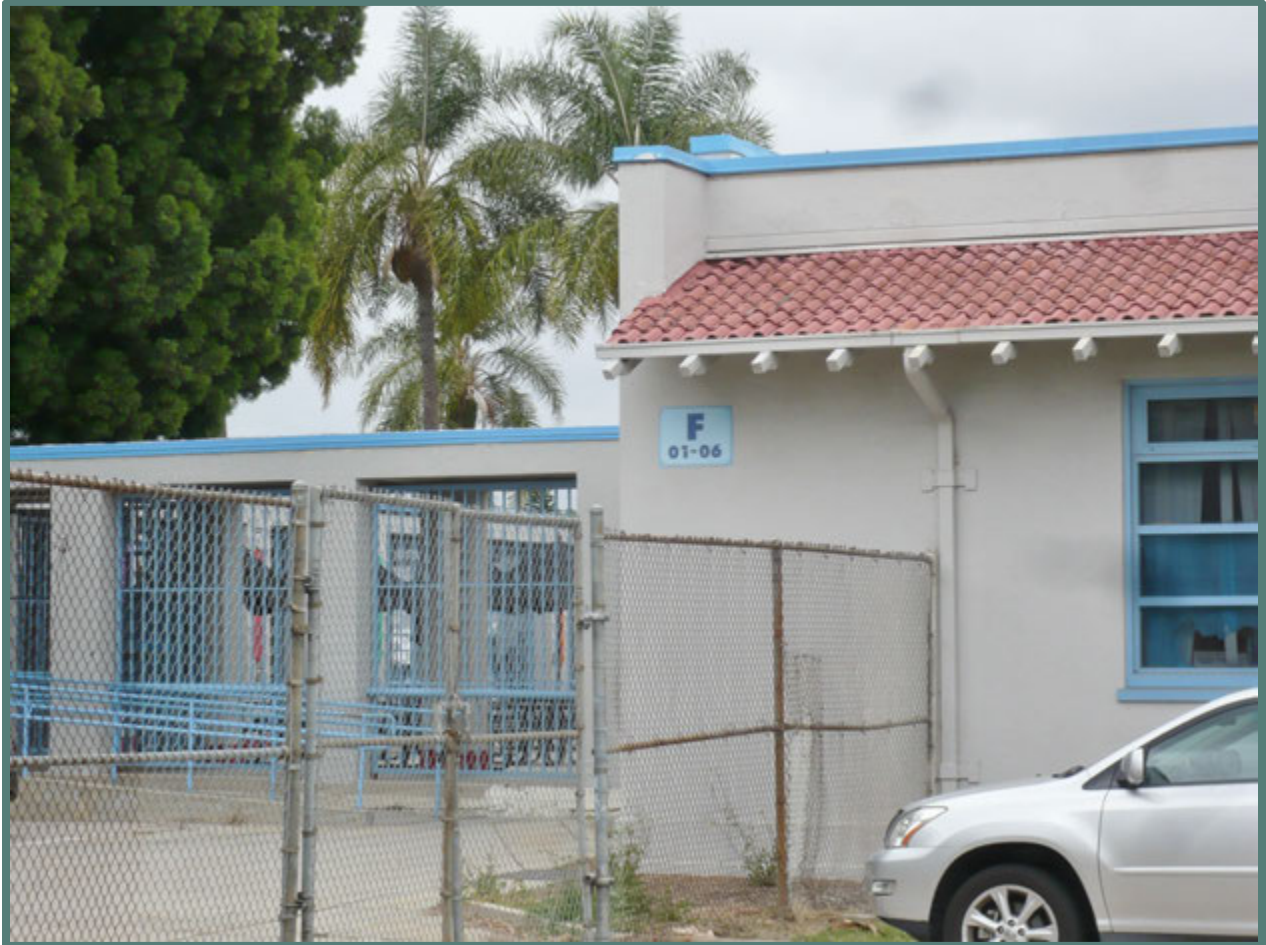
BUILDING "F"
HOME ECONOMICS

THERE IS AN ASSORTMENT OF FENCING TYPES AT ALL BUILDINGS AND THROUGHOUT THE CAMPUS. ALL CHAIN LINK TYPE FENCING IS RUSTING AND FAILING. NOTE STEEL BAR TYPE FENCING AT THE BREEZEWAY AND ROLLED TUBE TYPE RAILINGS AT THE WALKWAYS.

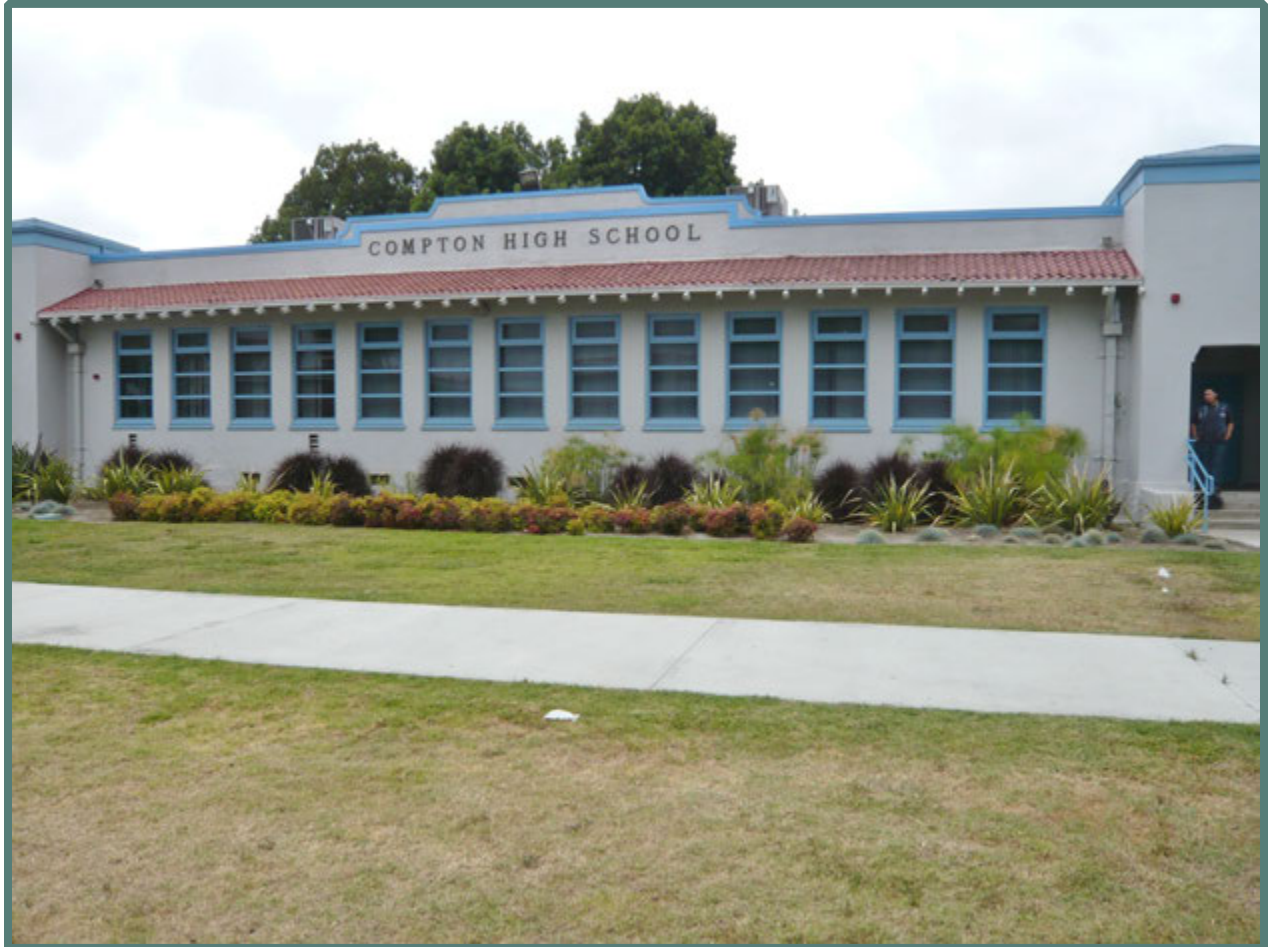
BUILDING "G"
BUSINESS EDUCATION

ONE OF TWO BUILDINGS REMAINING FROM THE ORIGINAL PRE-EARTHQUAKE PERIOD.
THE BUILDING WAS RECONSTRUCTED AFTER THE EARTHQUAKE AND HAS BEEN
REMODELED TWICE SINCE THEN. THE TERRA-COTTA EYEBROW AWNING
AND ROOFLINE RELIEF DETAIL SUGGESTS A SPANISH REVIVAL DESIGN.

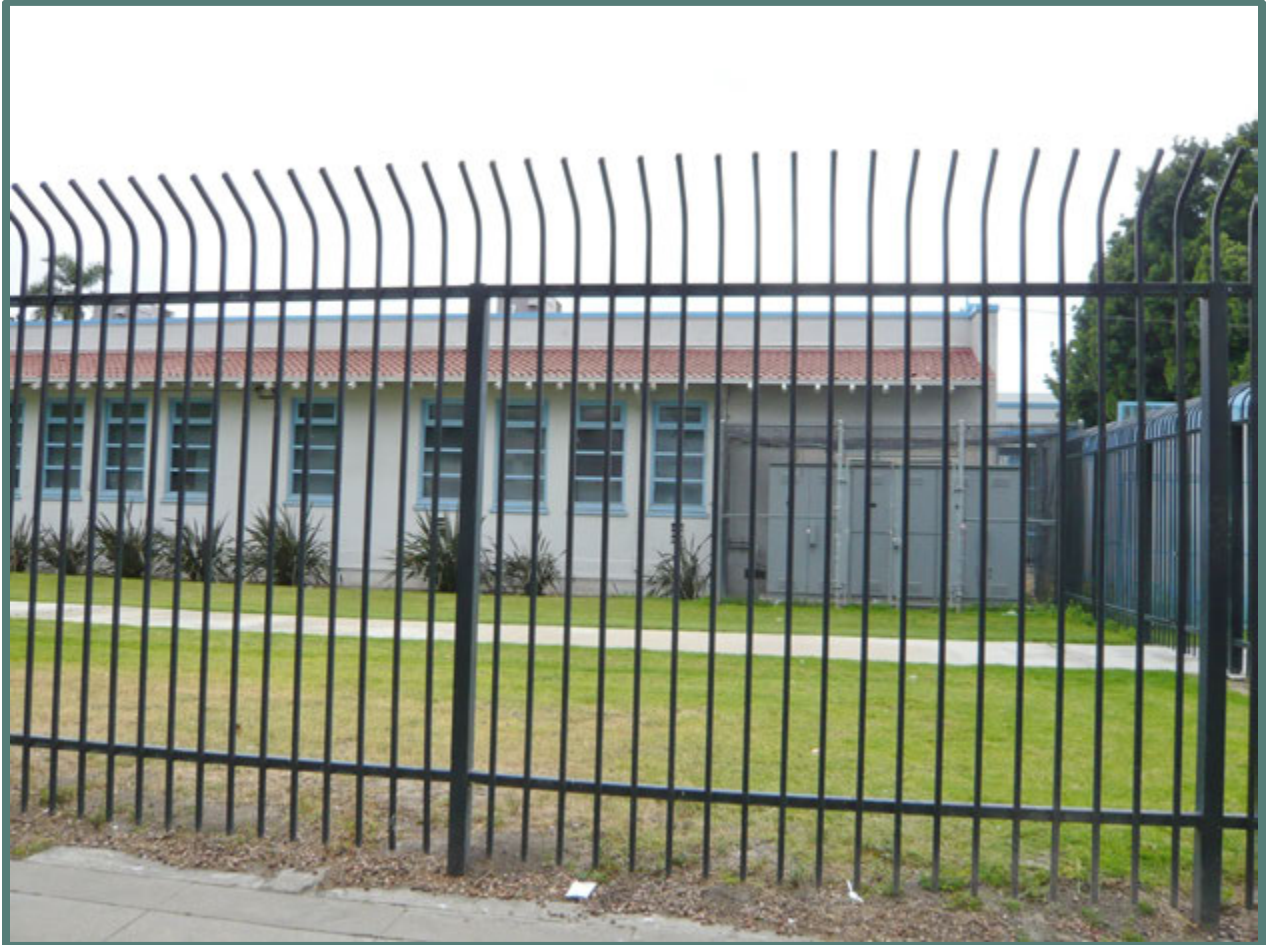
BUILDING "H"
CLASSROOMS

STEEL BAR TYPE FENCING IN THE FOREGROUND AND CHAIN-LINK FENCING
ADJACENT TO THE BUILDING TO ENCLOSE ELECTRICAL SWITCHGEAR EQUIPMENT.

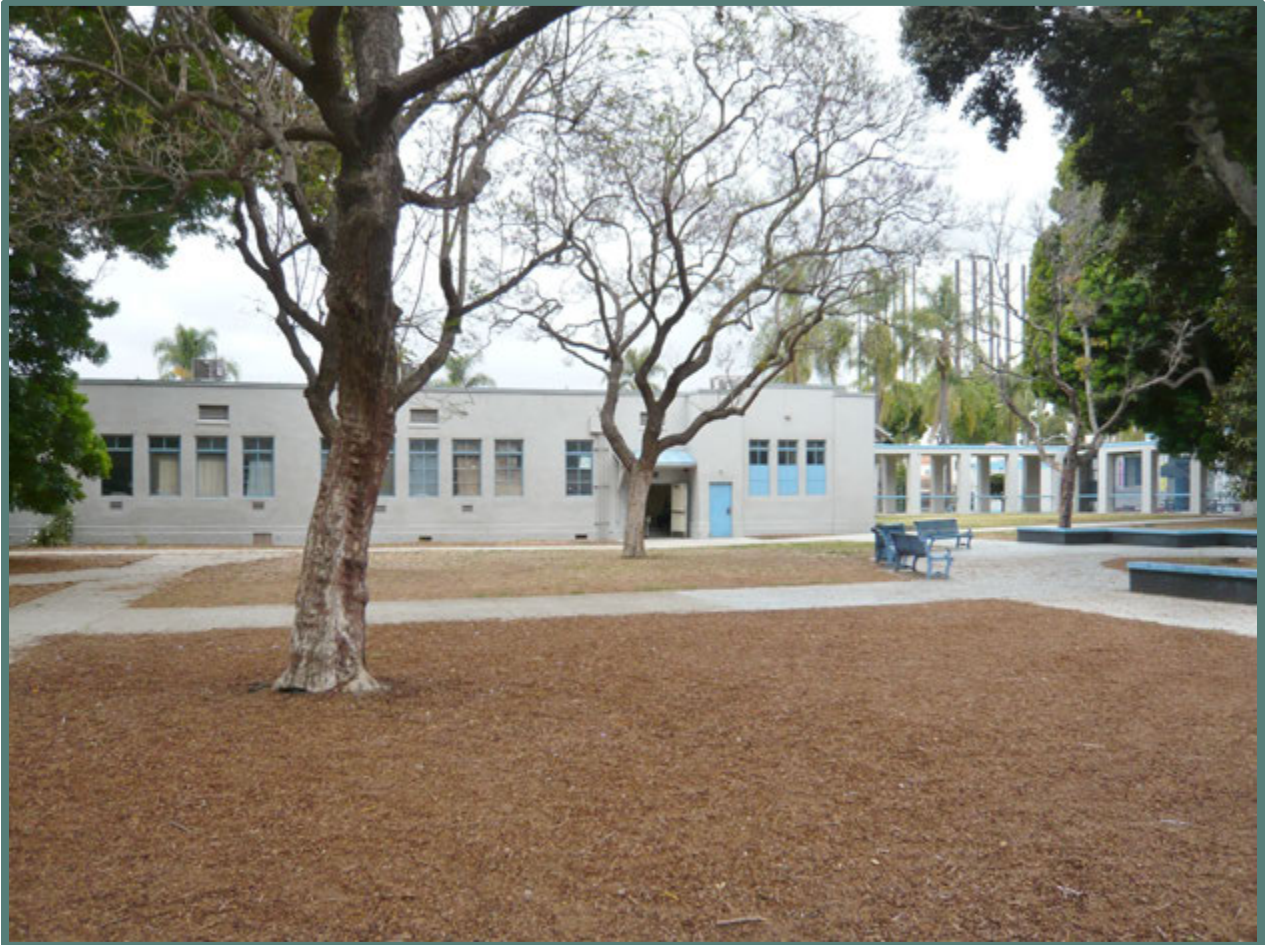
BUILDING "G"
BUSINESS EDUCATION

THE SOUTH FAÇADE OF BUILDING "G", ONE OF THE TWO PRE-EARTHQUAKE BUILDINGS REMAINING ON COMPUS. THE SOUTH, EAST AND WEST FAÇADES ARE VERY MINIMAL IN DESIGN AND ARCHITECTURAL FEATURES. THE TREES ARE NOT OLD GROWTH AND WERE PLANTED IN THE 1950'S – 1960'S. THE "QUAD" AREA IS VOID OF ANY OTHER PLANT MATERIAL.
