COMPTON UNIFIED SCHOOL DISTRICT

COMPTON HIGH SCHOOL CAMPUS WIDE & WEST COCOA STREET PROPERTIES

HISTORICAL RESOURCE ANALYSIS

June 2, 2018

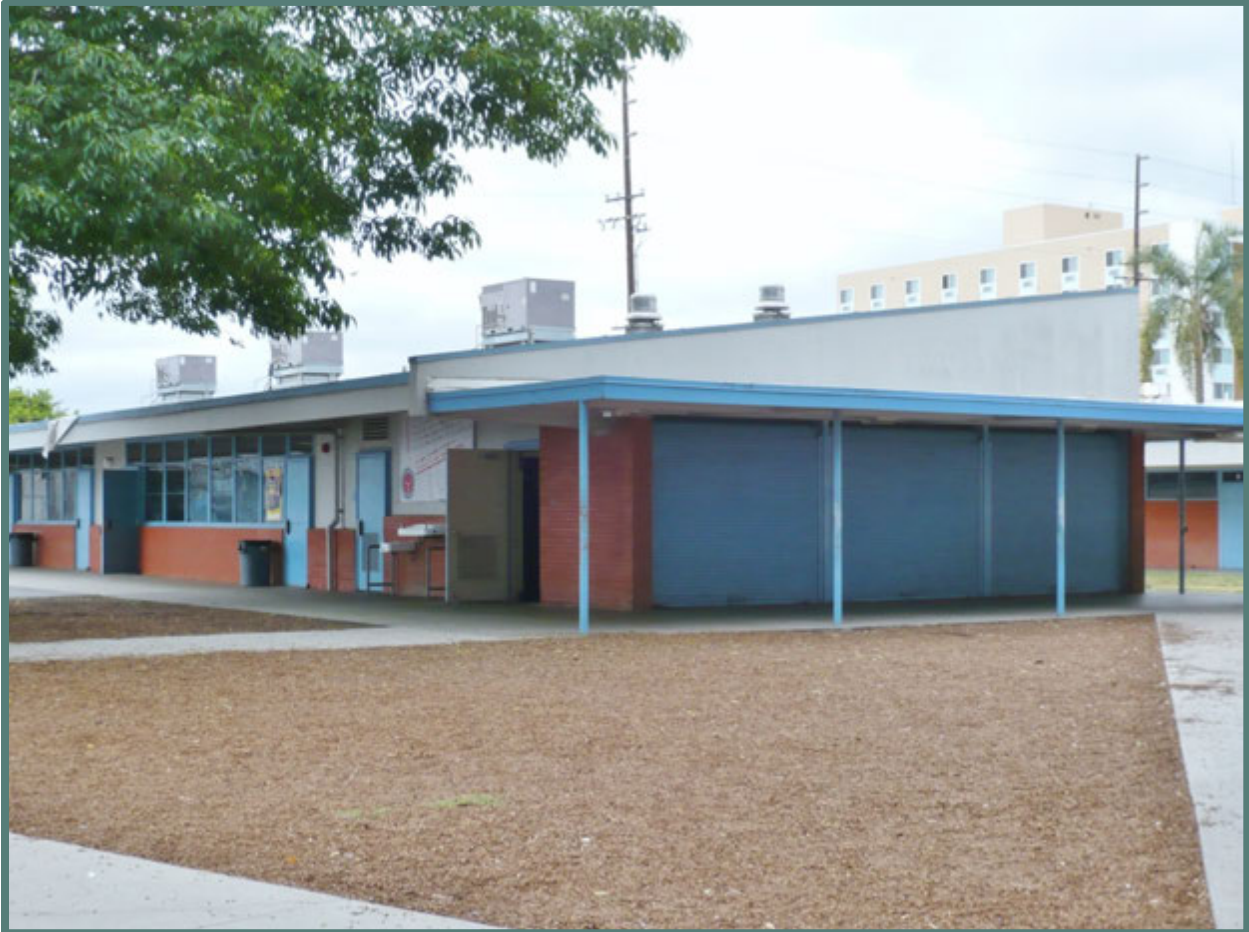
**BUILDING “J”
CLASSROOMS**

THIS BUILDING WAS GIVEN AN EXTERIOR “FACELIFT” IN THE 2004 MODERNIZATION PROGRAM. THE ORIGINAL DOORS AND WINDOWS WERE CHANGED OUT. UNSCREENED MECHANICAL EQUIPMENT WAS INSTALLED ON THE ROOF. THE PLANTER AREAS ON ALL SIDES OF THE BUILDING ARE VOID OF ANY LAWN OR PLANT MATERIALS. RESTROOMS WERE MODIFIED TO BE ADA COMPLIANT PER 2004 CODES.

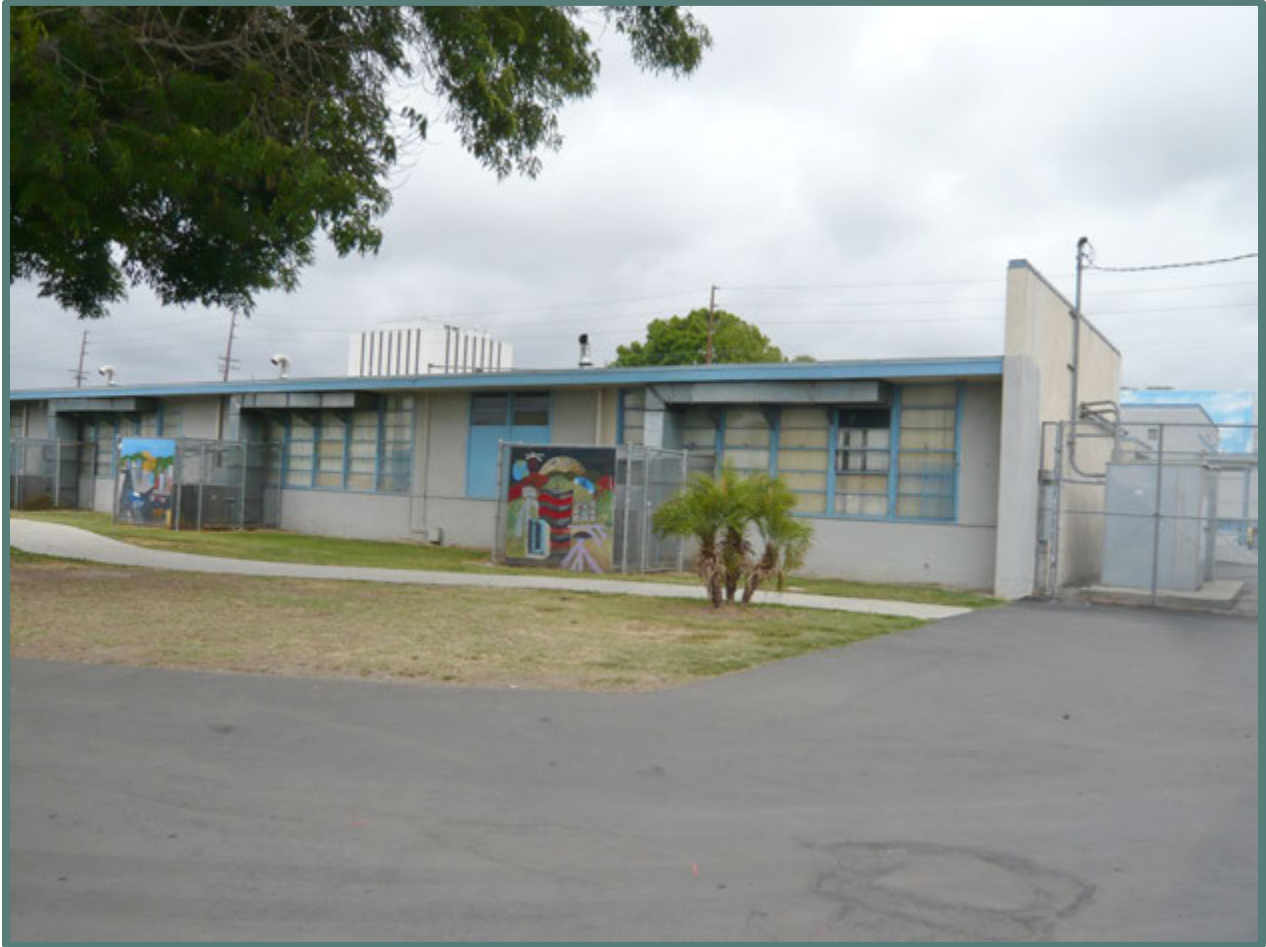
BUILDING "K"
MUSIC BUILDING

THIS BUILDING WAS CONSTRUCTED CIRCA 1938 IN A VERY MINIMAL INSTITUTIONAL DESIGN STYLE. THE EXTERIOR DOORS AND WINDOWS HAVE BEEN REPLACED FROM THE ORIGINALS. CHAIN-LINK ENCLOSED HVAC UNITS AND DUCTWORK HAVE BEEN INSTALLED ALL ALONG THE WEST FAÇADE. A TRANSFORMER AND ELECTRICAL SERVICE WAS ADDED TO THE SOUTH FAÇADE. LANDSCAPING AND PLANTINGS ARE MINIMAL.

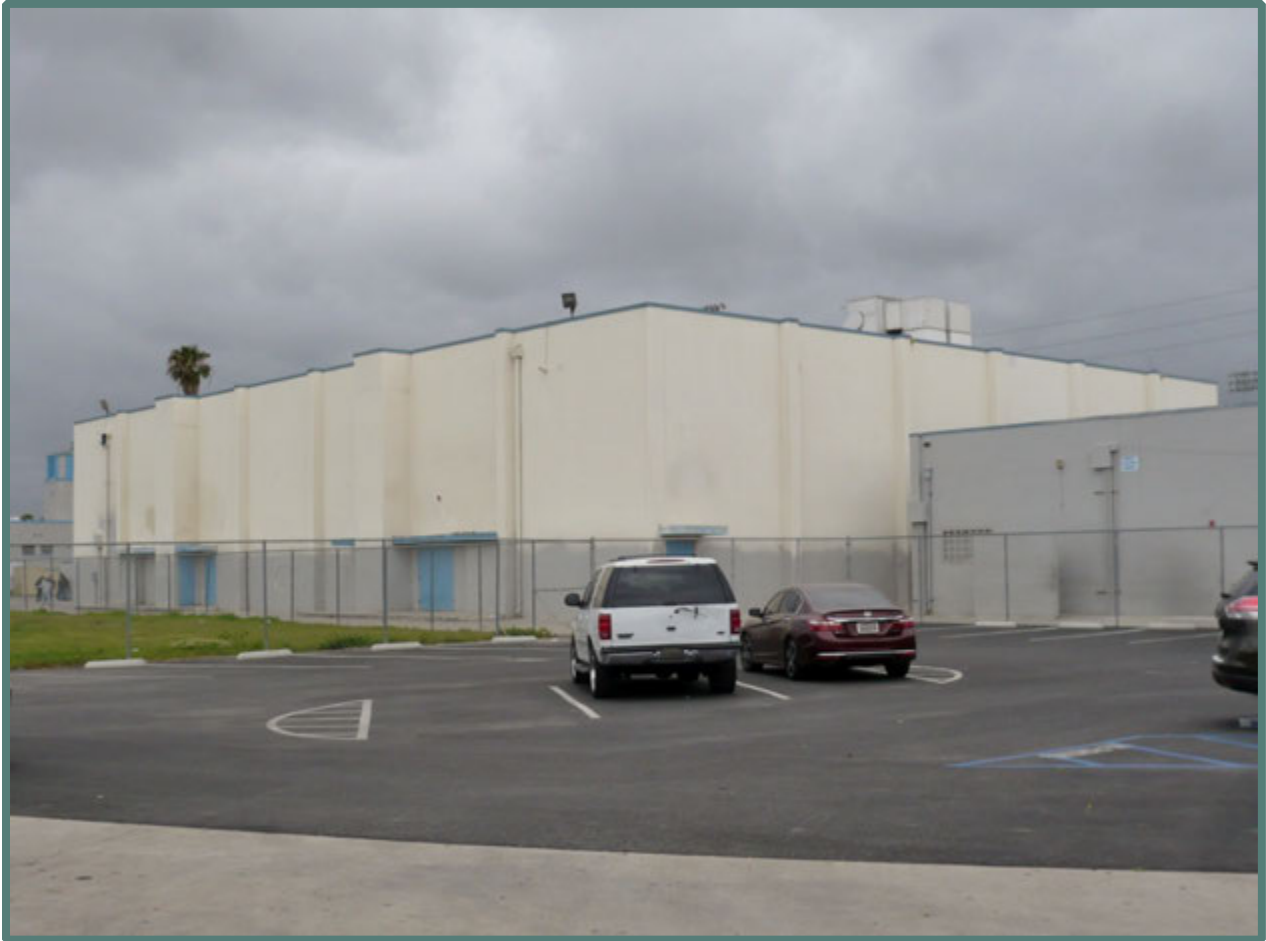
BUILDINGS “M” & “M-1”
GYMNASIUM AND MEN’S LOCKER ROOM

ORIGINAL EXTERIOR DOORS HAVE BEEN REPLACED. ELECTRICAL CONDUIT

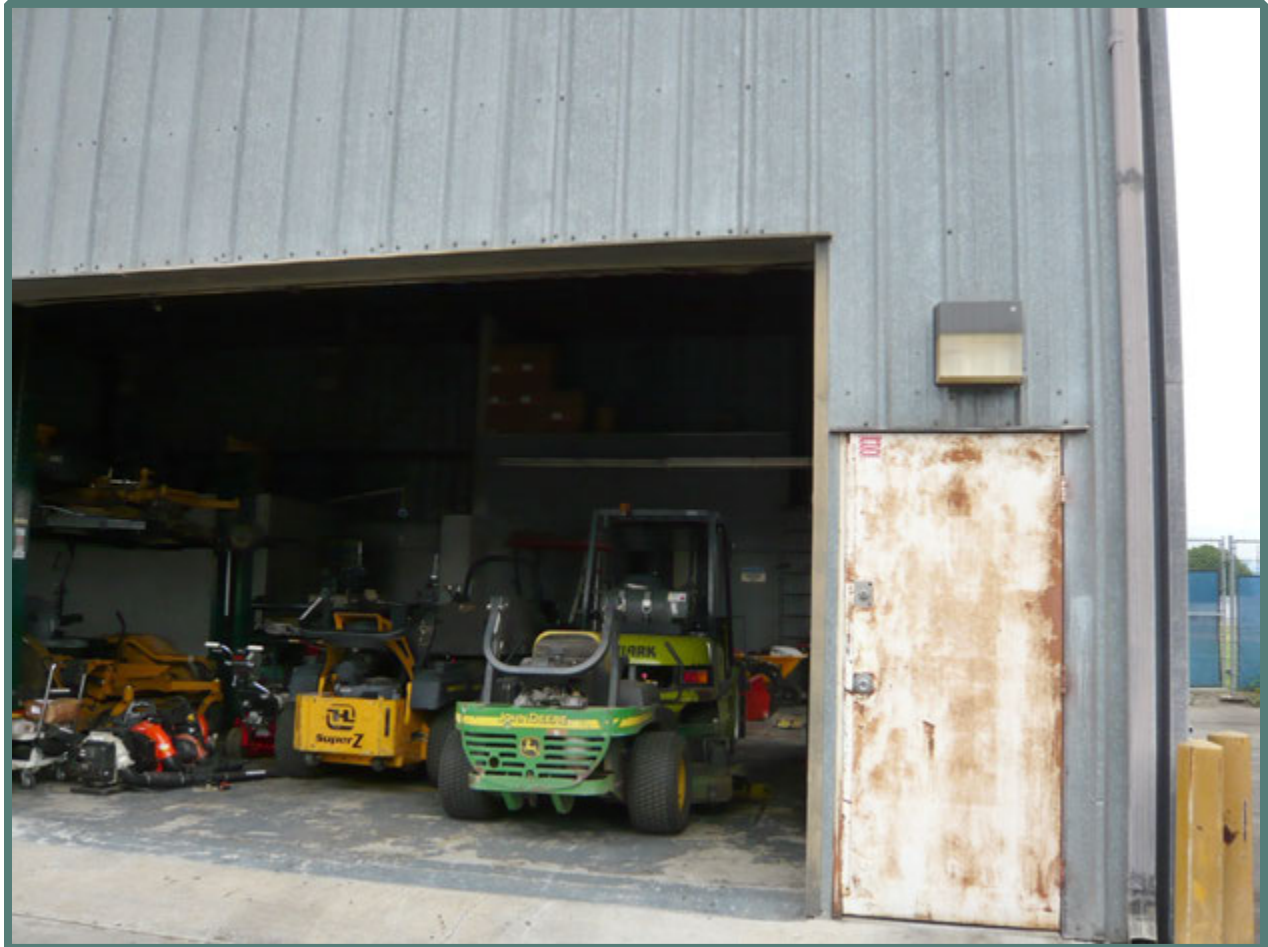
MECHANICAL SHOP

INTERIOR CONCRETE FLOOR IS CRACKED AND FAILING.

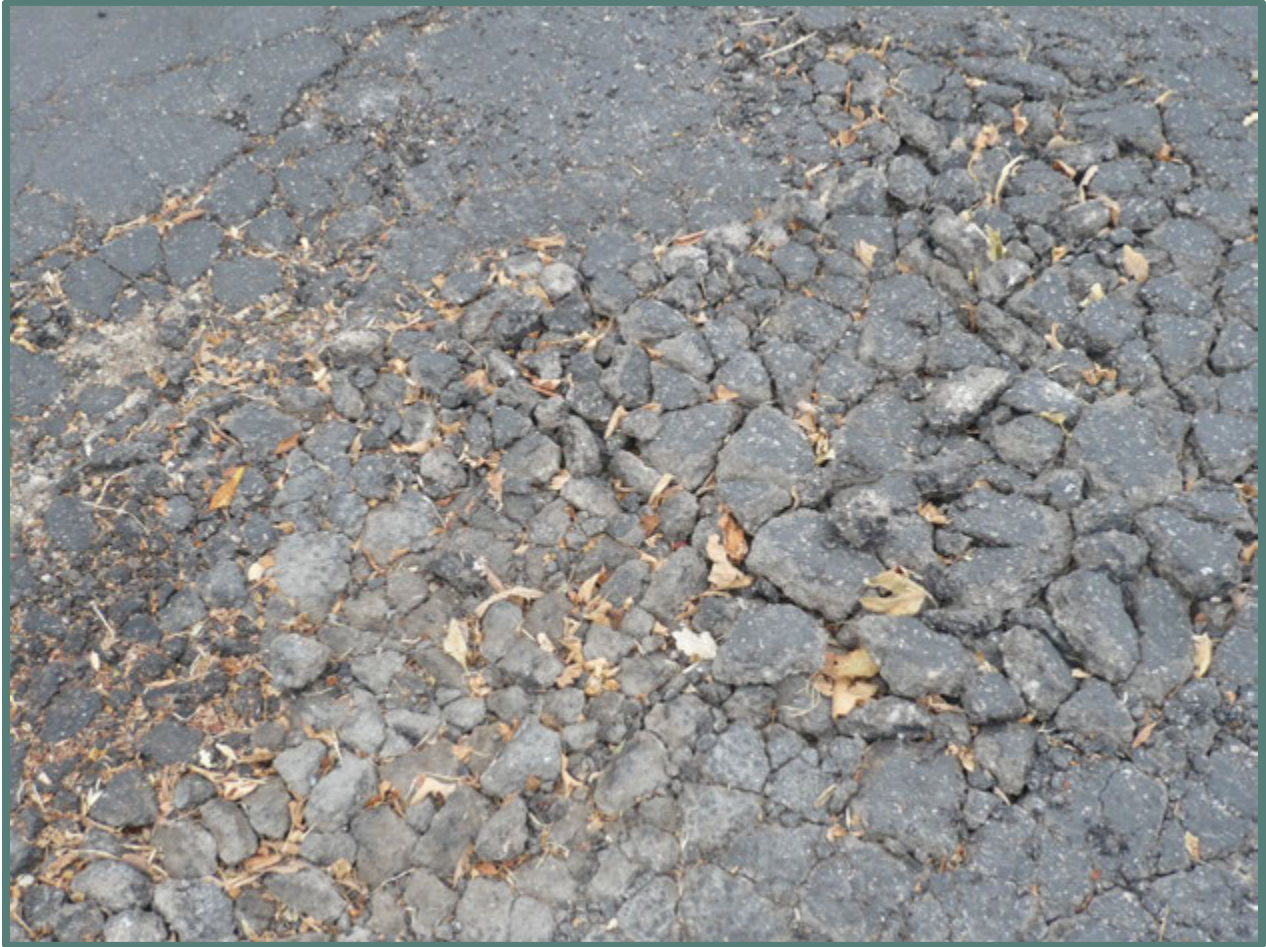
TYPICAL FAILED ASPHALT PAVING

MANY AREAS ARE TRIP AND FALL HAZARDS.

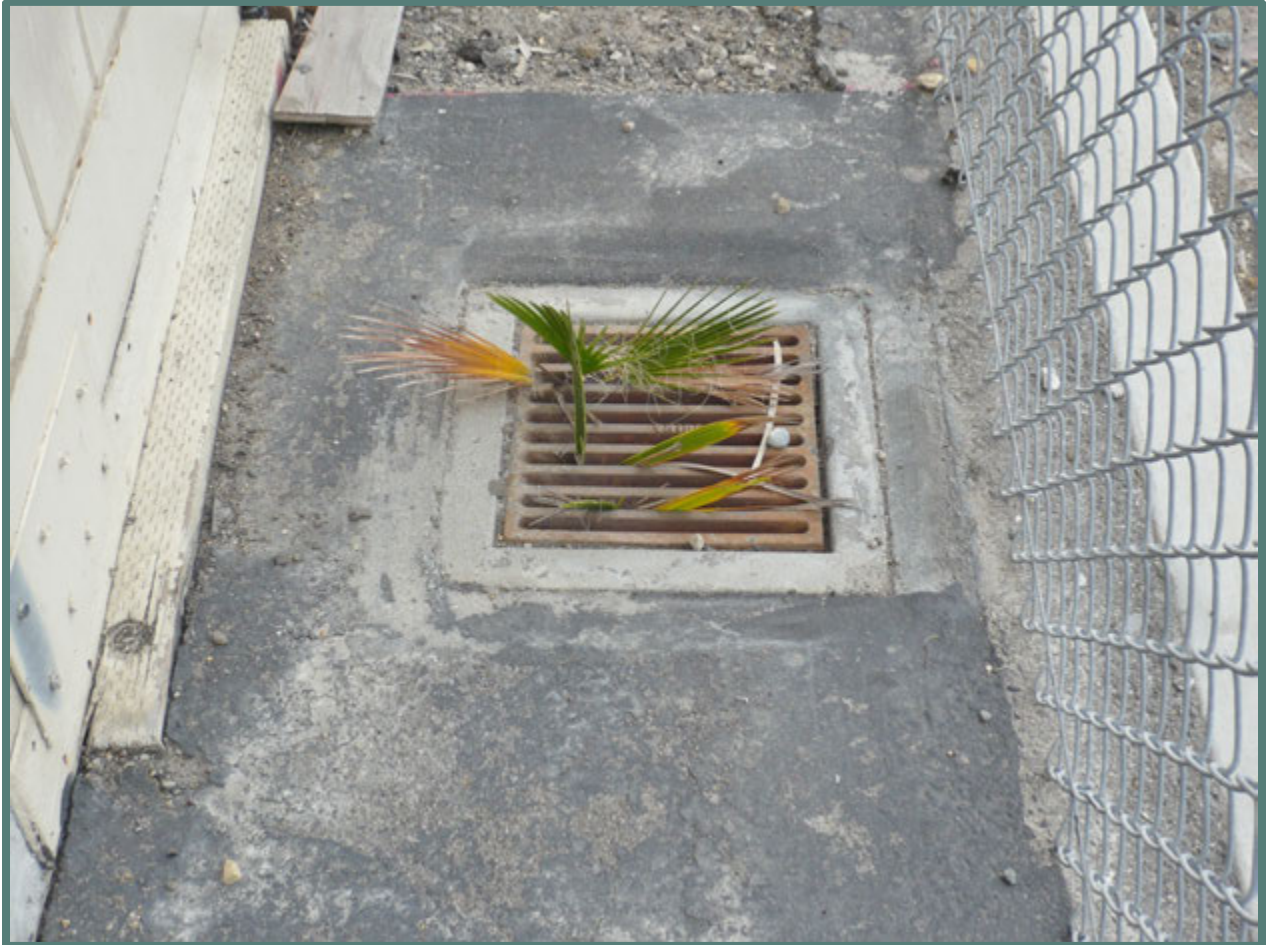
**OBSTRUCTED AREA DRAINS
LIVE PLANT MATERIAL**

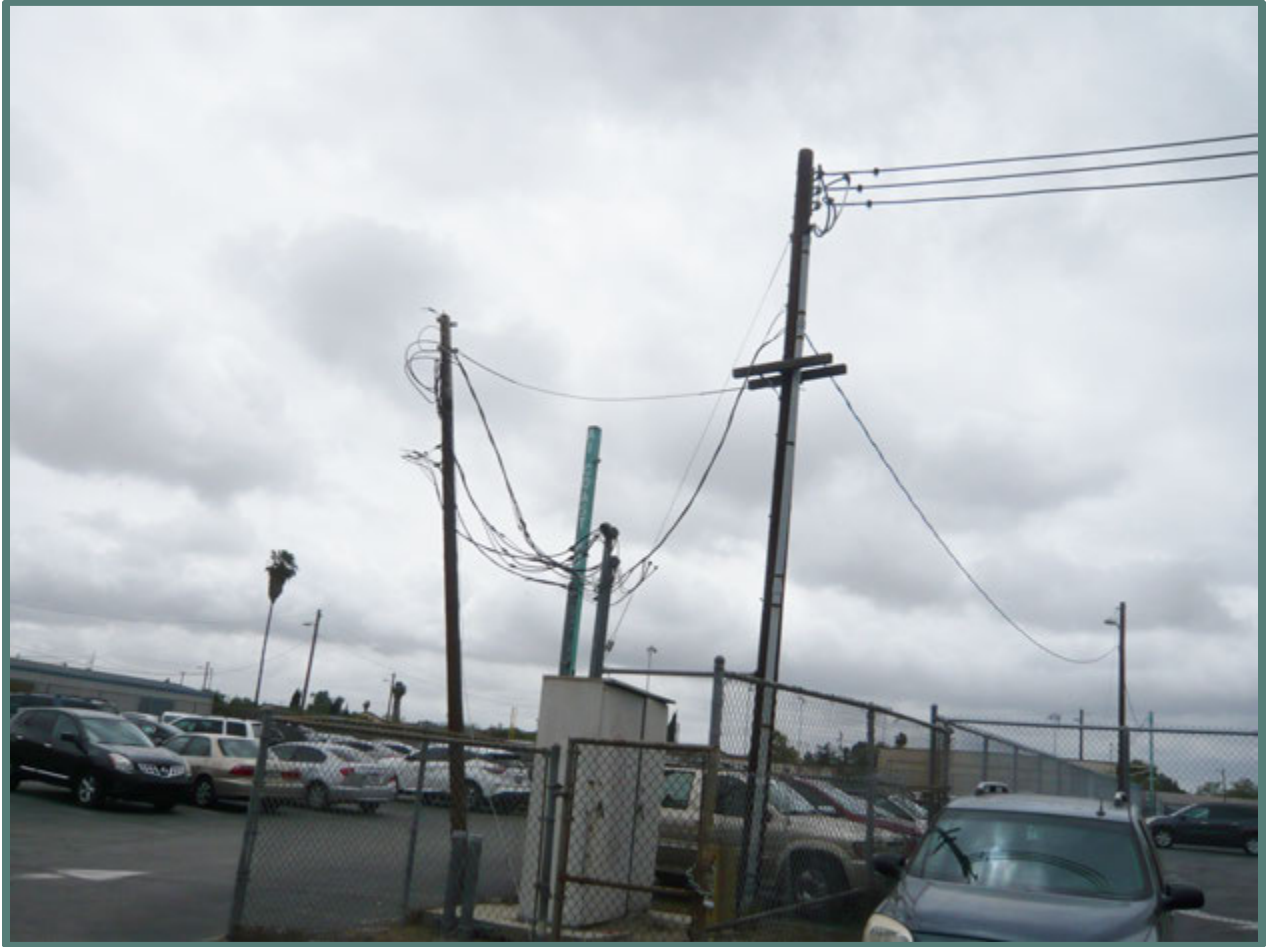
DETERIORATED UNSAFE ELECTRICAL SERVICE
