12338 Mona Blvd., Compton 90220 | <http://bms-compton-ca.schoolloop.com>

A. EXISTING SITE INFORMATION

B. OVERVIEW

C. ASSESSMENT OF SITE

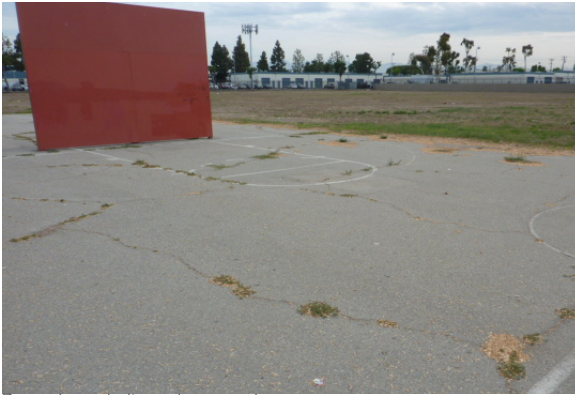
- Cross slope issues (>2%).
- Low spots in paving.
- Cracked AC allowing for water intrusion/weed growth.
- Trees are lifting paving.

Degrade asphalt on playground

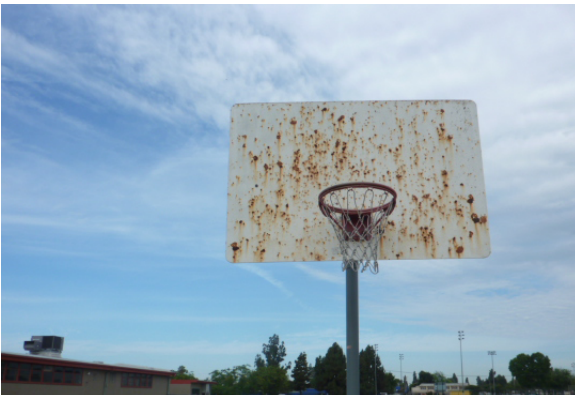
Degraded backboard on playground

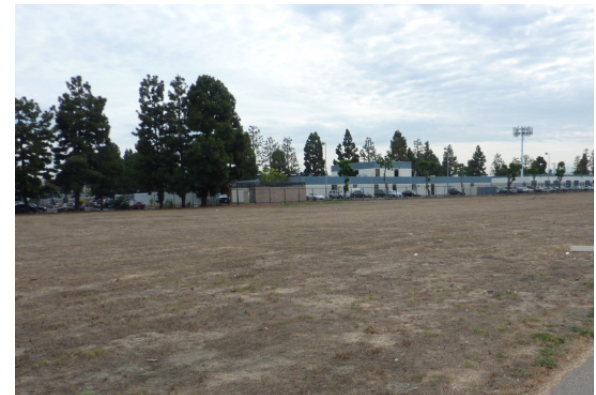
No irrigation in playfield to the north

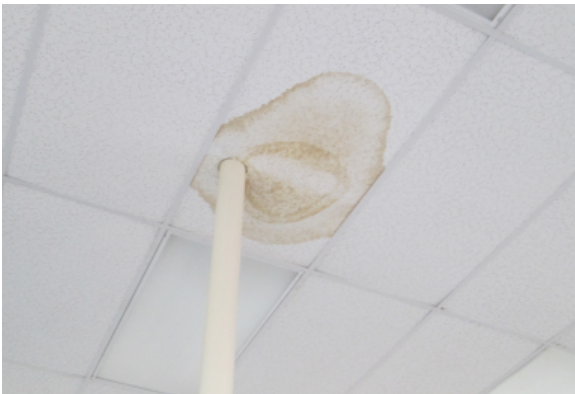
- Ceiling tiles appear worn and discolored with visible signs of damage.
- Several areas have stained or damaged tiles.

Water damaged ceiling tiles

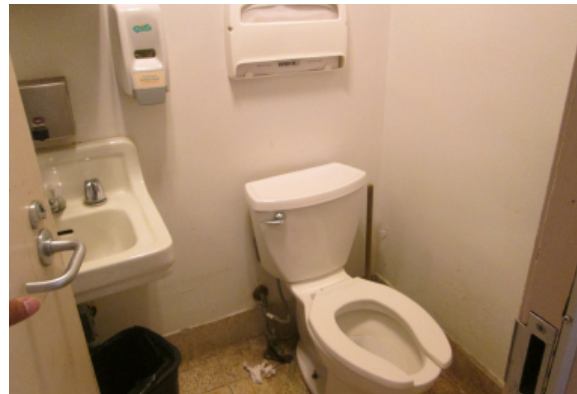
Non ADA compliant restroom

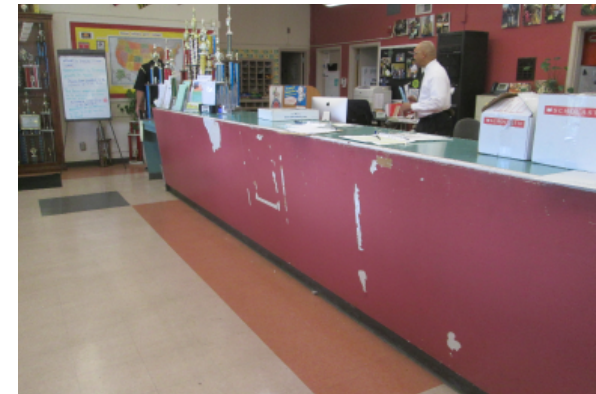
- Building and room signs are missing, damaged or not legible.
- Millwork at staff workrooms and offices do not meet ADA standards.

Non ADA complaint administration counter

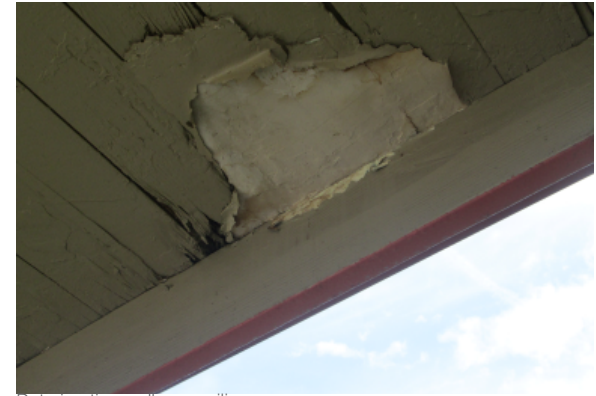
- Roof leaks reported by school personnel at several buildings.
- Covered walkway ceilings have visible damage to coping and flashing.
- Exterior plaster vents on ceiling damaged or missing.
- Fascias have visible signs of rotting or paint peeling.

Deteriorating walkway ceiling

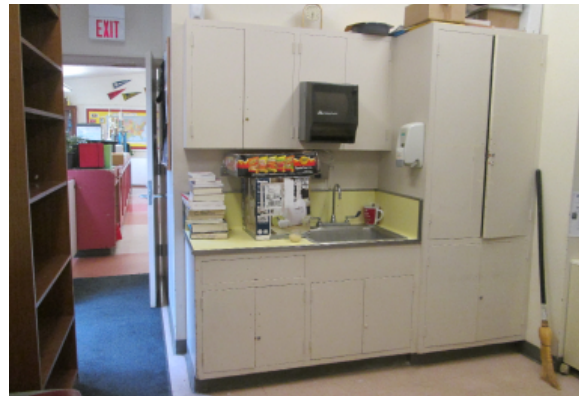
Non-compliant ADA sink

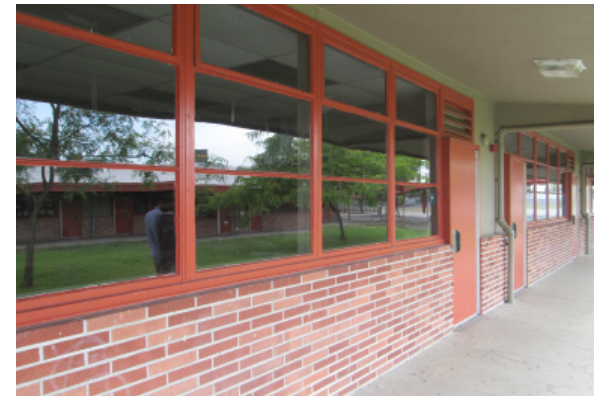
- Window frames are original to campus and have visible signs of wear.
- Windows are single pane and do not meet energy compliance.
- Windows have visible signs of glazing coming undone from frames.

Typical single pane windows

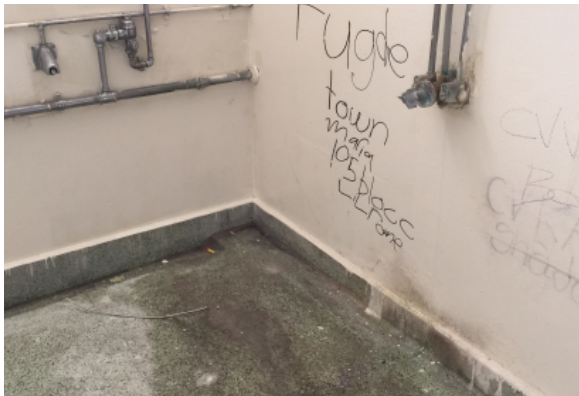
- Plumbing fixtures are a collection of different models and styles.
- Plumbing fixture Lead Free compliance is unknown.
- Restroom fixtures are damaged and pulled away from the walls.
- Locker room shower piping systems appear to be galvanized pipe.

Aged and vandalized showers

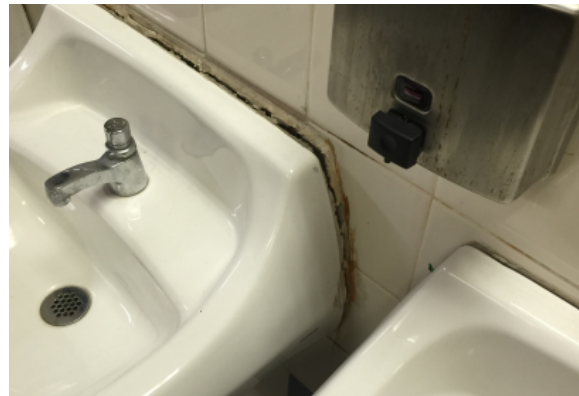
Lavatory separated from the wall

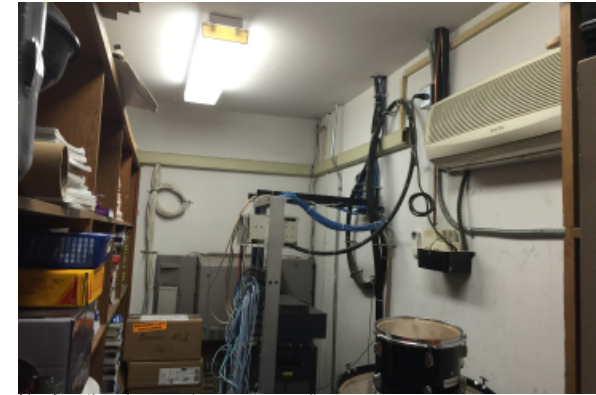
Nonfunctional computer room ac unit

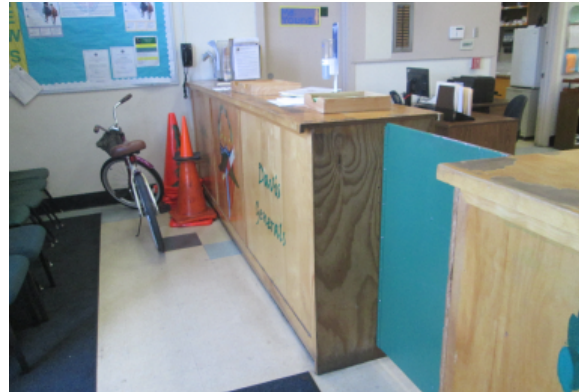
Original reception casework is deteriorating

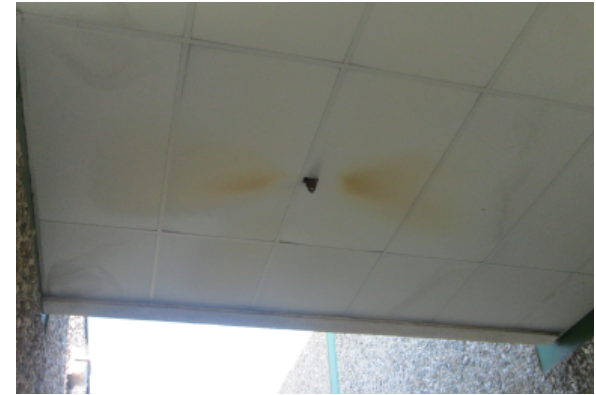
Damage/stains to ACT

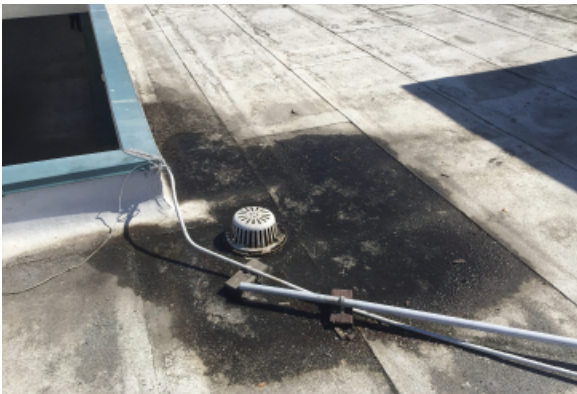
Standing condensate/water on roof

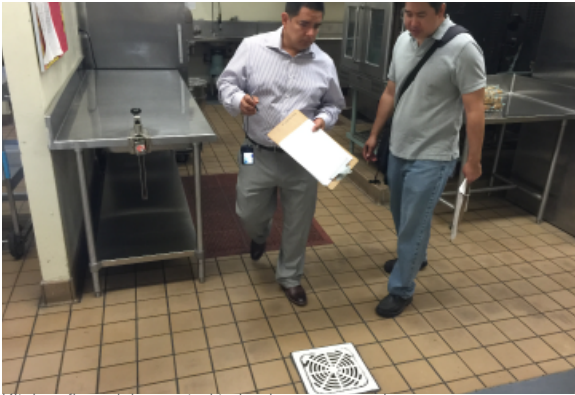
Kitchen floor sink reported to back up on occasion

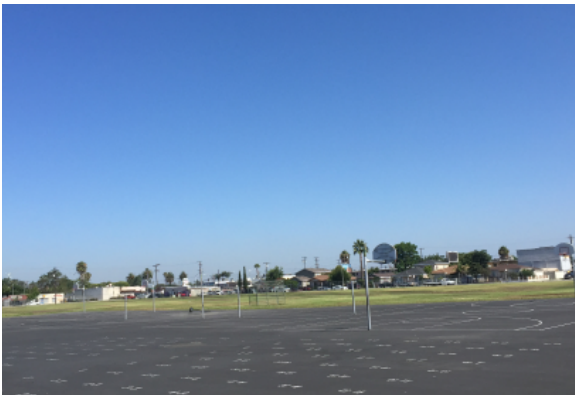
Inadequate site lighting coverage

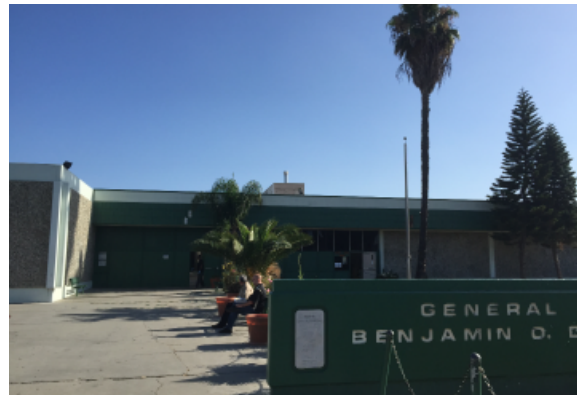
Lack of security cameras

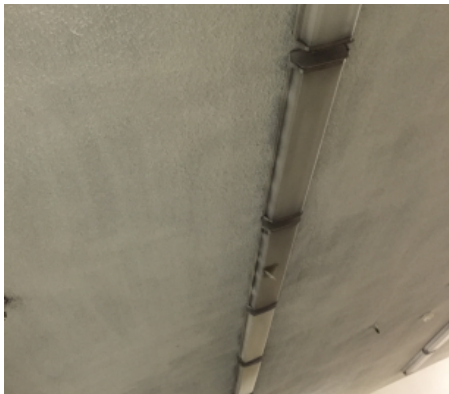
Original surface mounted fixtures are inefficient

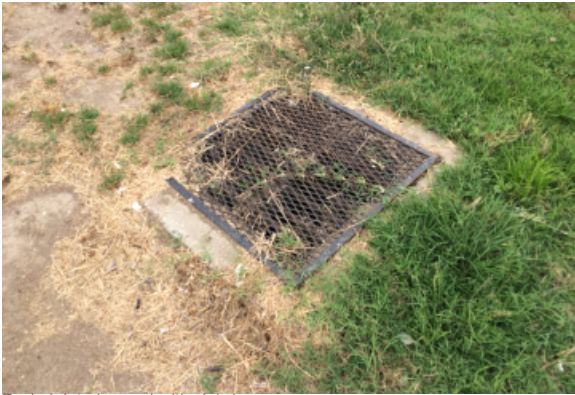
Drain inlet clogged with debris

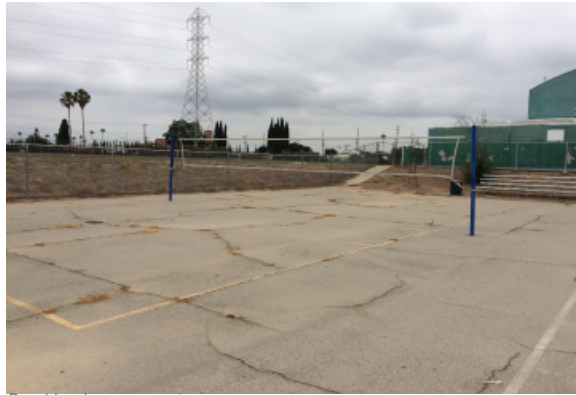
Cracking in pavement

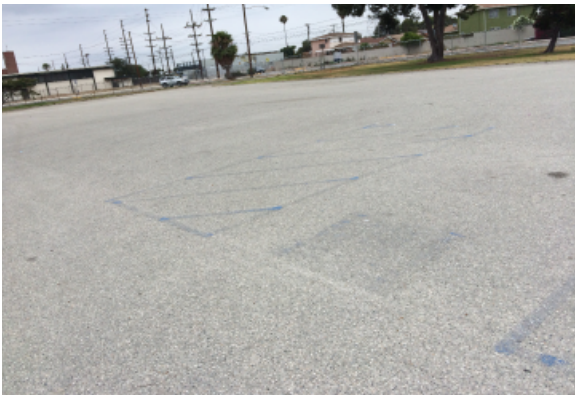
Lacking ADA stall markings/signage/truncated domes

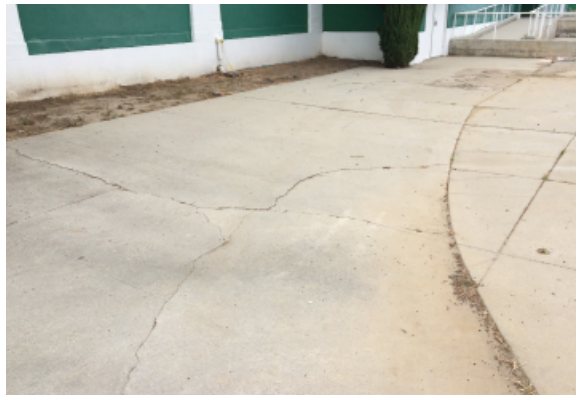
Concrete paving cracking

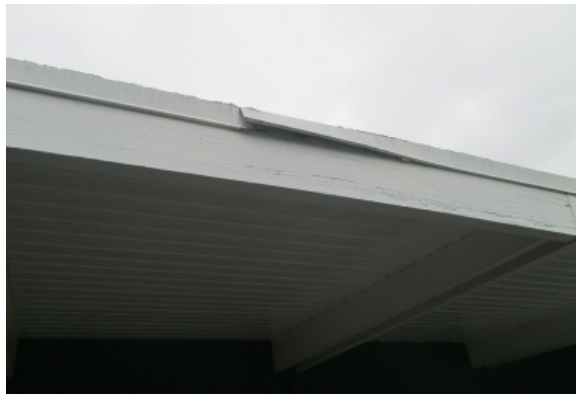
Damaged walkway coping / flashing

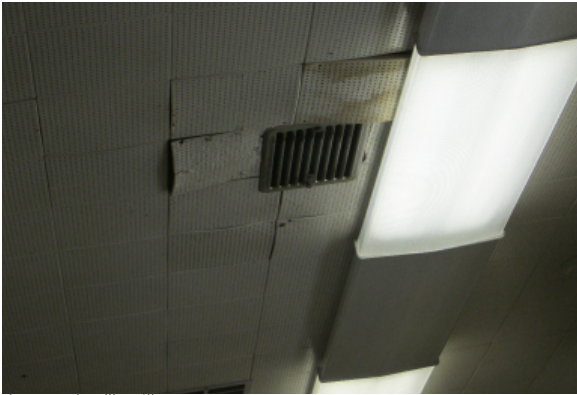
damaged ceiling tiles

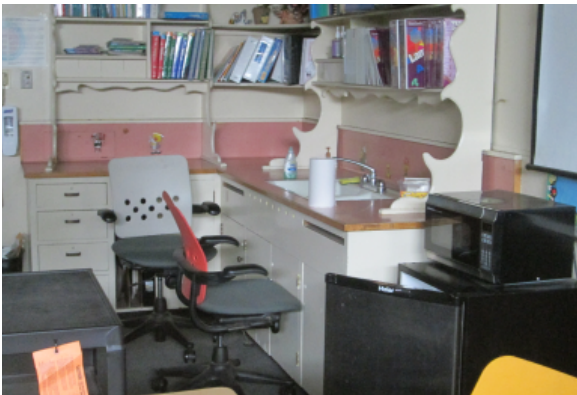
Non ADA compliant sink

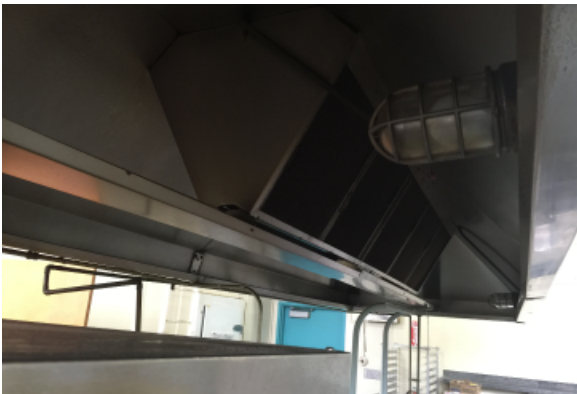
Kitchen hood without fire suppression system

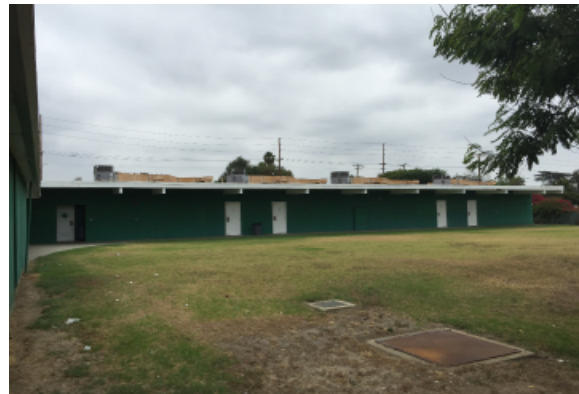
typical rooftop package units

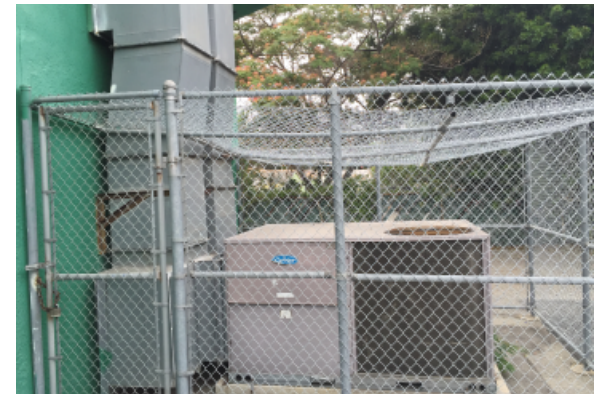
Ground mounted package unit without outside air intake

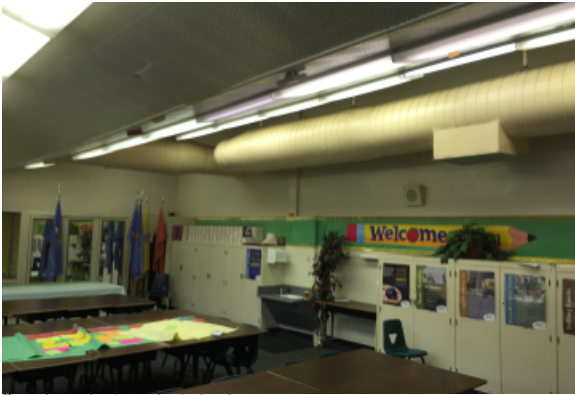
Supply and return ducts in classroom

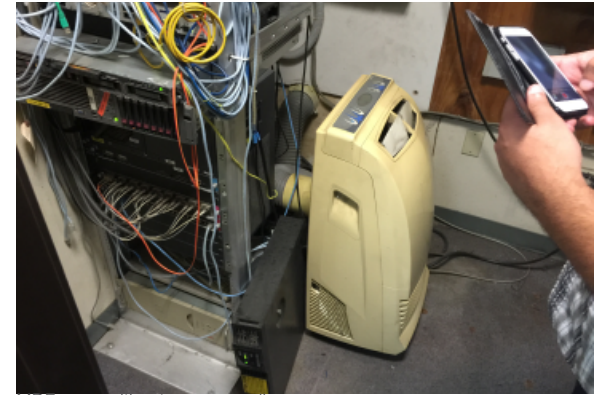
MDF room without proper cooling

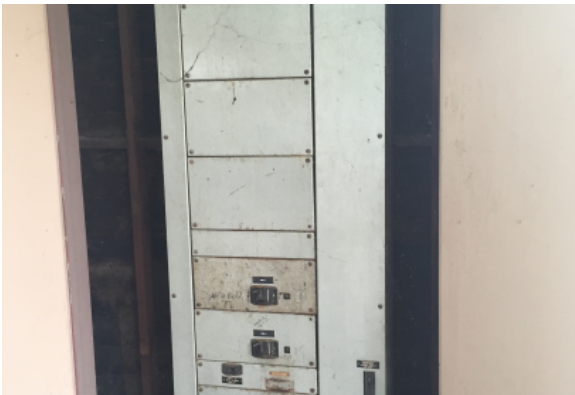
Old switchboard needs replacement

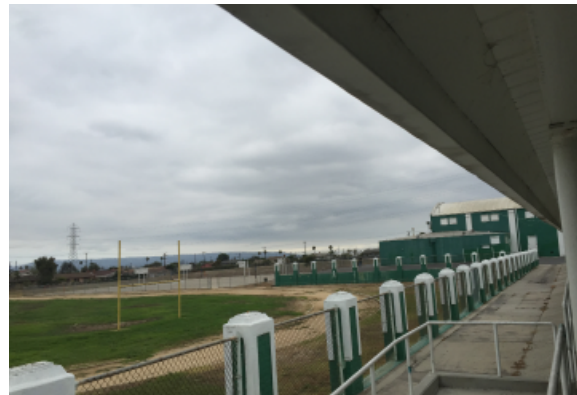
Inadequate site lighting coverage

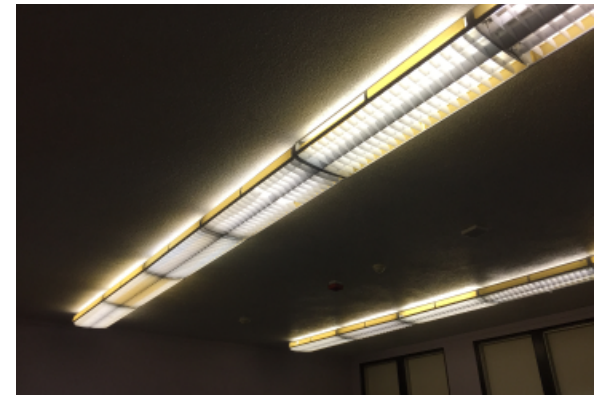
typical condition of interior surface mounted light fixtures

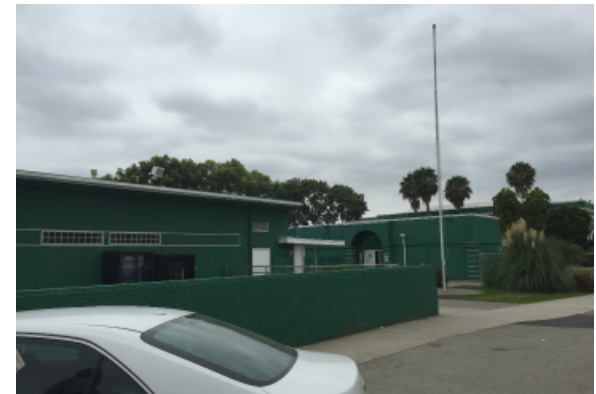
Lack of security cameras

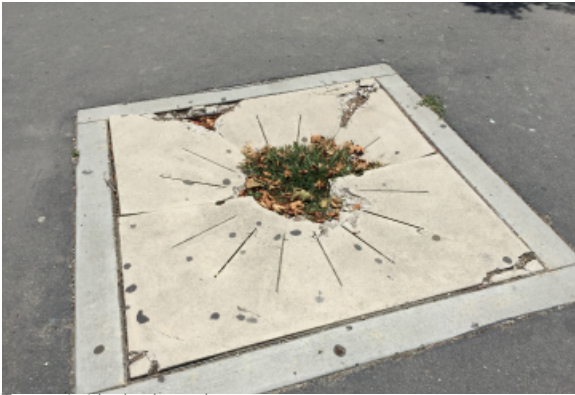
Tree grate tripping hazard

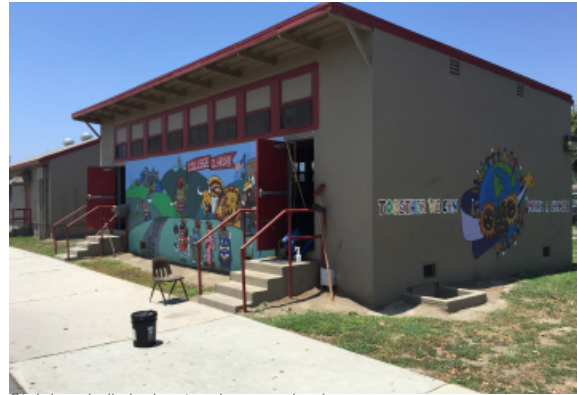
Stair handrails lack extensions, nosing have no grooves nor contrasting color

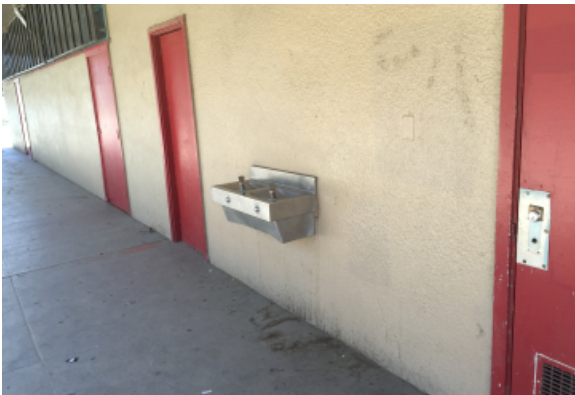
Drinking fountain missing rails

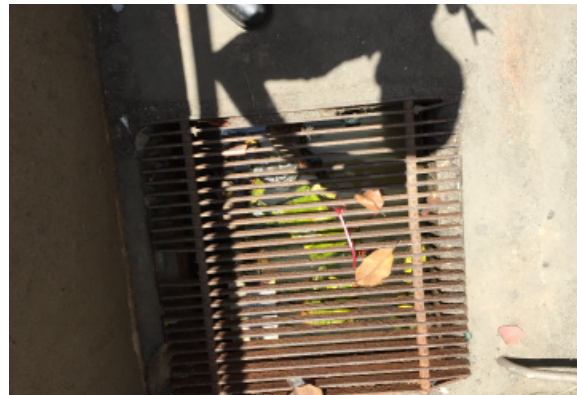
Standing water in drain inlet behind main building

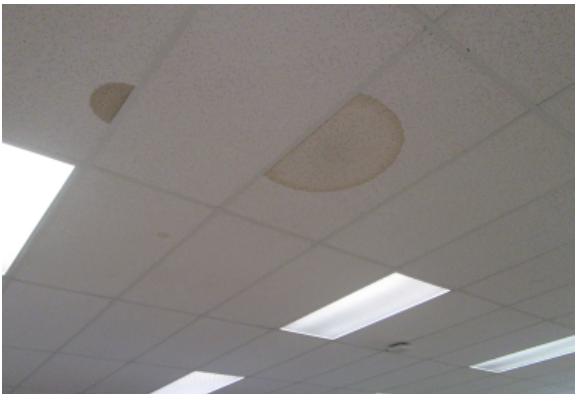
Water damaged ceiling tiles

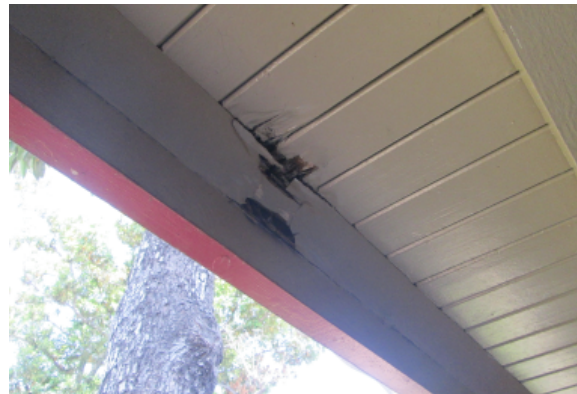
Covered walkway wood deteriorating

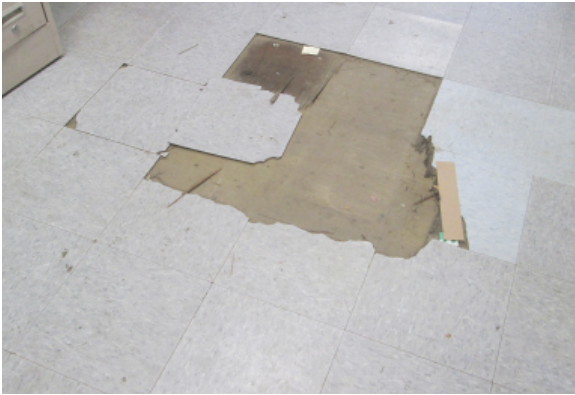
Damaged VCT flooring

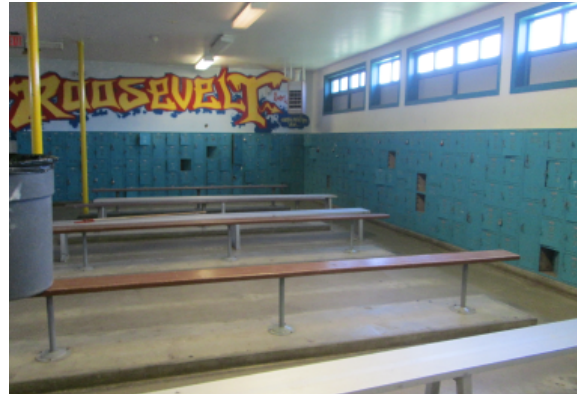
Original lockers deteriorating

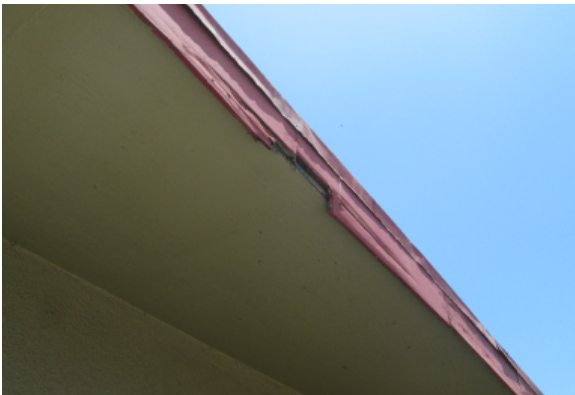
Damaged building fascia

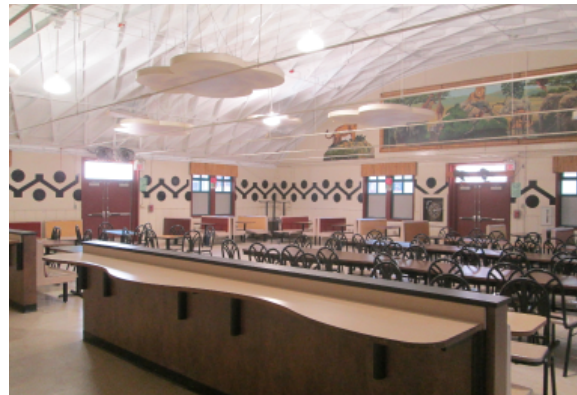
Non ADA complaint counters

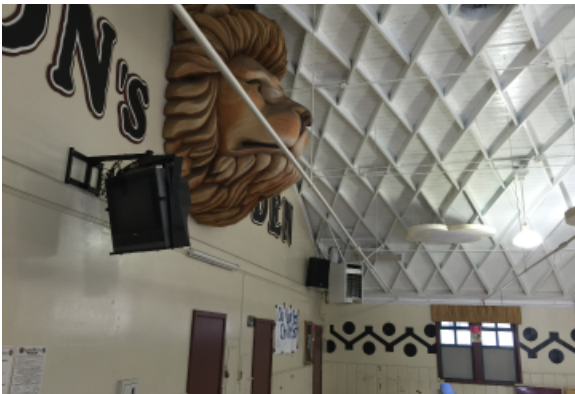
Cafeteria with gas unit heaters no ventilation no AC

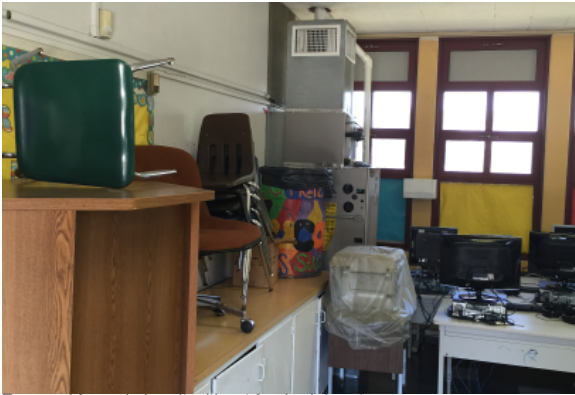
Exposed forced air unit without fresh air input

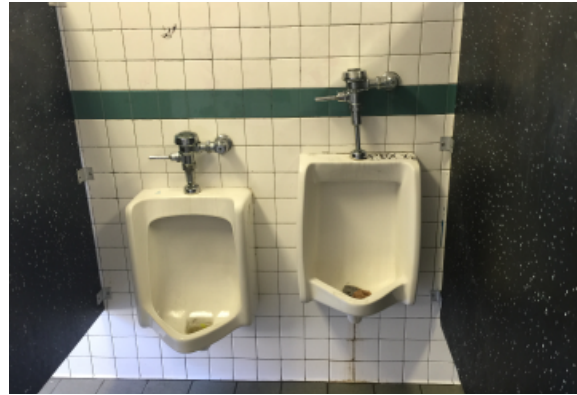
Damaged urinal piping

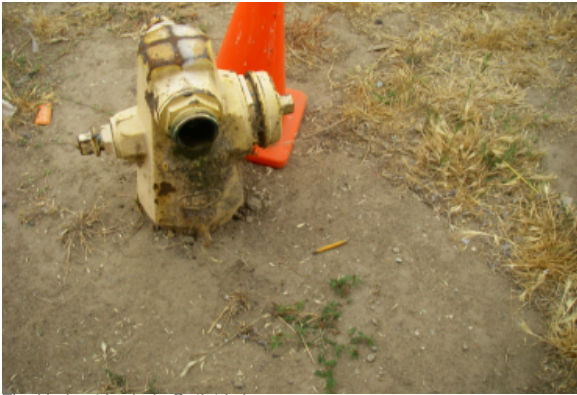
Fire Hydrant buried. Outlet is low.

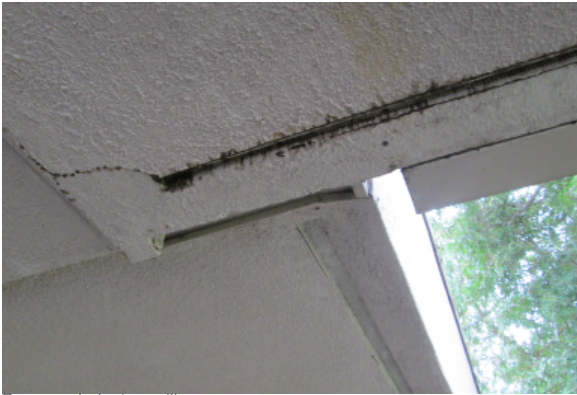
Damaged plaster ceiling

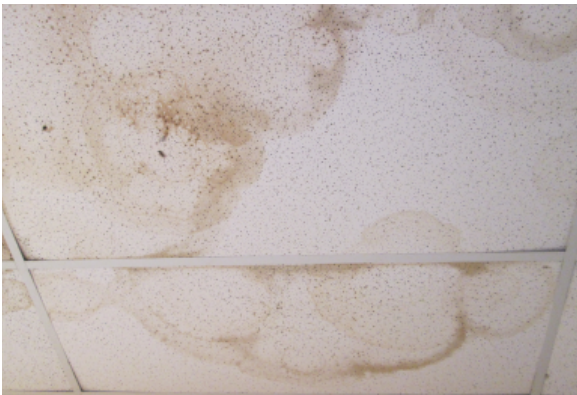
Water damaged ceiling tiles

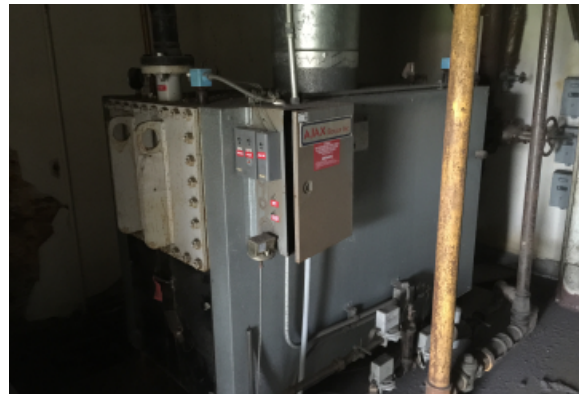
Non-operational domestic water heater

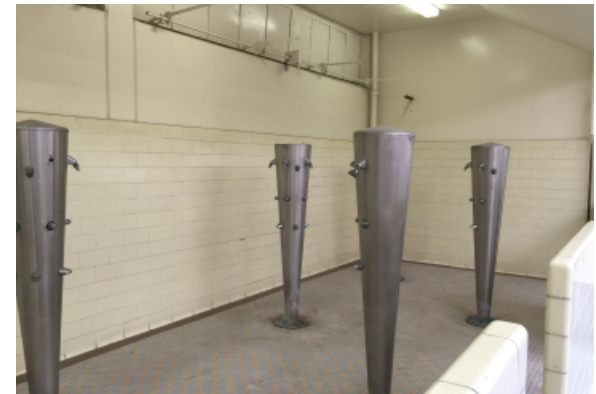
Aged locker room shower

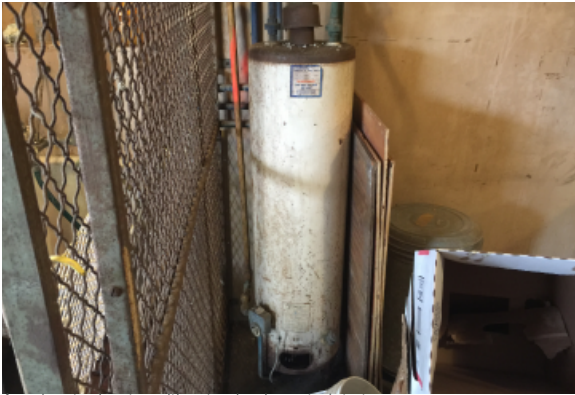
Aged water heater without seismic restraint straps

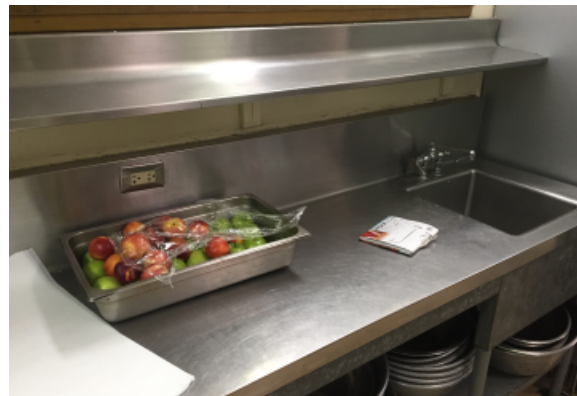
Improper receptacle type used by water sources

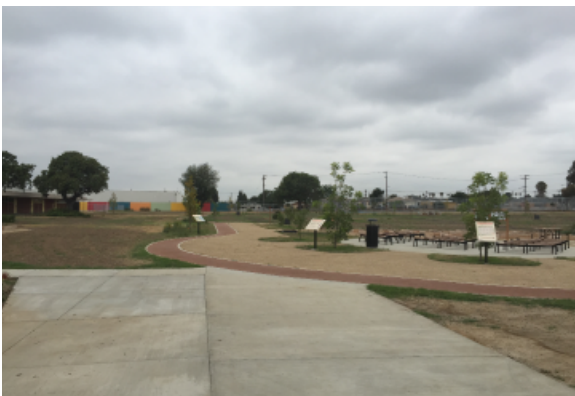
Inadequate site lighting coverage

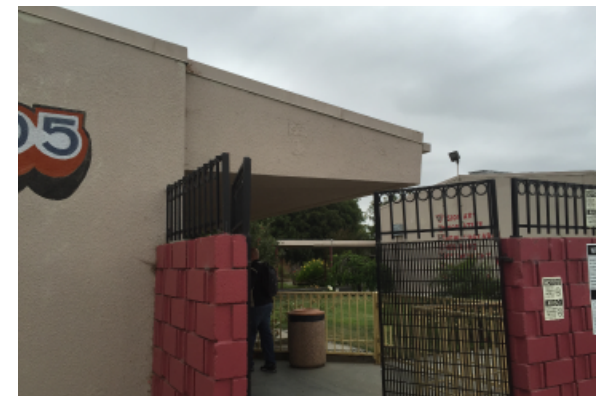
- Intrusion alarm system is functional but old. System upgrade is recommended. There are no security cameras installed. For safety and vandalism prevention reasons, security camera system shall be added to the school.

Lack of security cameras

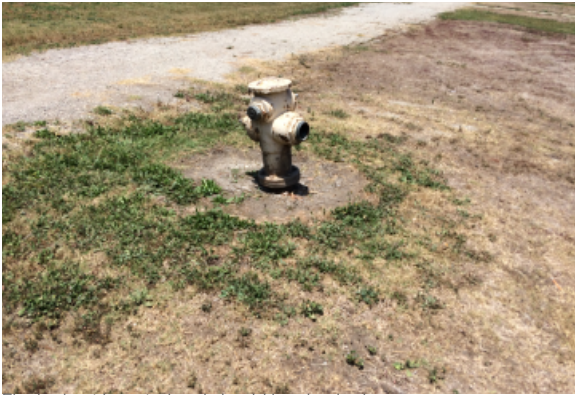
Fire hydrant is rusted and should be checked

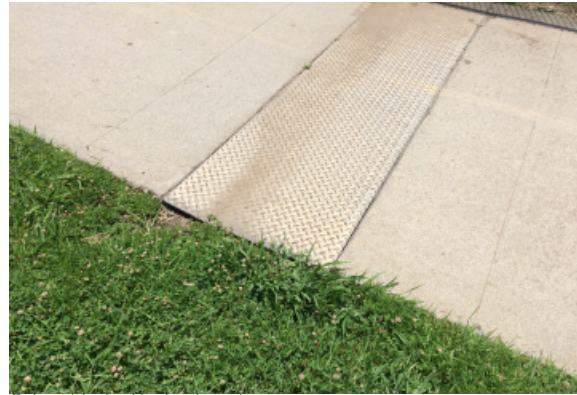
Culvert blocked by landscaping

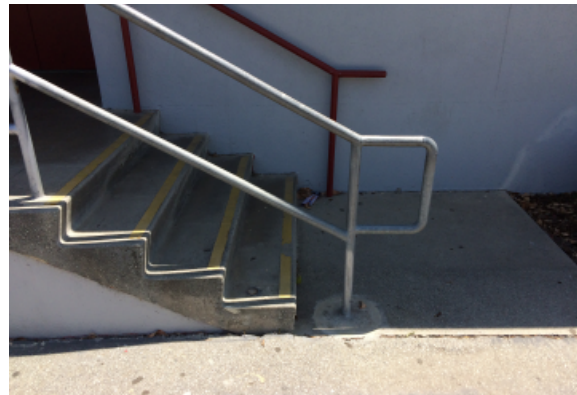
Stair risers and nosing not up to current code

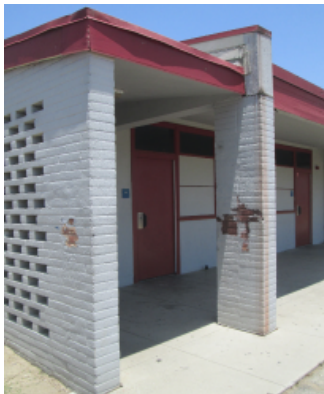
paint is chipping and peeling, metal coping is warped

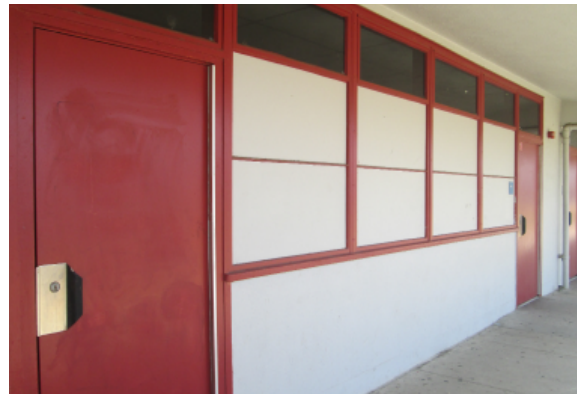
Exterior windows are covered blocking natural daylight

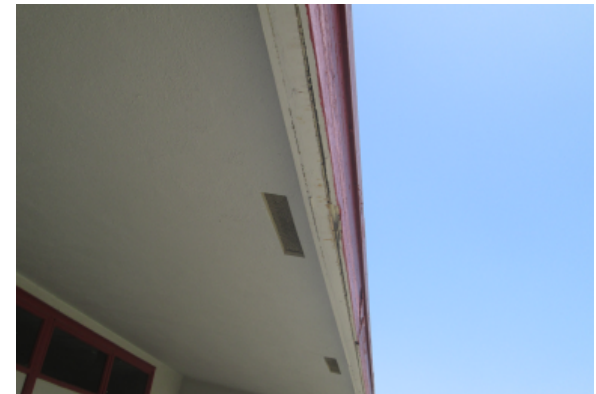
Paint is peeling at fascia

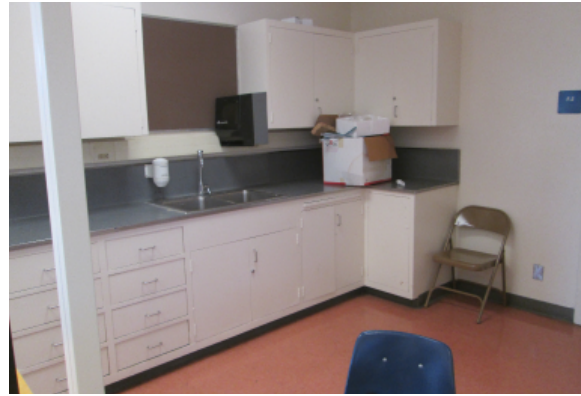
Original casework and sink not accessible

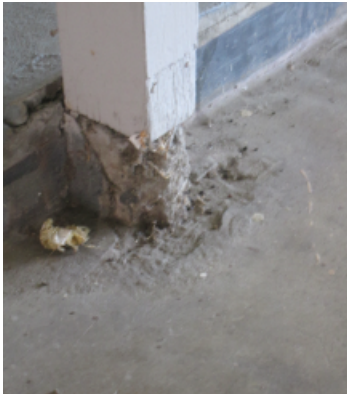
Deteriorating exterior column

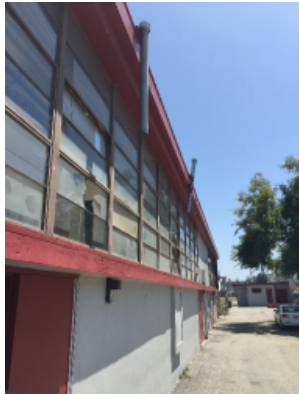
Disconnected flue piping that discharges above classroom ceilings

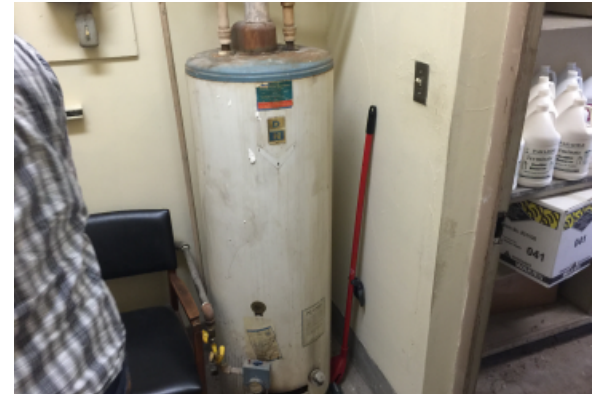
Aged water heater with seismic restraint straps

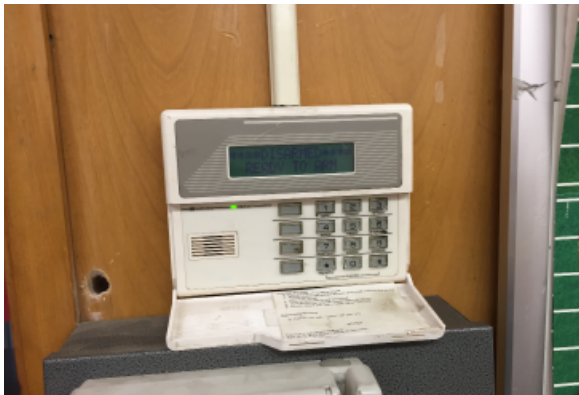
Burglary alarm system is old and needs upgrade

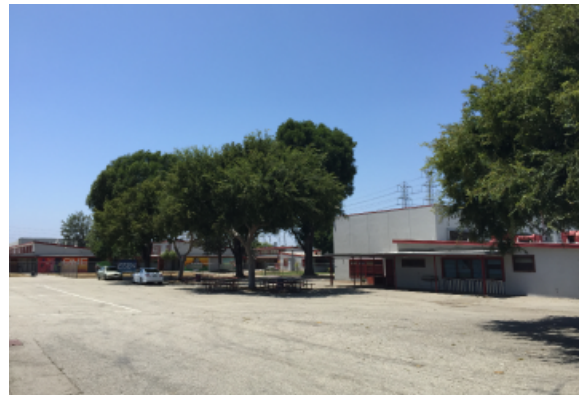
Inadequate site lighting coverage

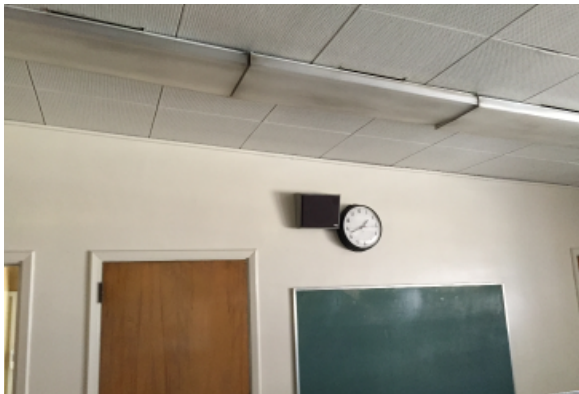
Original classroom lighting

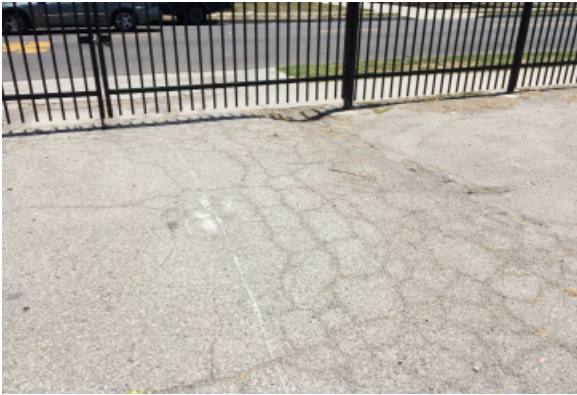
AC paving is cracked/depressed

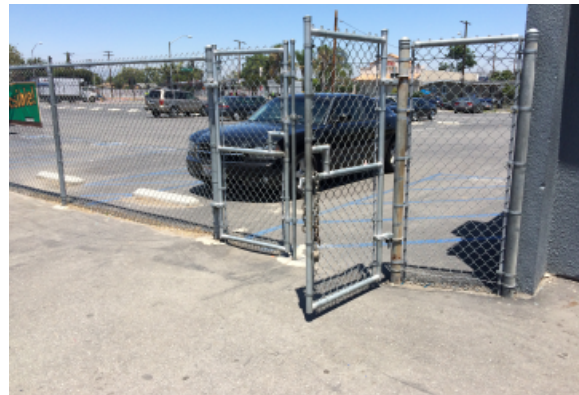
Gate hardware and width is not compliant

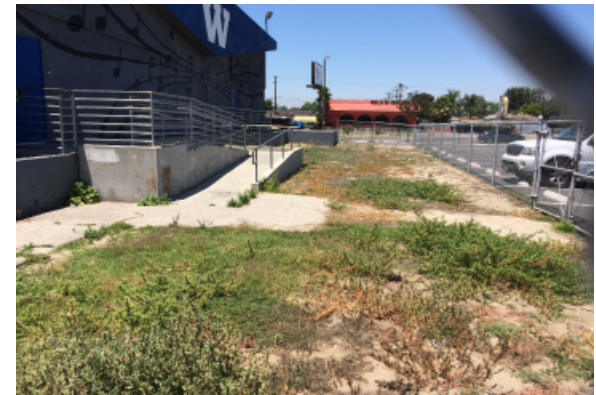
Irrigation system does not work properly

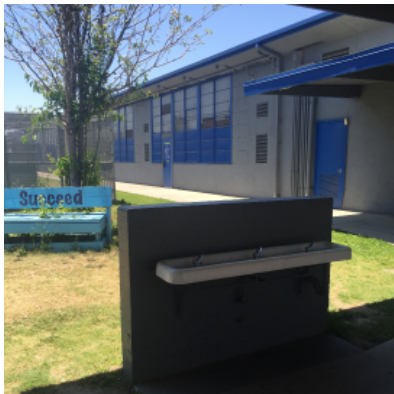
Need to provide accessible drinking fountain and side warning rails

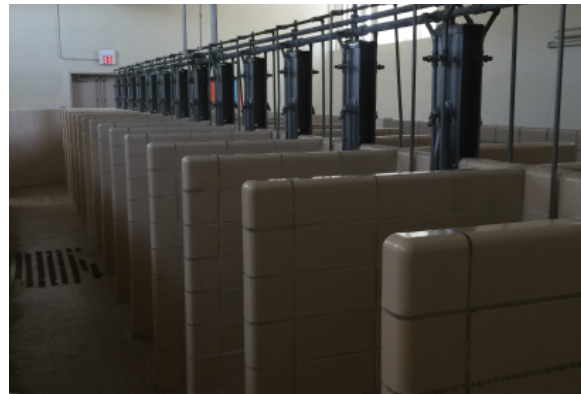
Aged locker showers with galvanized piping

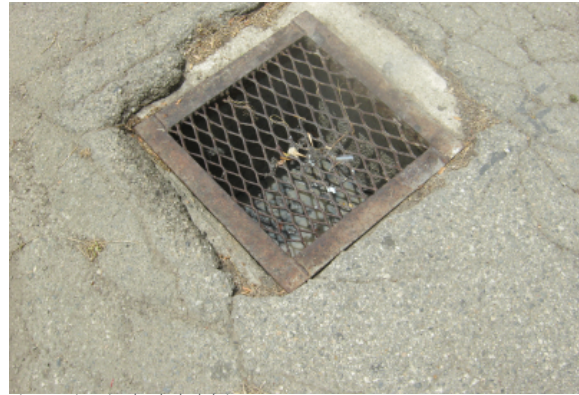
stagnant water in drain inlet

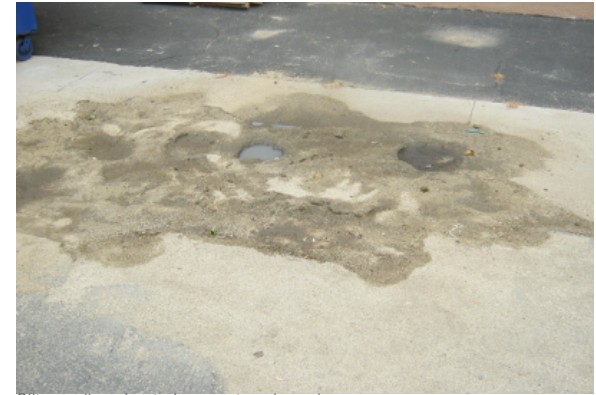
Silt ponding due to low spot and erosion

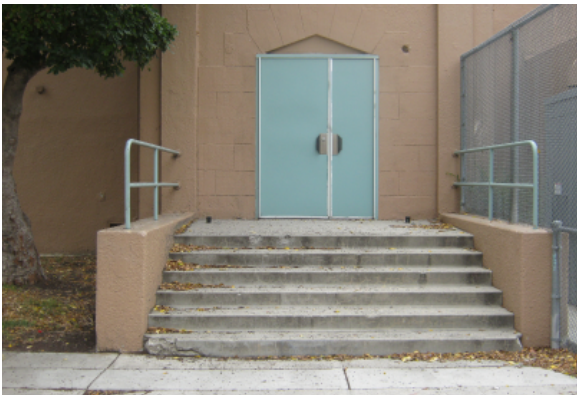
Handrails missing & guardrails non-compliant

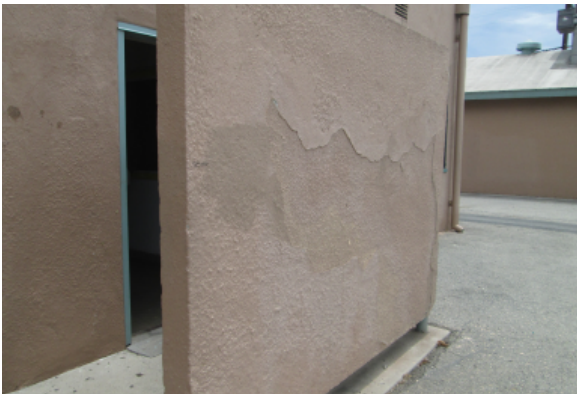
Damaged plaster wall

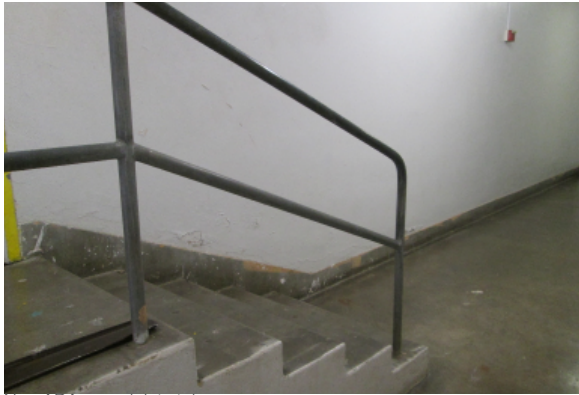
Non ADA complaint stairs

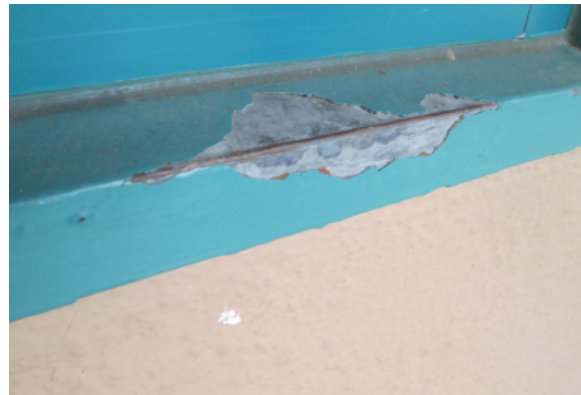
Paint peeling on window frames

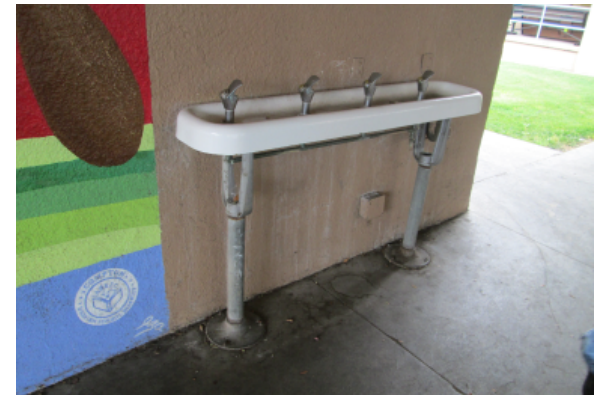
Non ADA complaint drinking fountain

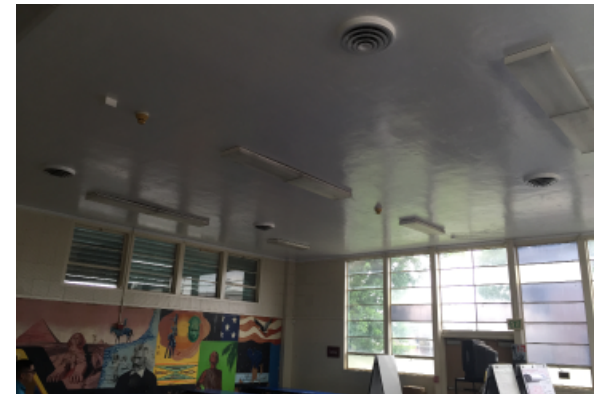
- Classrooms are served by DX packaged rooftop units
- No Air Conditioning is present in the MPR/ Cafeteria.

MPR/cafeteria with air conditioning

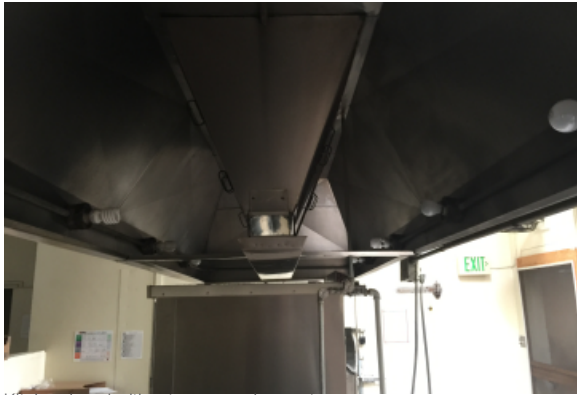
Kitchen hood without suppression system

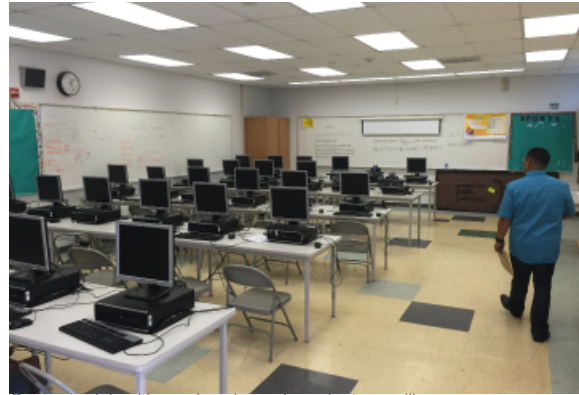
Computer lab with overhead supply and return grilles

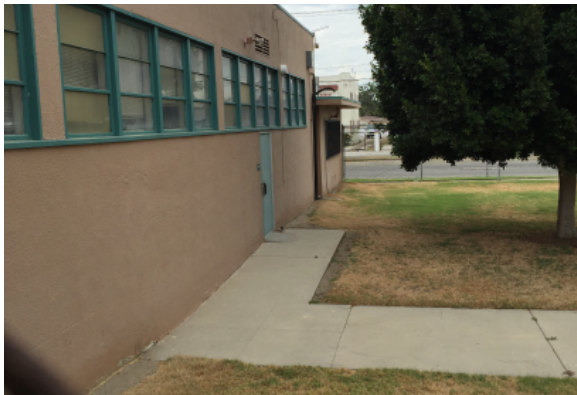
- The Security System has been upgraded and is in good condition. The System requires no maintenance from the Districts facility staff.
- System is fully functional but does not meet the user needs. Buildings on site have ceiling mounted motion sensors.
- In addition to the existing motion sensors, door devices are needed in the Computer Lab Classrooms.
- The Site does not have campus wide CCTV

Lack of security cameras

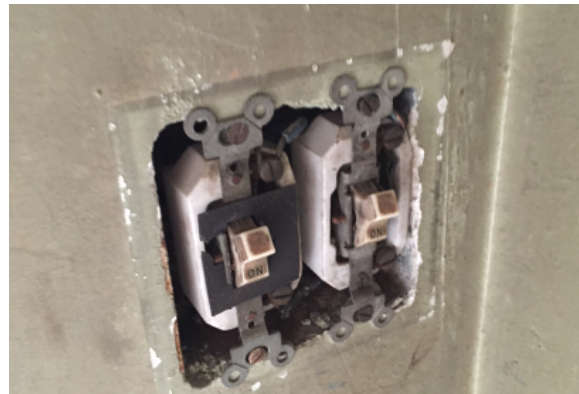
Outlets without protective cover plates
