COMPTON UNIFIED SCHOOL DISTRICT

COMPTON HIGH SCHOOL CAMPUS WIDE & WEST COCOA STREET PROPERTIES

HISTORICAL RESOURCE ANALYSIS

June 2, 2018

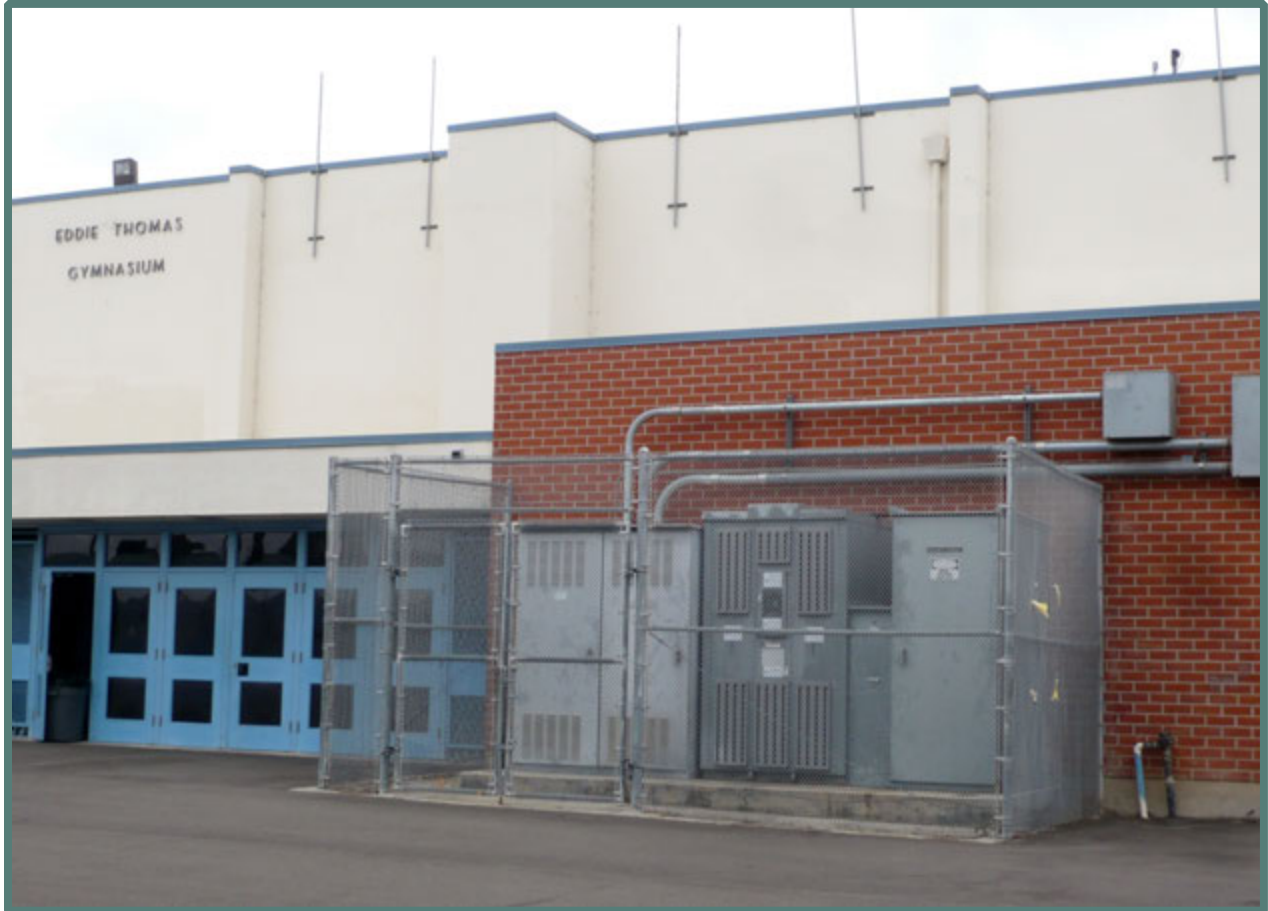
BUILDING "M"
GYMNASIUM

NO SIGNIFICANT DESIGN ELEMENTS OR ARCHITECTURAL DETAILS ARE PRESENT.
THE ORIGINAL EXTERIOR DOORS AND WINDOWS HAVE BEEN REPLACED. ELECTRICAL
SWITCHGEAR, CONDUIT AND PULL BOXES HAVE BEEN ADDED TO THE BUILDING'S FRONT FAÇADE
AND ENCLOSED WITH CHAIN-LINK FENCING.

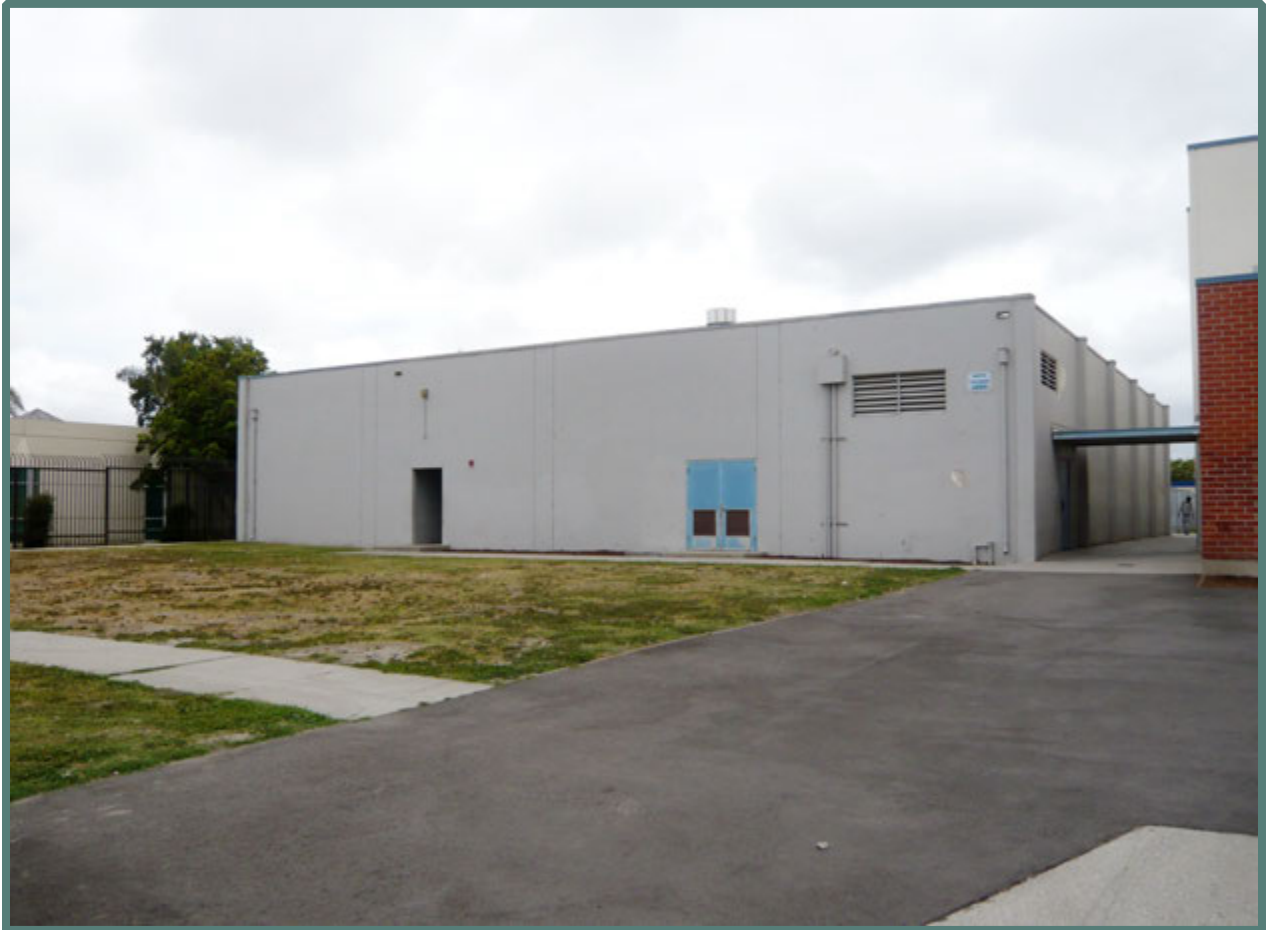
BUILDING "M-2"
GIRL'S LOCKER ROOM

MINIMAL UTILITARIAN DESIGN WITH NO SIGNIFICANT ARCHITECTURAL DETAILS.
ORIGINAL EXTERIOR DOORS HAVE BEEN REPLACED. ELECTRICAL CONDUIT
AND PULL BOXES HAVE BEEN MOUNTED TO THE EXTERIOR WALLS.

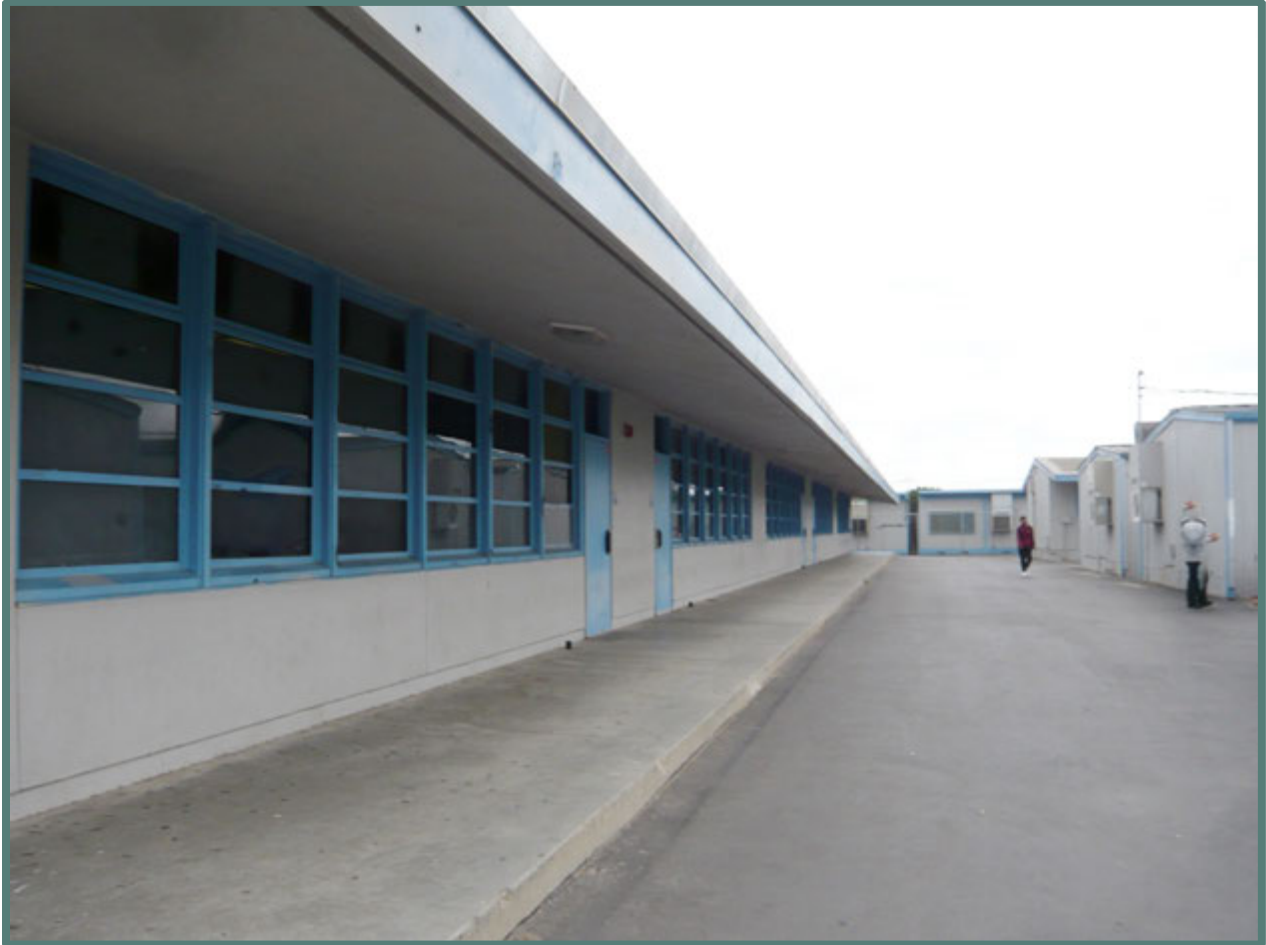
BUILDING “Z”
CLASSROOMS WITH ADJACENT PORTABLES

CONSTRUCTED CIRCA 1960, AS A STANDARD UTILITARIAN STRUCTURE WITH NO SIGNIFICANT ARCHITECTURAL DETAILS. THE BUILDING WAS PART OF THE 2004 “MODERNIZATION” PROGRAM. THE ADJACENT PORTABLE CLASSROOM BUILDINGS WERE ADDED IN MORE RECENT YEARS AND ARE VOID OF ANY NOTABLE DESIGN FEATURES.

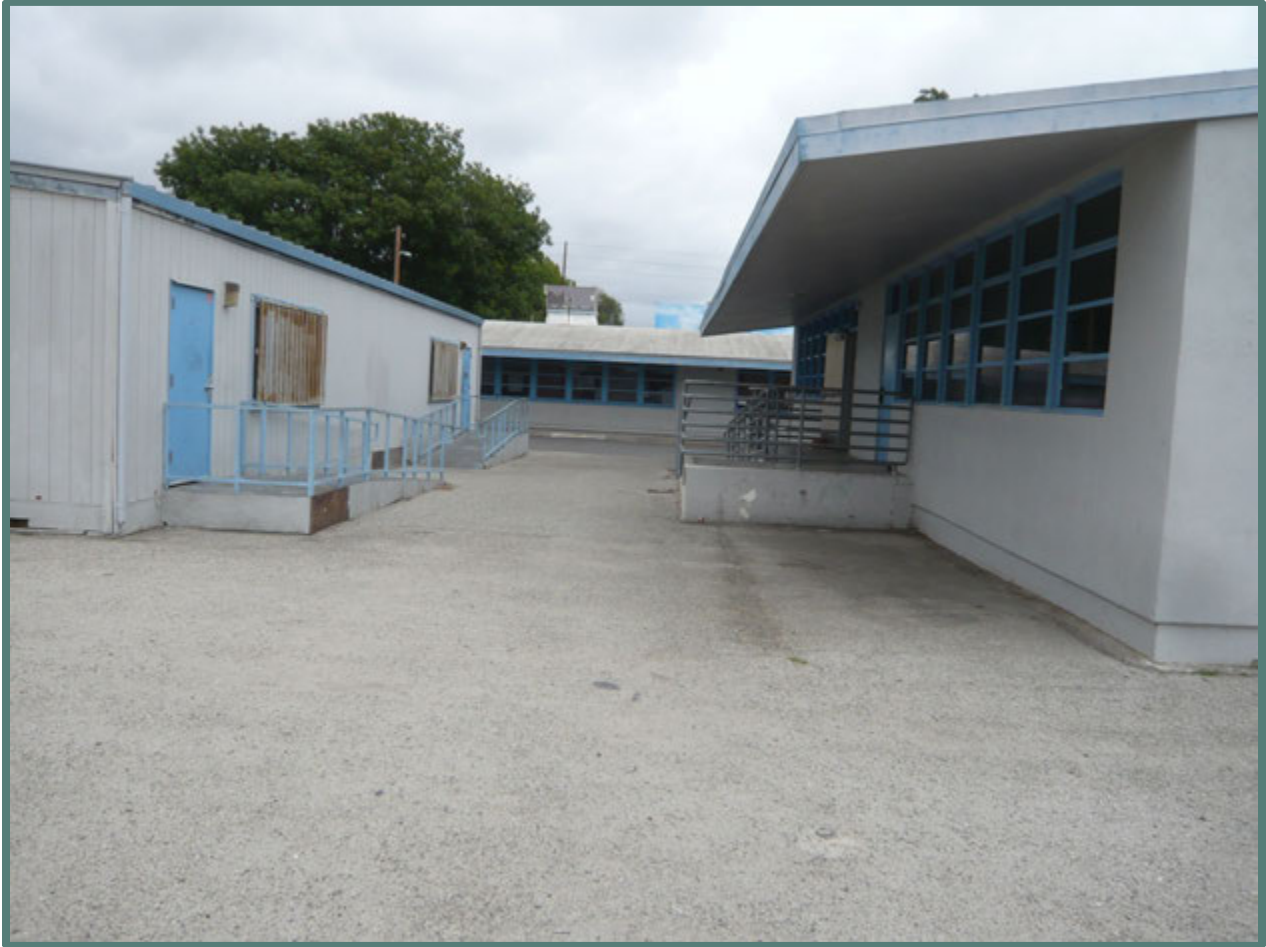
BUILDING “W”
CLASSROOM WITH ADJACENT PORTABLES

CONSTRUCTED CIRCA 1960, AS A STANDARD UTILITARIAN STRUCTURE WITH NO SIGNIFICANT ARCHITECTURAL DETAILS. THE BUILDING WAS PART OF THE 2004 “MODERNIZATION” PROGRAM. THE ADJACENT PORTABLE CLASSROOM BUILDINGS WERE ADDED IN MORE RECENT YEARS AND ARE VOID OF ANY NOTABLE DESIGN FEATURES.

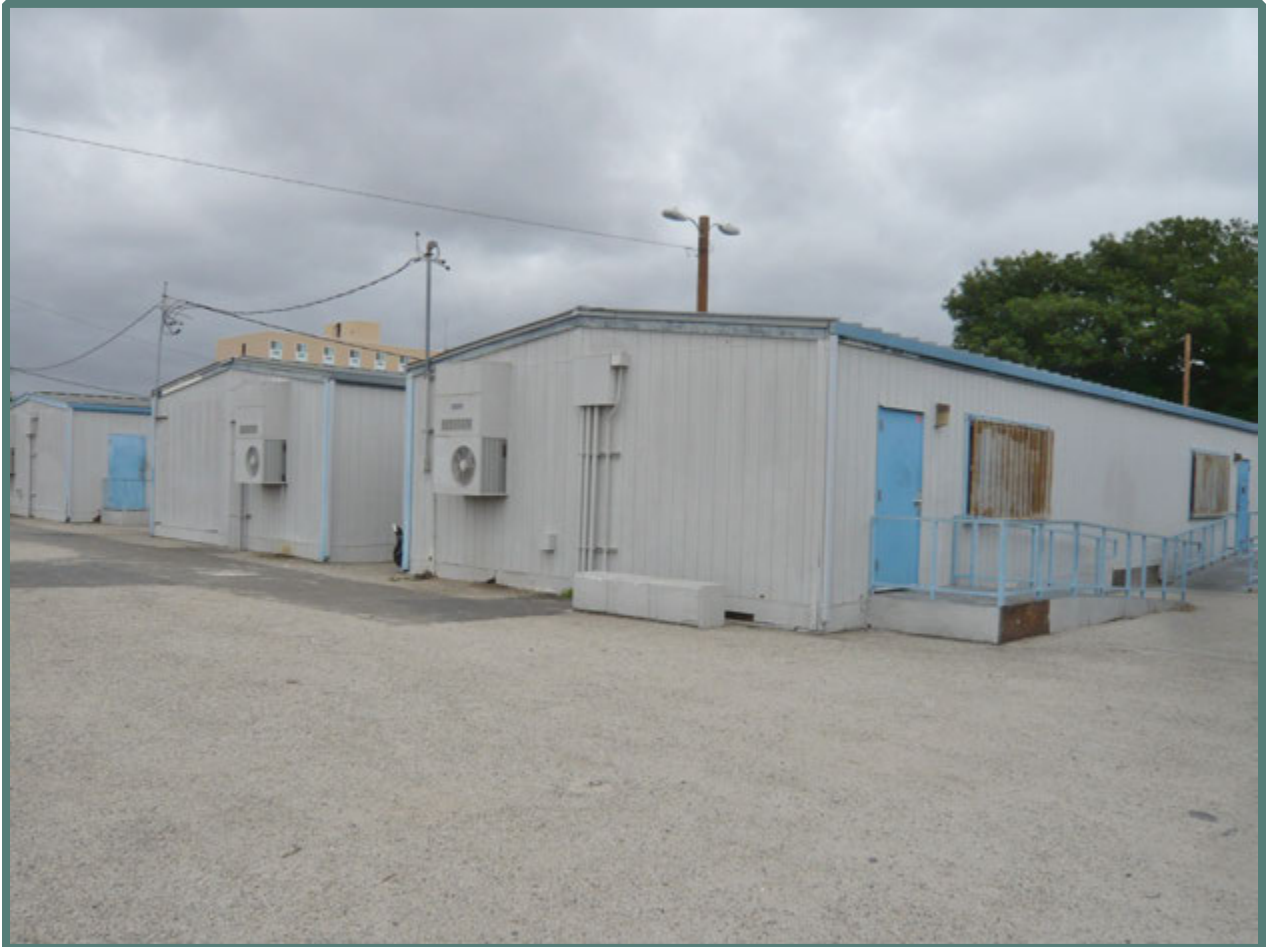
**TYPICAL PORTABLE CLASSROOMS
AND
ACCESSORY BUILDINGS**

UTILITARIAN CLASSROOMS AND BUILDINGS ADDED IN RECENT YEARS ARE IN DETERIORATING CONDITION. ALL OF THESE PORTABLES HAVE NO ARCHITECTURAL OR HISTORICAL SIGNIFICANCE.

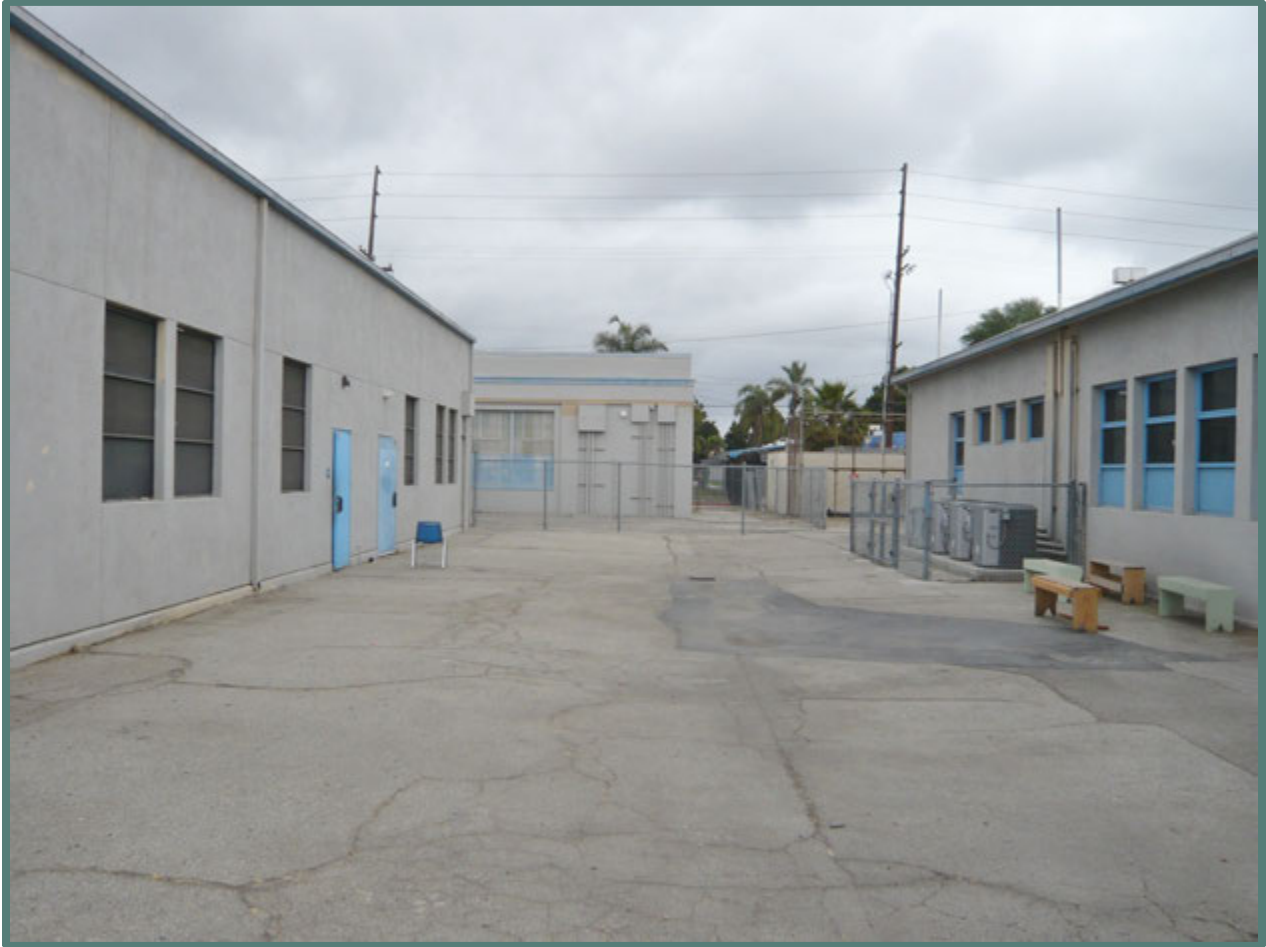
**BUILDINGS “R” & “S”
COMMON COURTYARD**

THESE BUILDINGS WERE CONSTRUCTED CIRCA 1950 – 1960 AS SHOP CLASSROOMS.
THEY ARE MINIMAL UTILITARIAN DESIGN WITH NO ARCHITECTURAL FEATURES.
THE COURTYARD SURFACE IS FAILING/DETERIORATING ASPHALT WITH POOR DRAINAGE.
CHAIN-LINK ENCLOSED HVAC UNITS ARE A PRIMARY FEATURE.

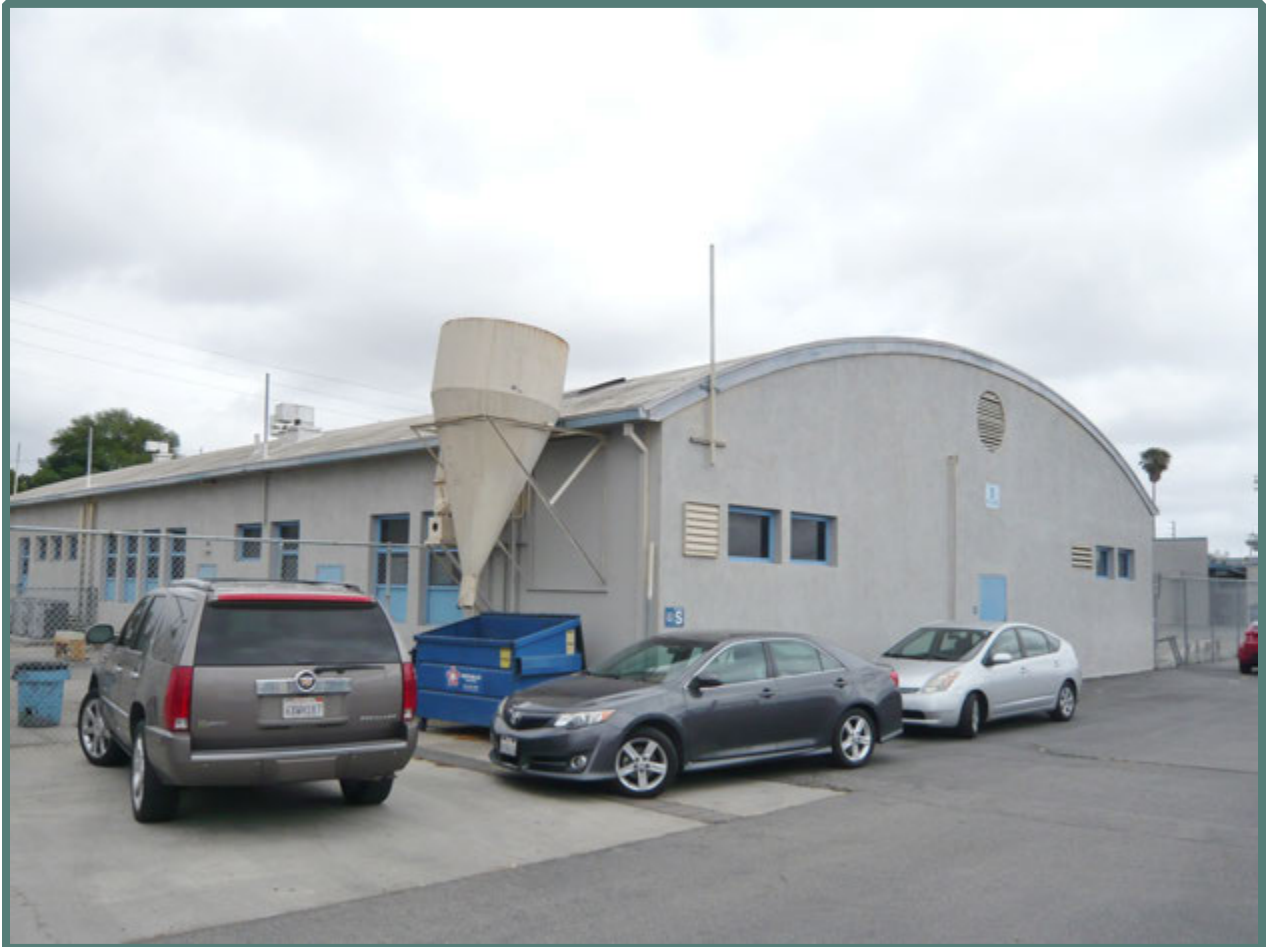
BUILDING "S"
WOODSHOP

MINIMAL UTILITARIAN DESIGN WITH NO ARCHITECTURAL ELEMENTS.
THE BARREL ROOF IS THE ONLY DESIGN FEATURE.

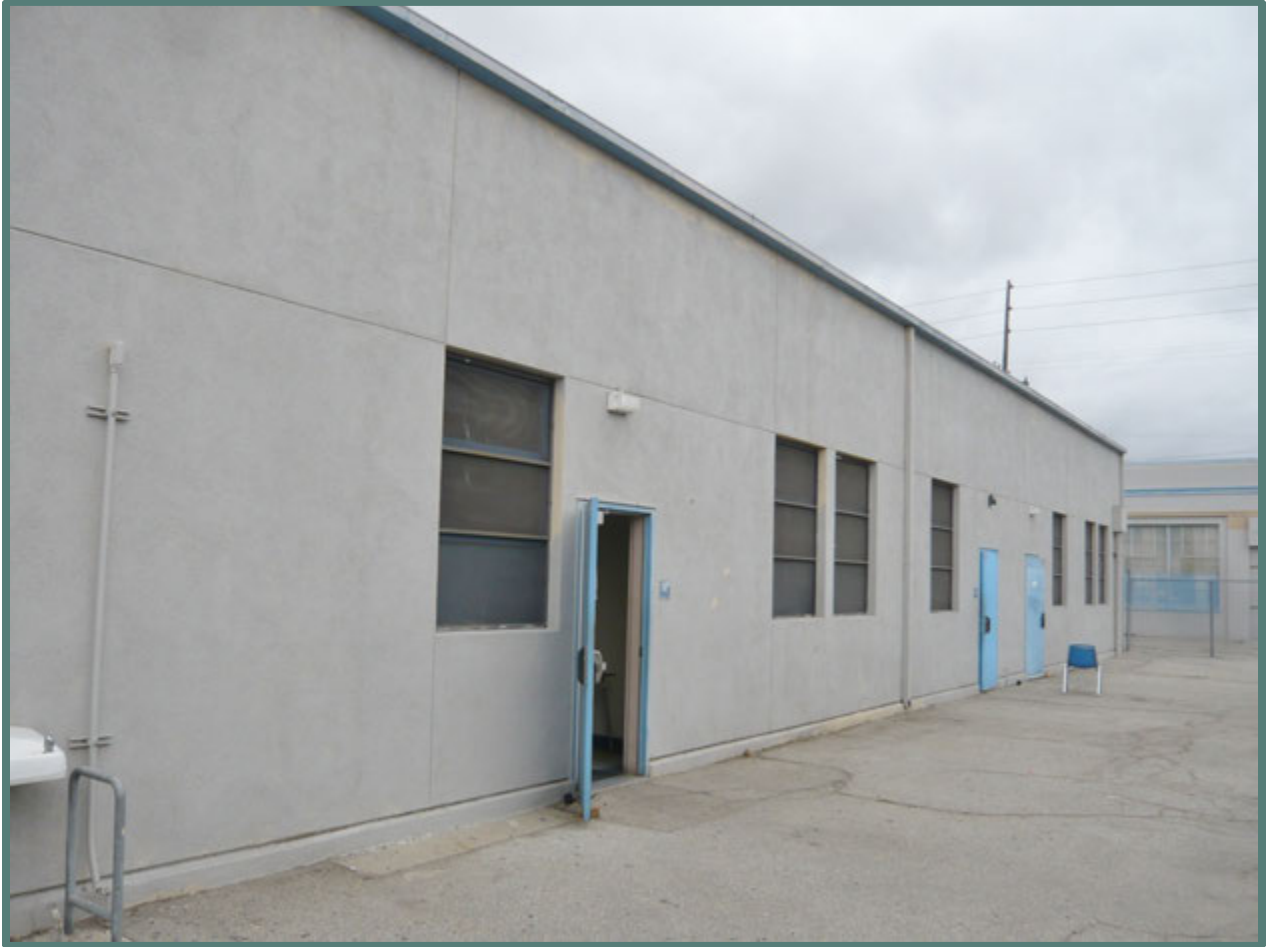
BUILDING "R"
CLASSROOM

CONSTRUCTION CIRCA 1950 – 1960 WITH MINIMAL UTILITARIAN
DESIGN AND NO ARCHITECTURAL ELEMENTS.

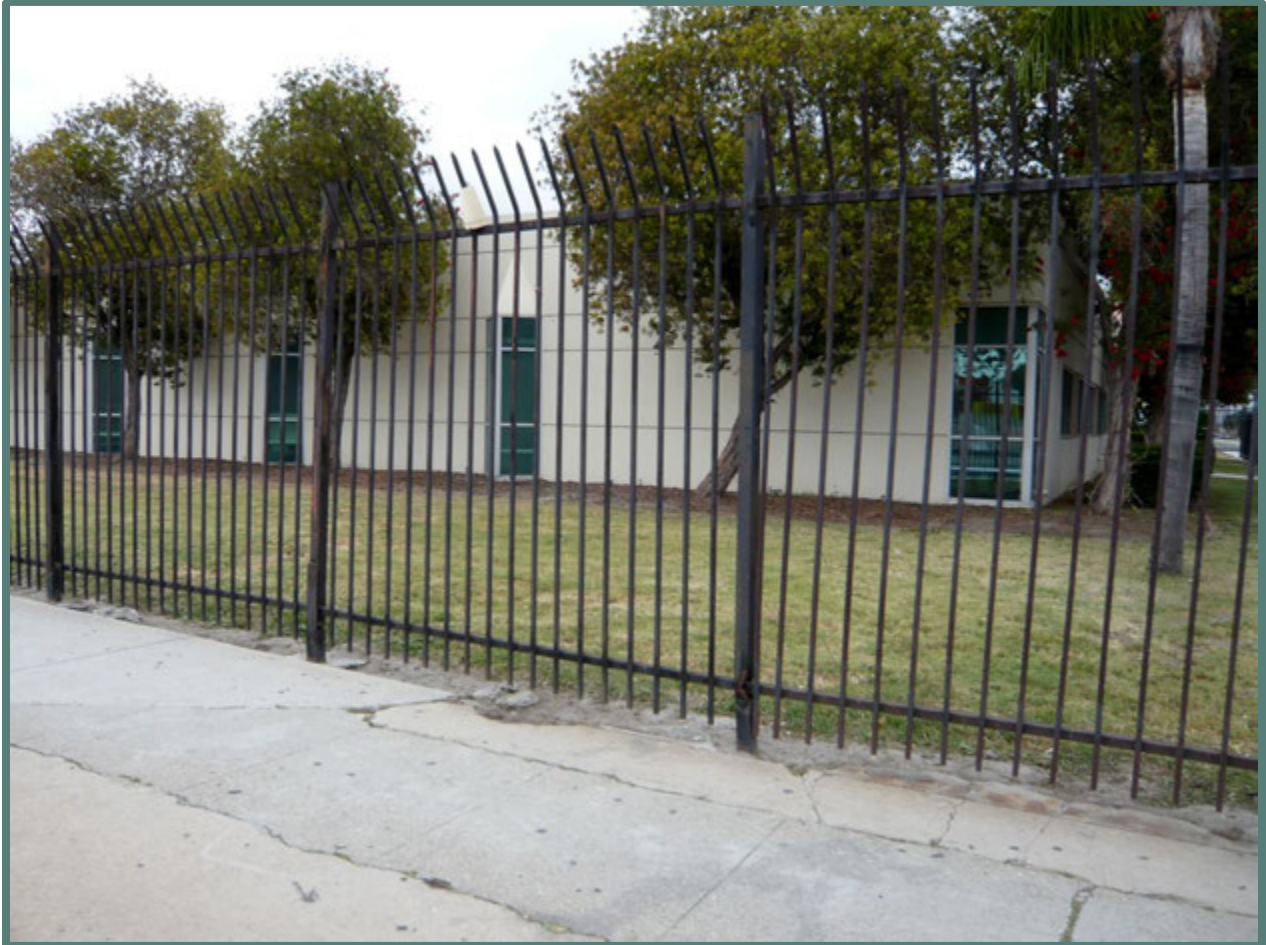
STUDENT SERVICES BUILDING
SOUTHWEST CORNER

MINIMAL MODERN BOX DESIGN. ALUMINUM STOREFRONT TYPE FENESTRATION.
NO SIGNIFICANT ARCHITECTURAL FEATURES AND MINIMAL LANDSCAPING.

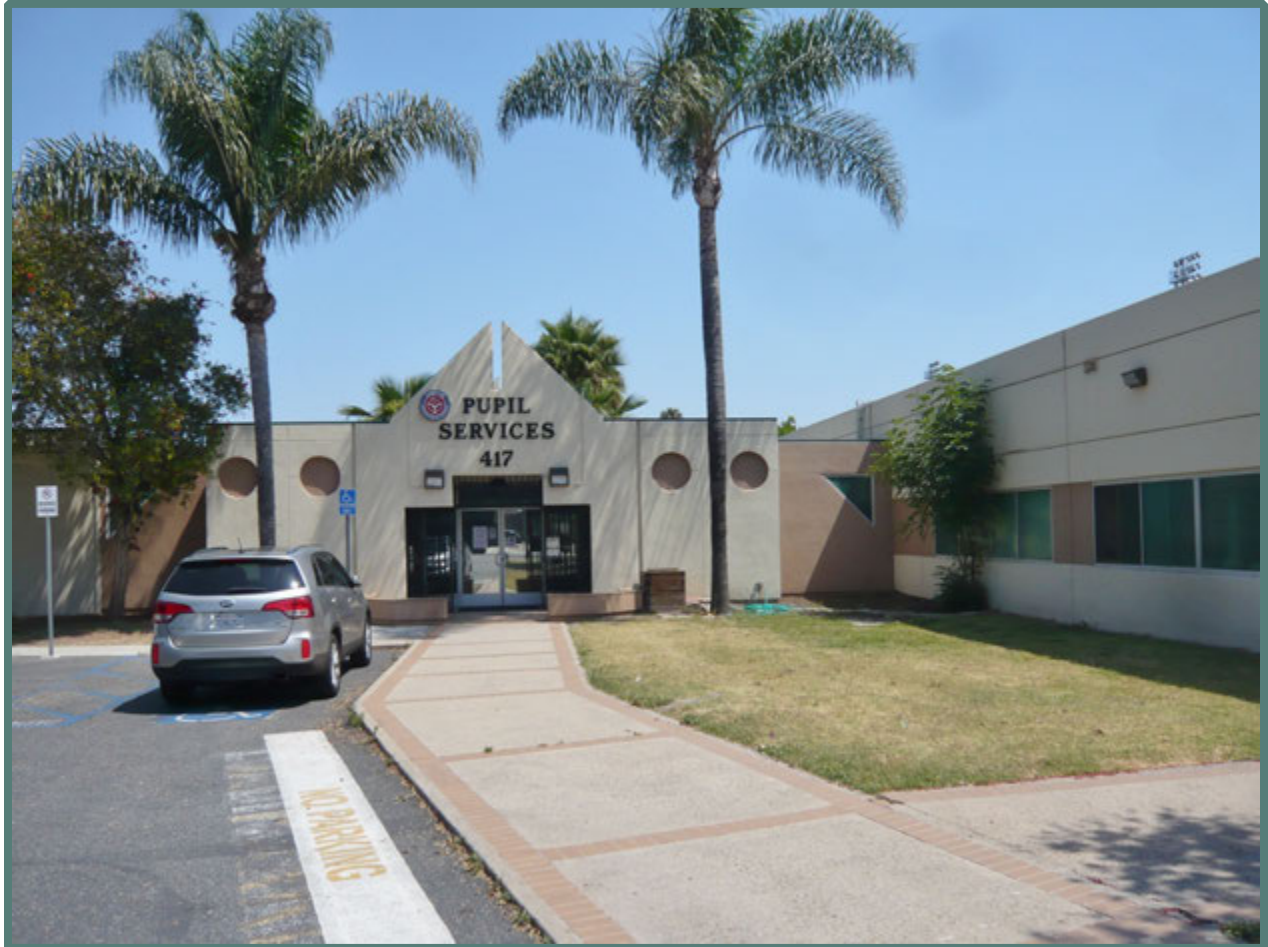
STUDENT SERVICES BUILDING

THE ENTRY TO THE BUILDING EXHIBITS CONTEMPORARY DESIGN
ELEMENTS – GEOMETRIC FAÇADE AND ALUMINUM STOREFRONT.

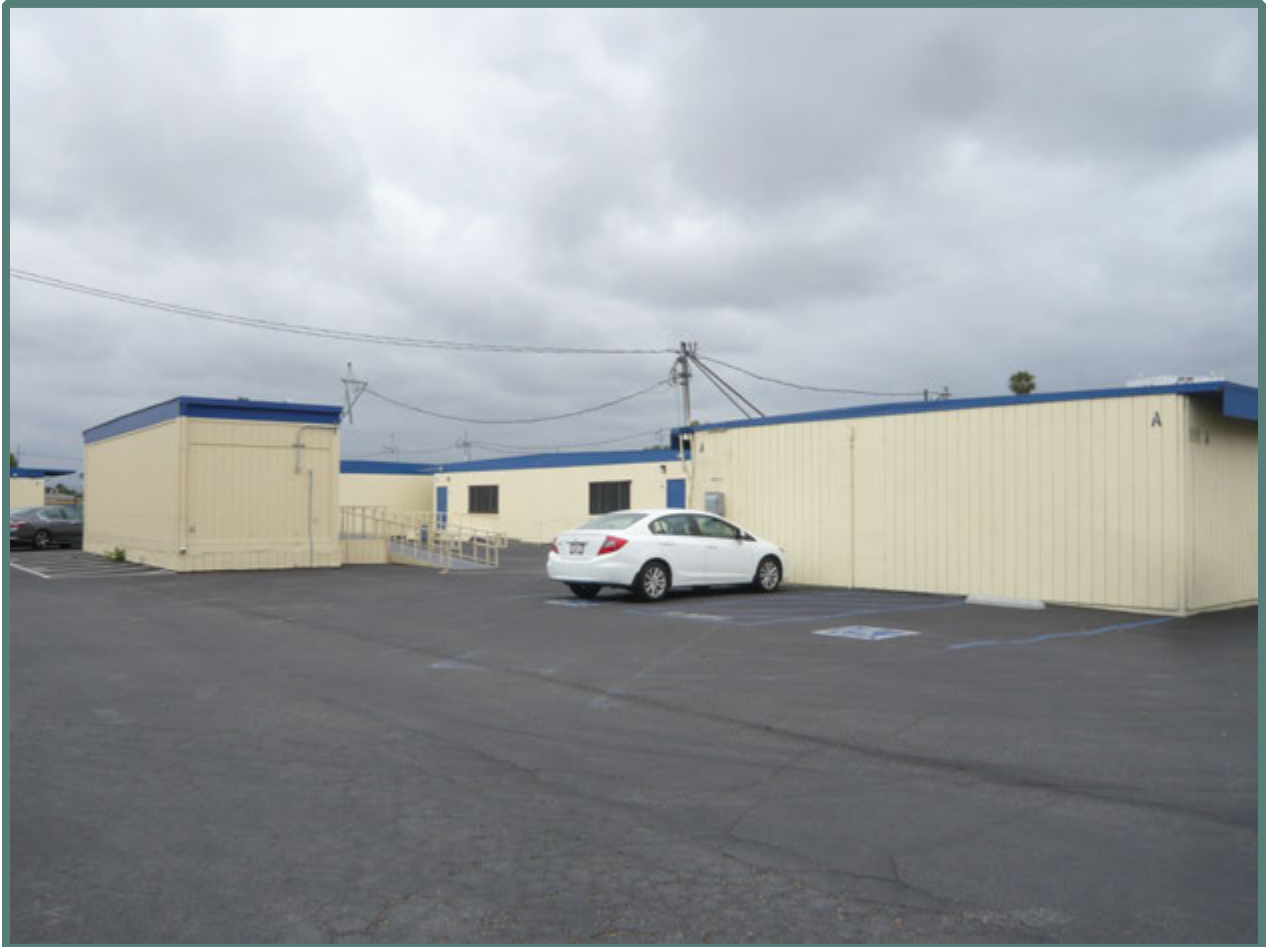
**PORTABLE OFFICES
AND
ACCESSORY BUILDINGS**

MORE RECENTLY INSTALLED FEATURELESS PORTABLES AT THE
SOUTHWEST AREA OF THE CAMPUS. STANDARD UTILITARIAN DESIGN.

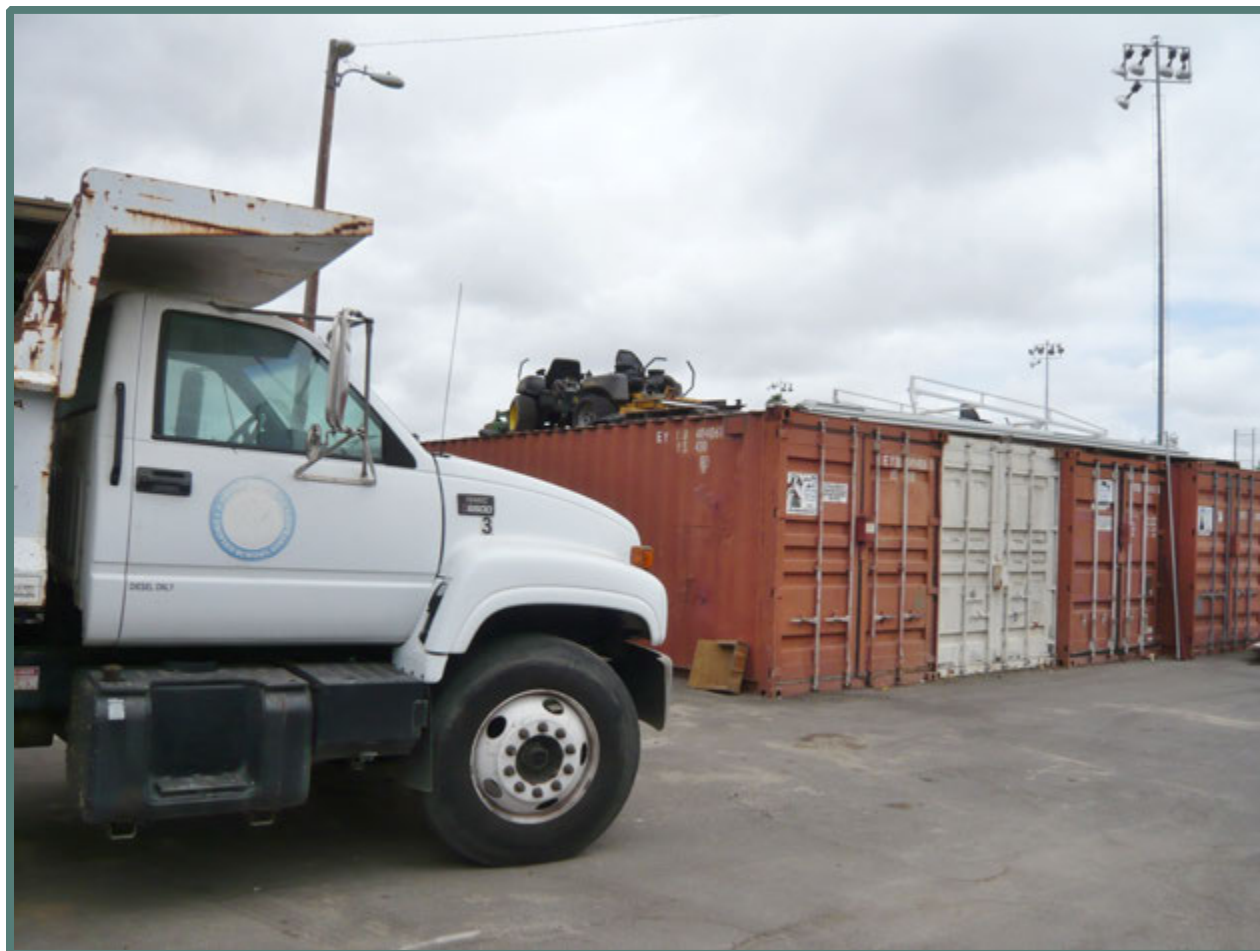
**ONSITE CONTAINER STORAGE
NORTH CAMPUS**

MULTIPLE STORAGE CONTAINERS ARE LOCATED AT THE ASPHALT LOT AREA OF THE NORTHWEST CAMPUS. THERE IS AN ASSORTMENT OF INDUSTRIAL LIGHTING FIXTURES THROUGHOUT THIS AREA.

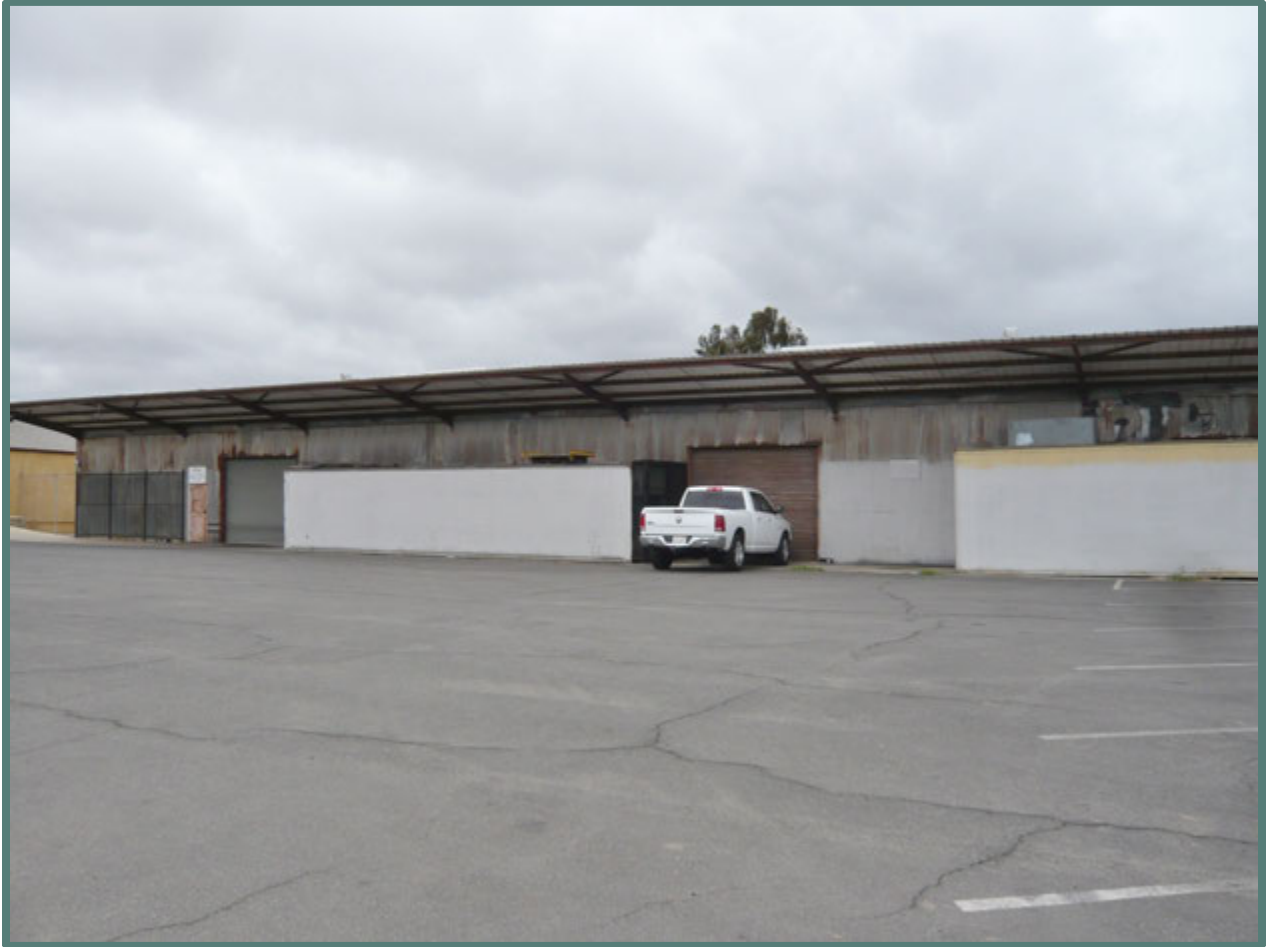
FOOD STORAGE WAREHOUSE

THIS ALL STEEL BUILDING IS RUSTING AND DETERIORATING.
THE SURROUNDING ASPHALT IS SEVERELY CRACKED AND FAILING.

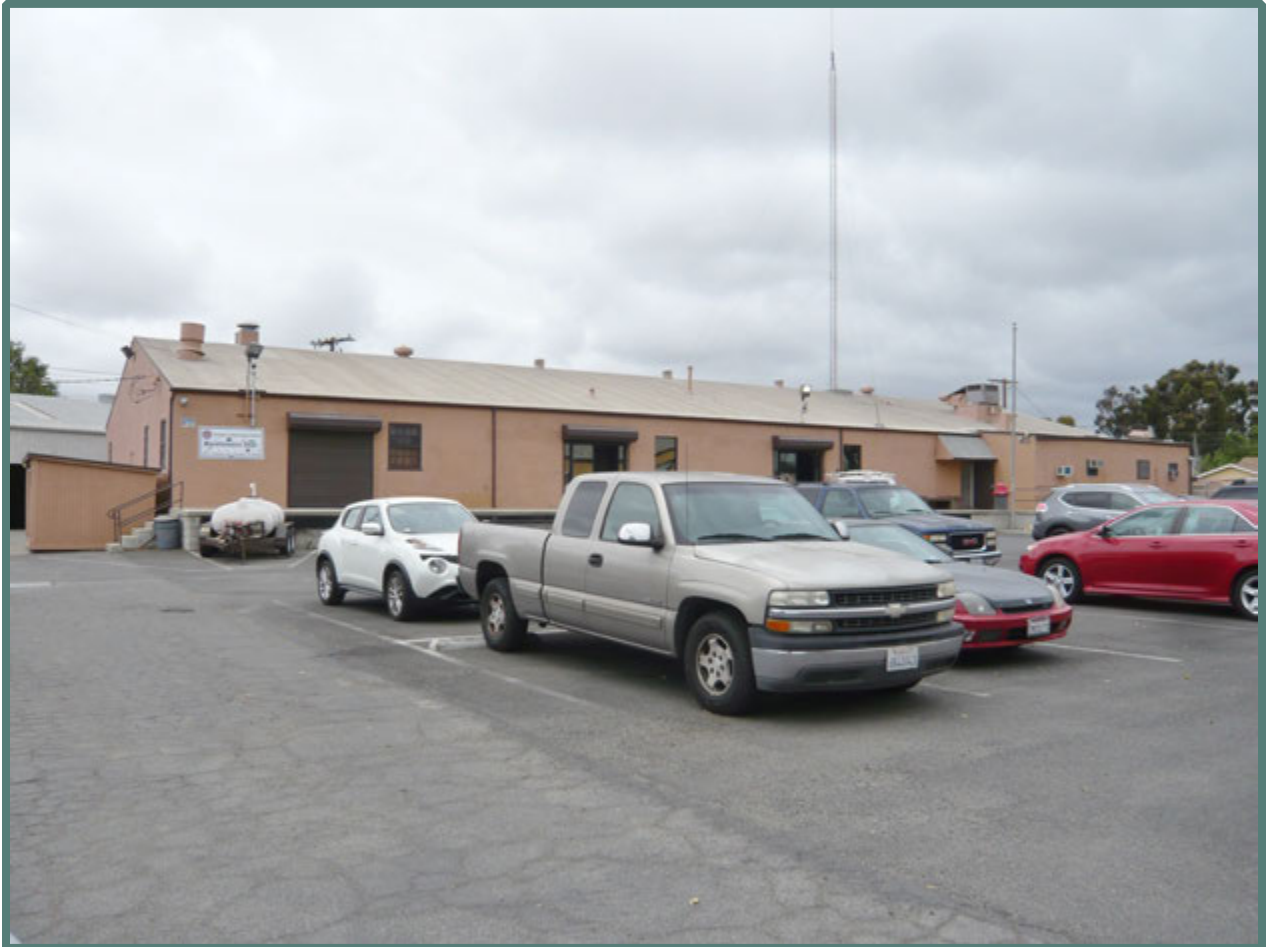
FOOD SERVICES BUILDING

RECTANGULAR UTILITARIAN DESIGN BUILDING WITH NO SIGNIFICANT ARCHITECTURAL ELEMENTS IS LOCATED AT THE NORTHWEST CAMPUS AREA. CORRUGATED STEEL ROOF WITH FLAT SAND FINISH PLASTER WALLS. PARKING LOT AND DRIVE ISLES HAVE SEVERELY CRACKED AND FAILED ASPHALT.

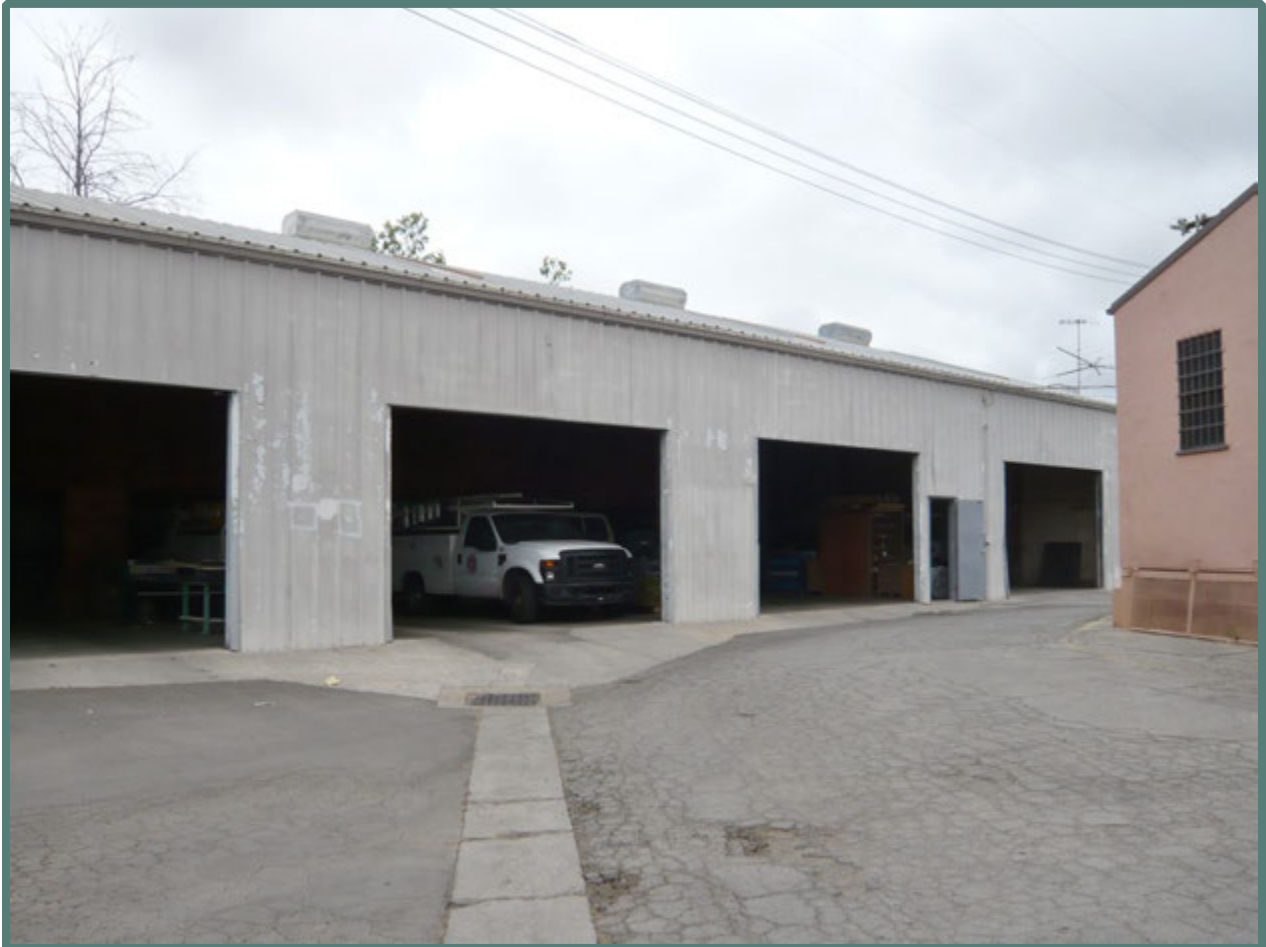
MAINTENANCE BUILDING

WAREHOUSE TYPE ALL STEEL STRUCTURE DESIGNED FOR TYPICAL GARAGE AND SERVICE FUNCTIONS. LOCATED AT NORTHWEST CAMPUS AREA AND SURROUNDED BY CRACKED AND FAILED CONCRETE AND ASPHALT.

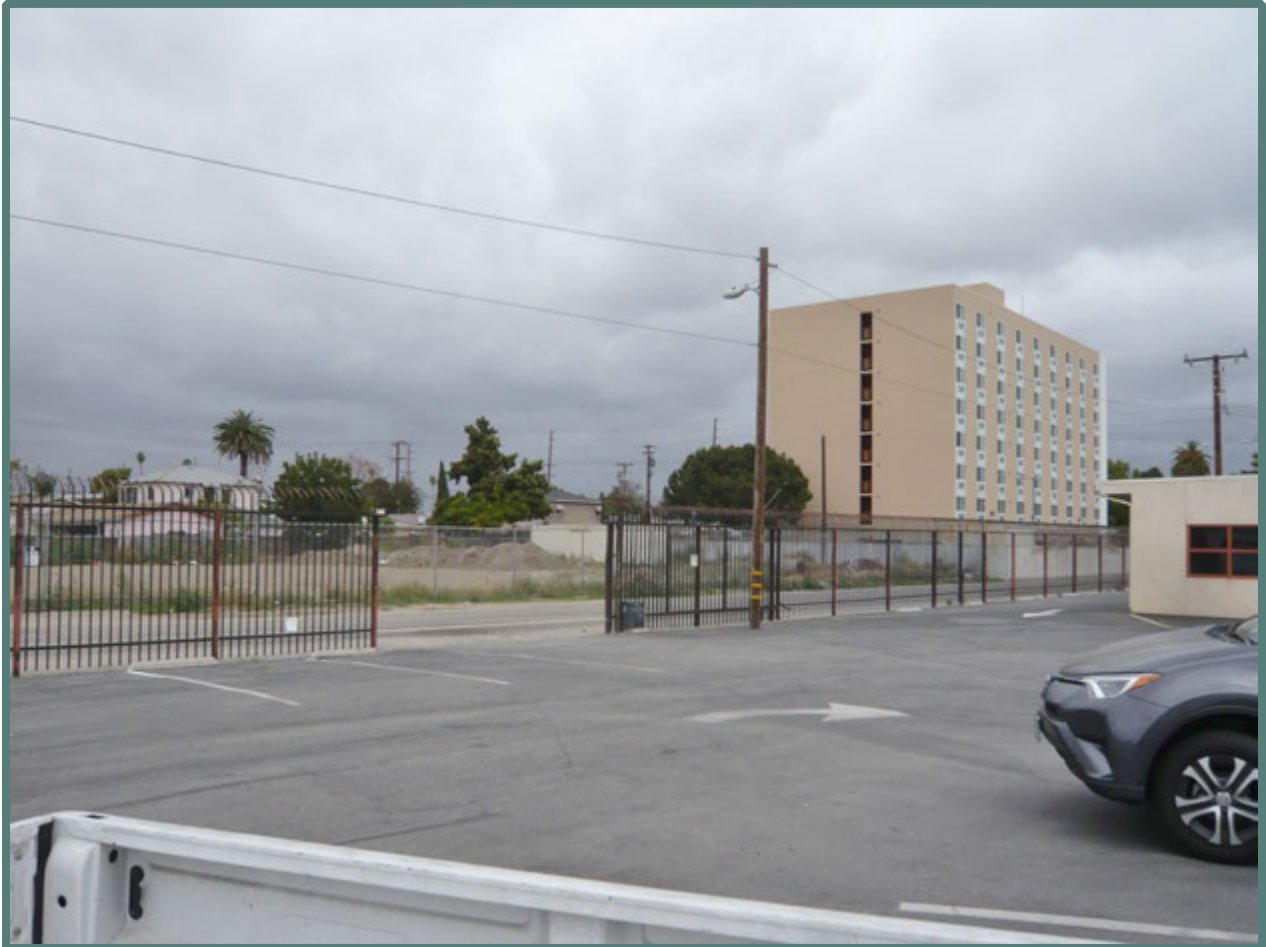
NORTHWEST CAMPUS

TYPICAL FENCING IS CHAIN-LINK AND STEEL BAR TYPE.

ALL FENCING IS RUSTING AND DETERIORATING

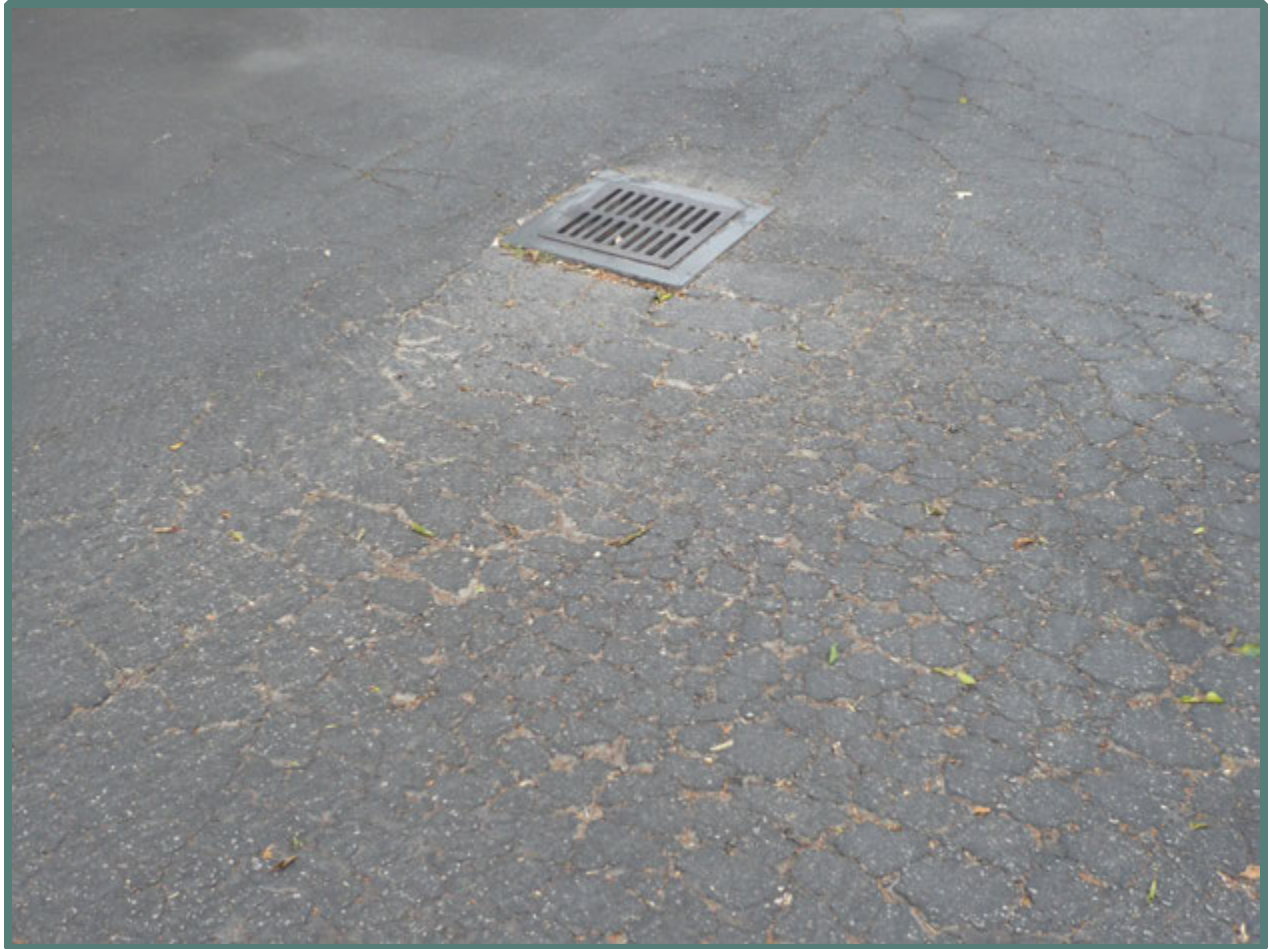
TYPICAL CONDITIONS OF ASPHALT PAVING

SEVERELY CRACKED AND FAILED ASPHALT IS COMMON THROUGHOUT THE CAMPUS.

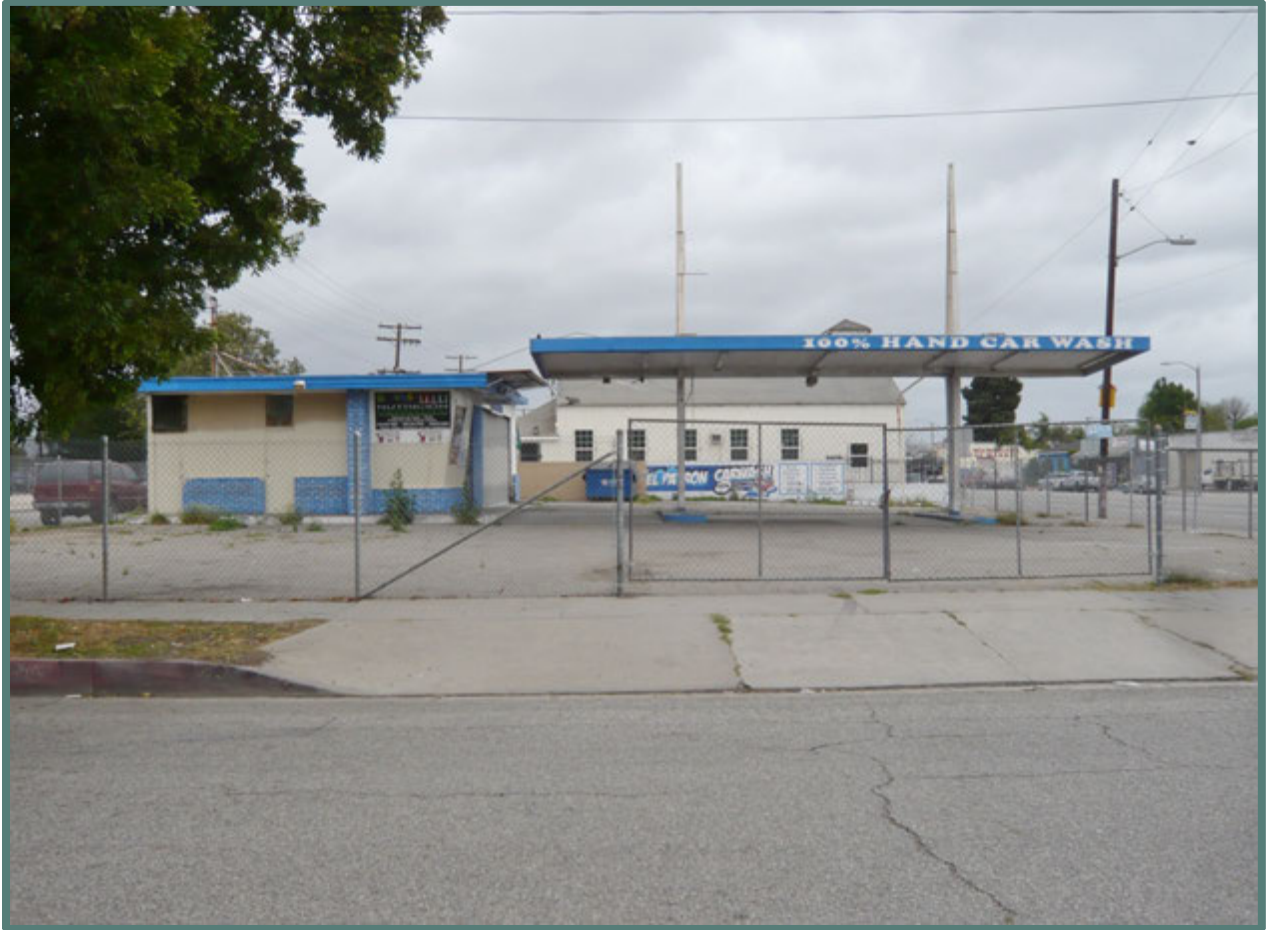
ABANDONED CARWASH AT WEST END

METAL BUILDING ABANDONED FOR A FEW YEARS.

CURRENTLY SLATED FOR DEMOLITION.
