COMPTON UNIFIED SCHOOL DISTRICT

COMPTON HIGH SCHOOL CAMPUS WIDE & WEST COCOA STREET PROPERTIES

HISTORICAL RESOURCE ANALYSIS

June 2, 2018

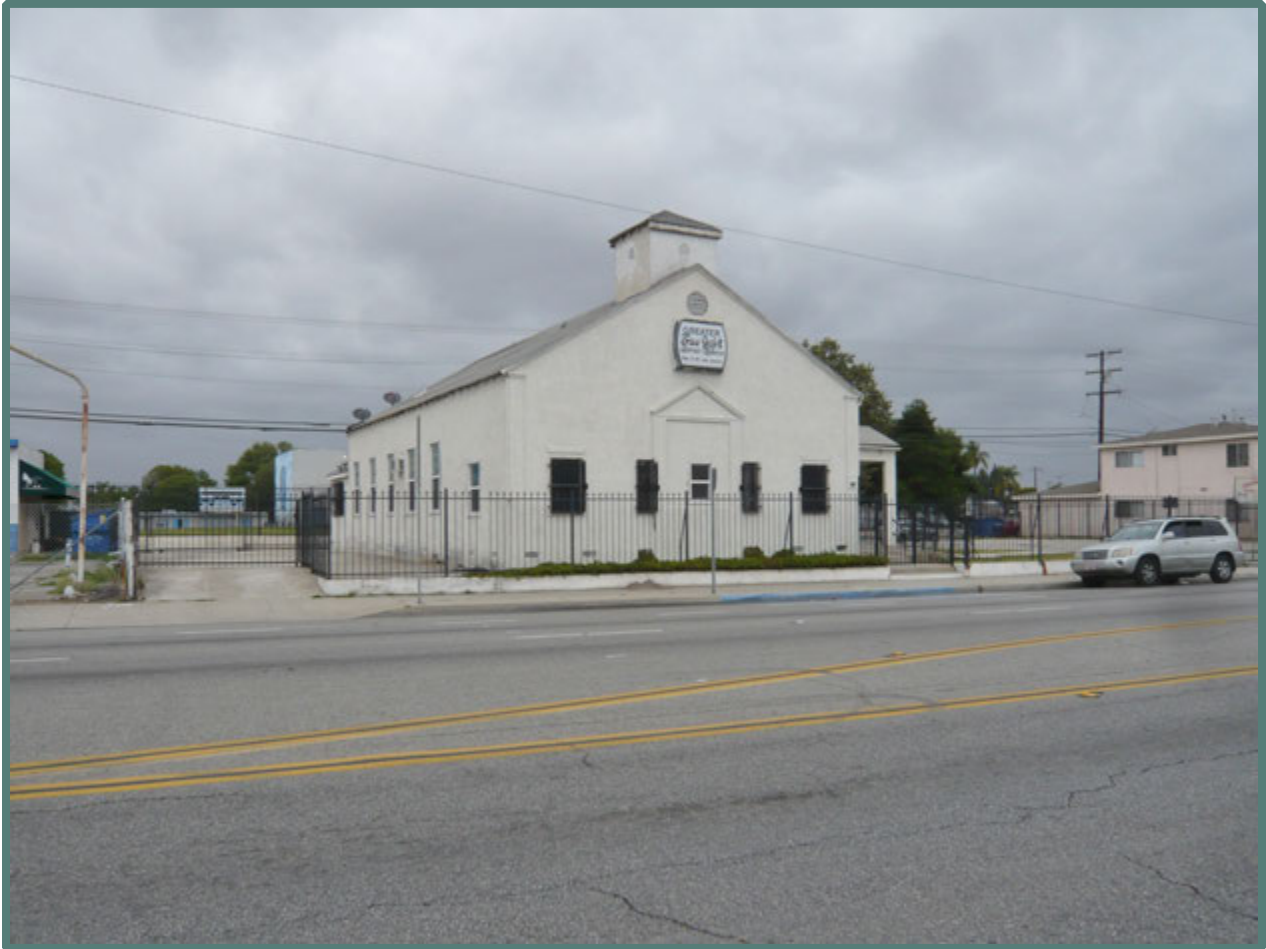
BAPTIST CHURCH
333 WEST ALONDRA BLVD.

SIMPLE PLASTER AND WOOD FRAME DESIGN.

ELECTRICAL SIGNAGE HAS BEEN ADDED TO THE STREET FAÇADE

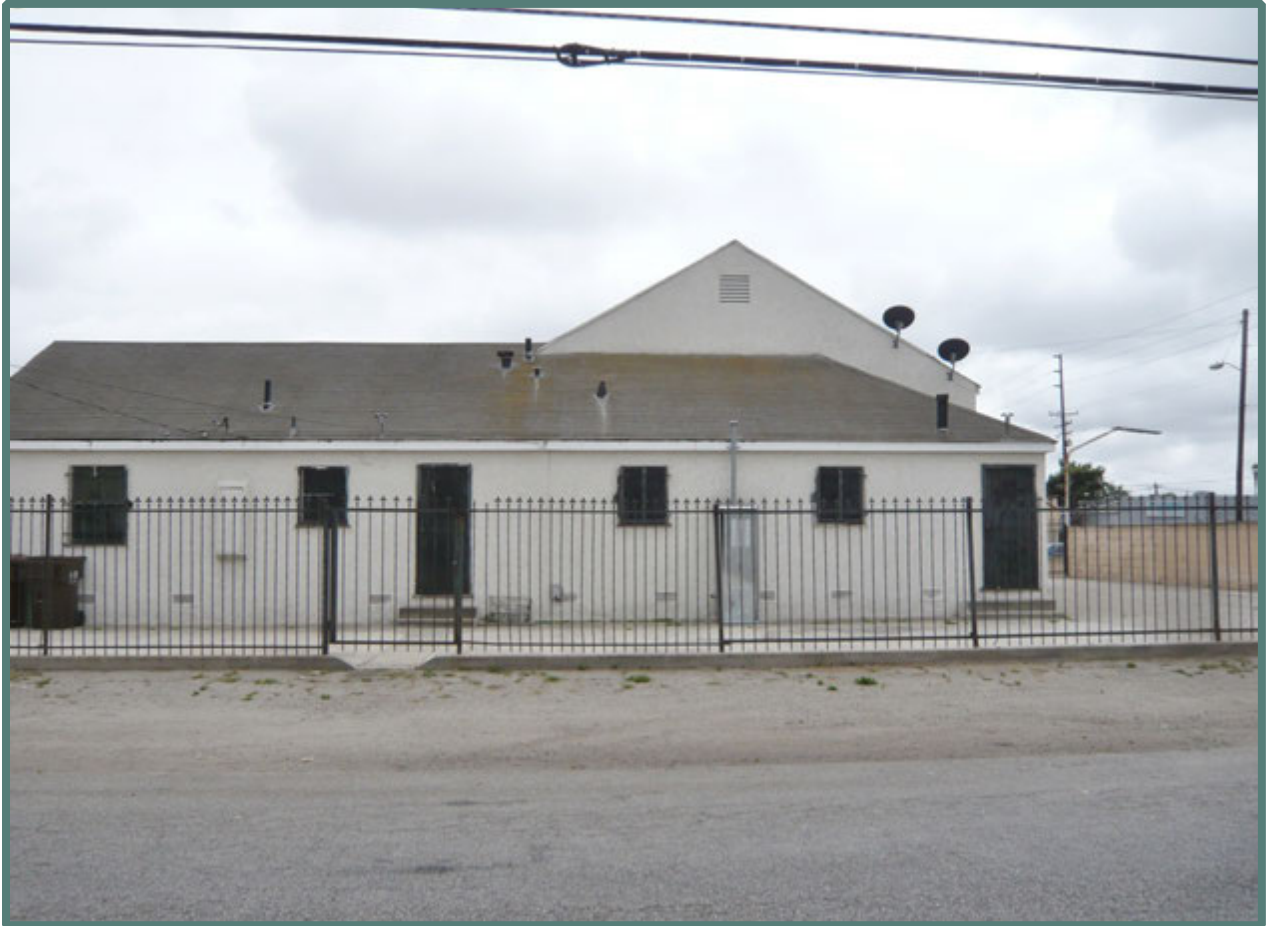
**NORTH (REAR) SIDE OF CHURCH
FACING HIGH SCHOOL CAMPUS**

NO SIGNIFICANT FEATURES ARE PRESENT.

THE PAVEMENT IS FAILING THROUGHOUT THE
PROPERTY AND THE ADJACENT WEST COCOA STREET.

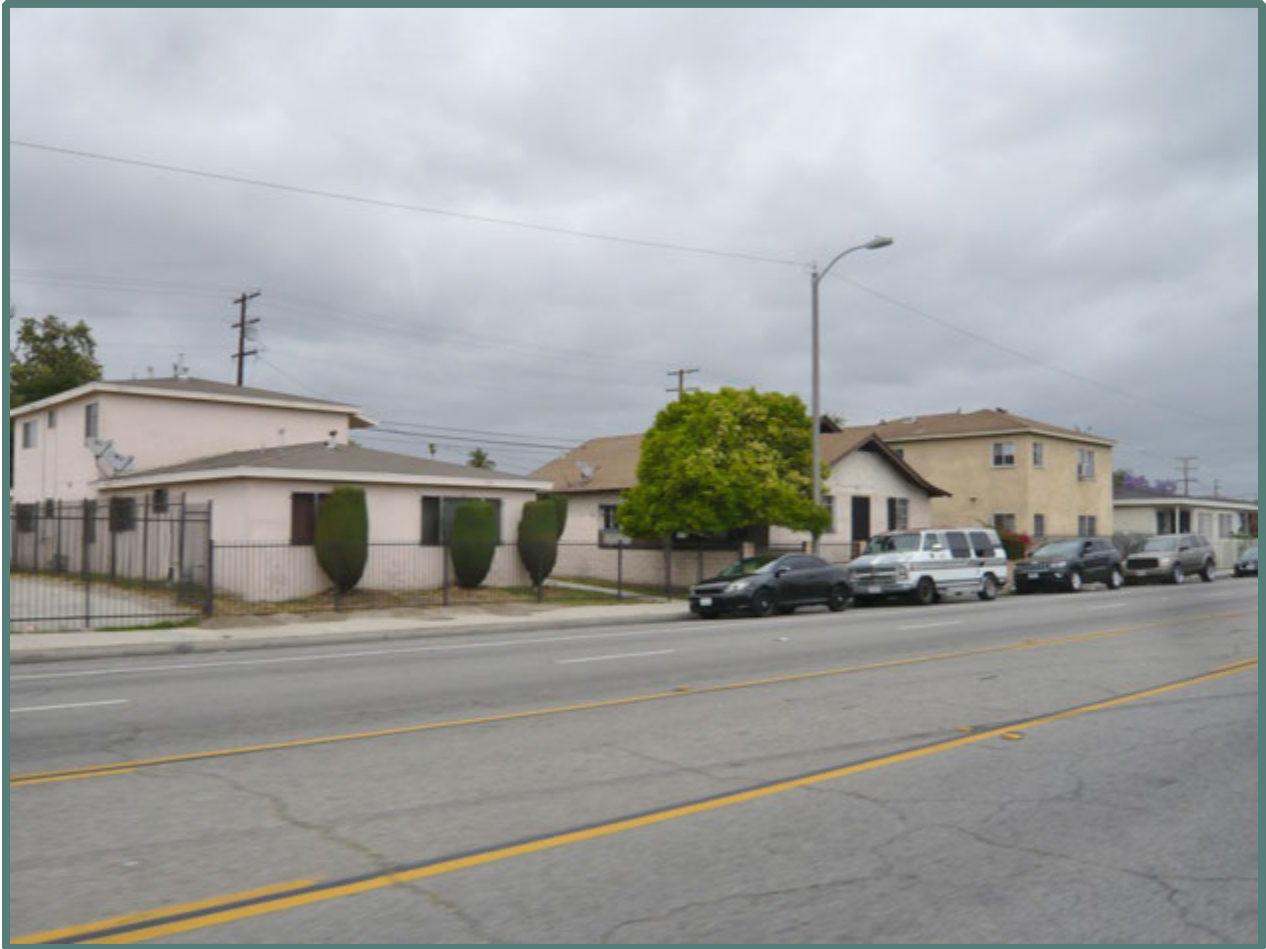
325, 321 AND 317 WEST ALONDRA BLVD.

SIMPLE DESIGN AND COMMON BUILDING MATERIALS
ARE TYPICAL TO ALL STRUCTURES.

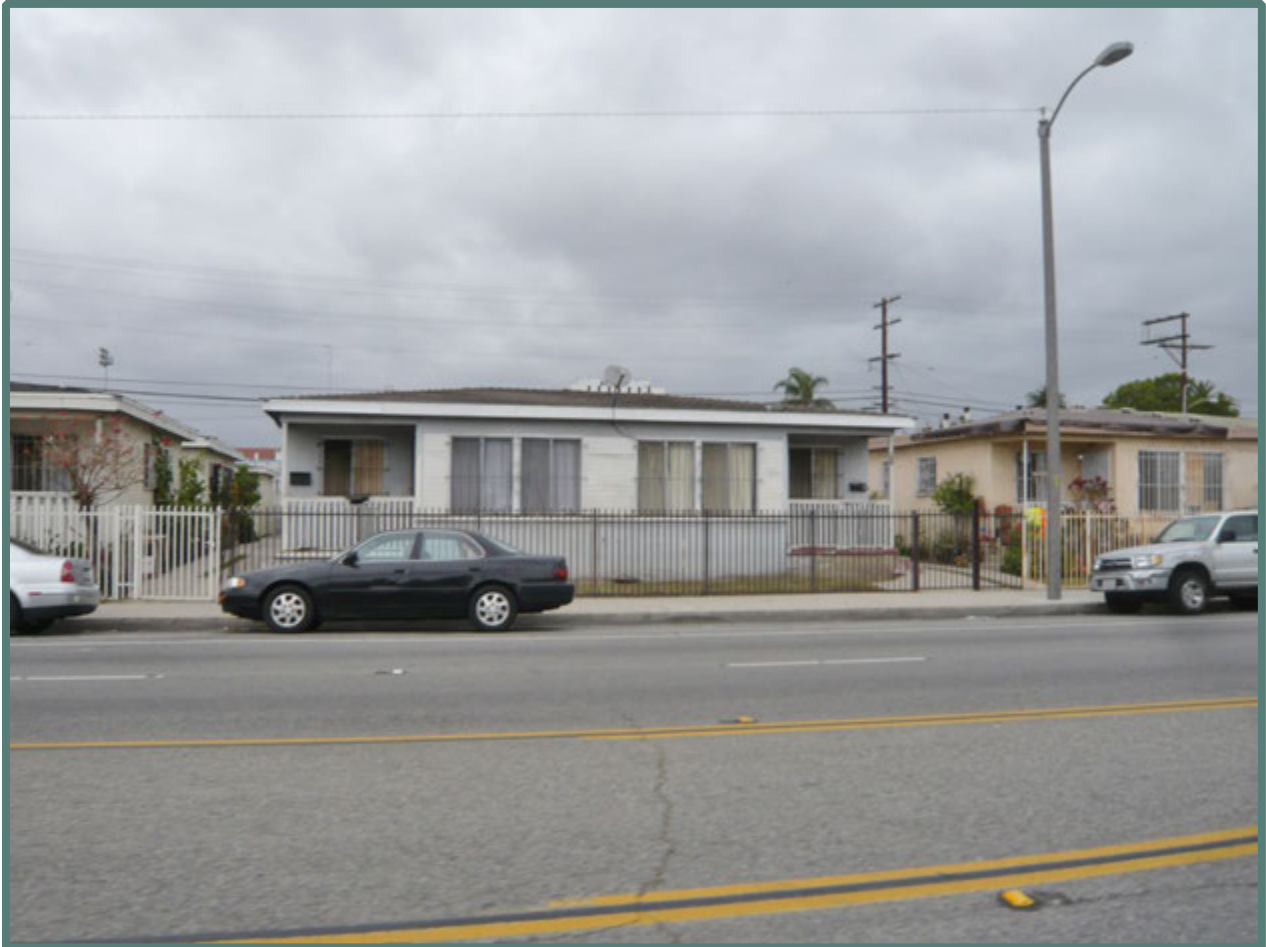
313 WEST ALONDRA BLVD.

COMMON DESIGN AND SPARSE OR MISSING
LANDSCAPING ARE TYPICAL OF ALL EIGHT PROPERTIES.

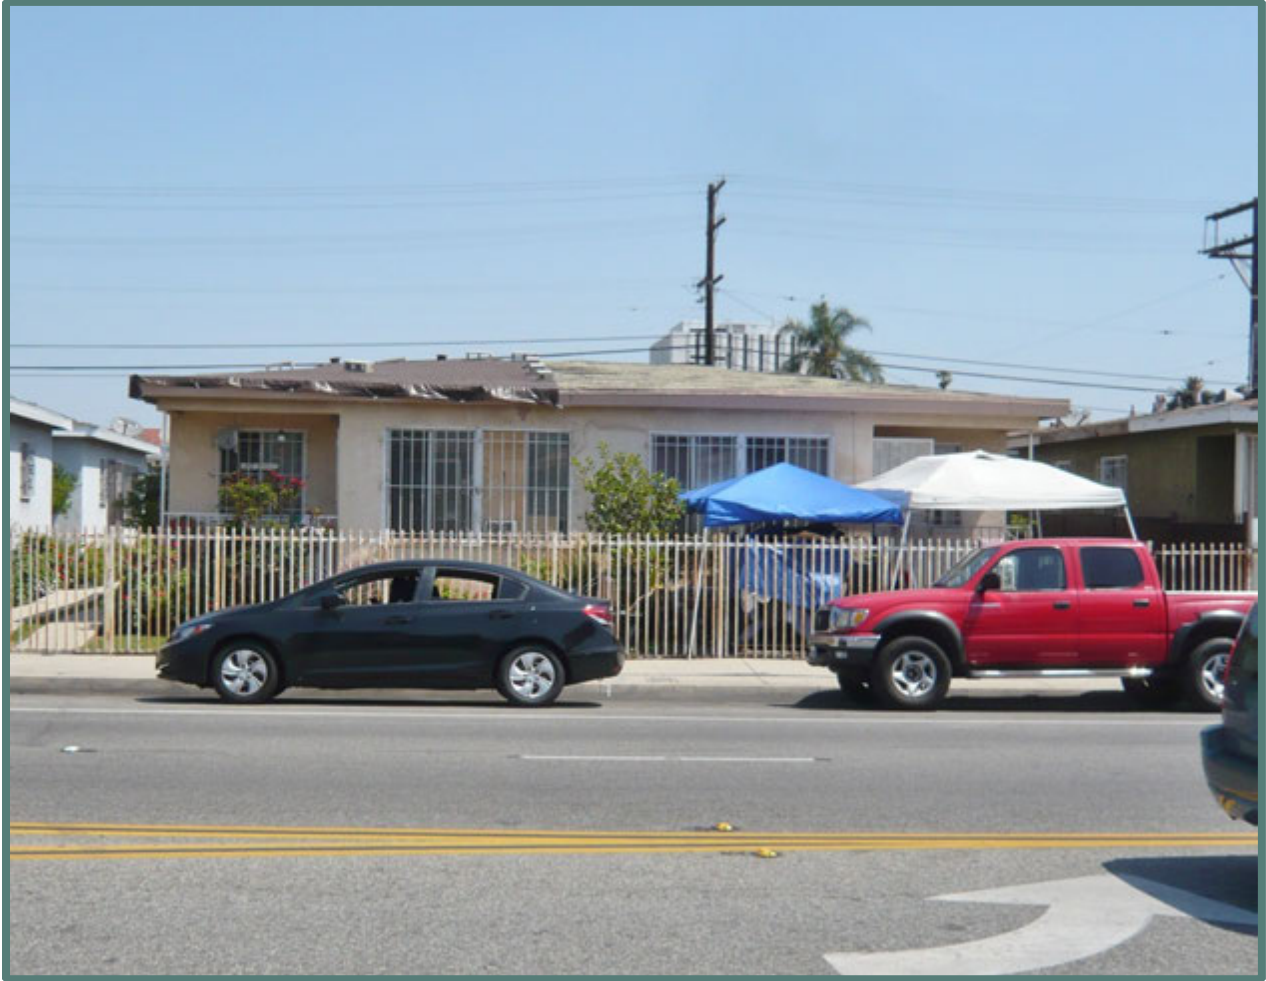
305 WEST ALONDRA BLVD.

FAILING ROOF IS COVERED WITH A TARP THAT APPEARS TORN AND FRAYED,
INDICATING THAT IS HAS BEEN IN PLACE FOR A LONG PERIOD OF TIME.
RUSTING STEEL SECURITY BARS ON ALL WINDOWS AND DOORS ARE
TYPICAL OF ALL THESE BUILDINGS.

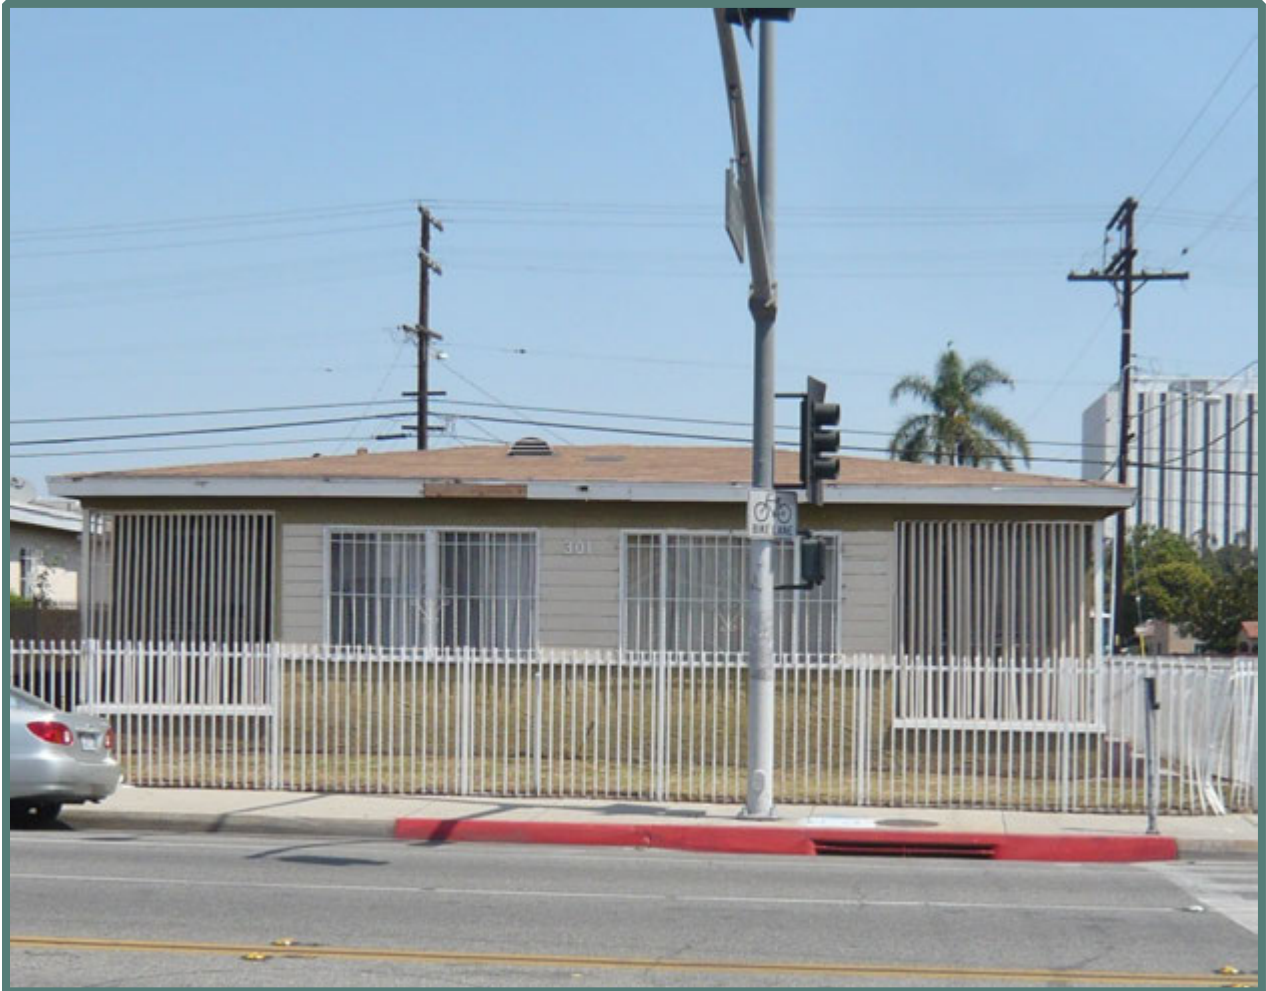
301 WEST ALONDRA BLVD.

FAILING WOOD SIDING AND FASCIA OCCUR AT ALL FAÇADES.

THE PROPERTY IS VOID OF ANY LANDSCAPING.

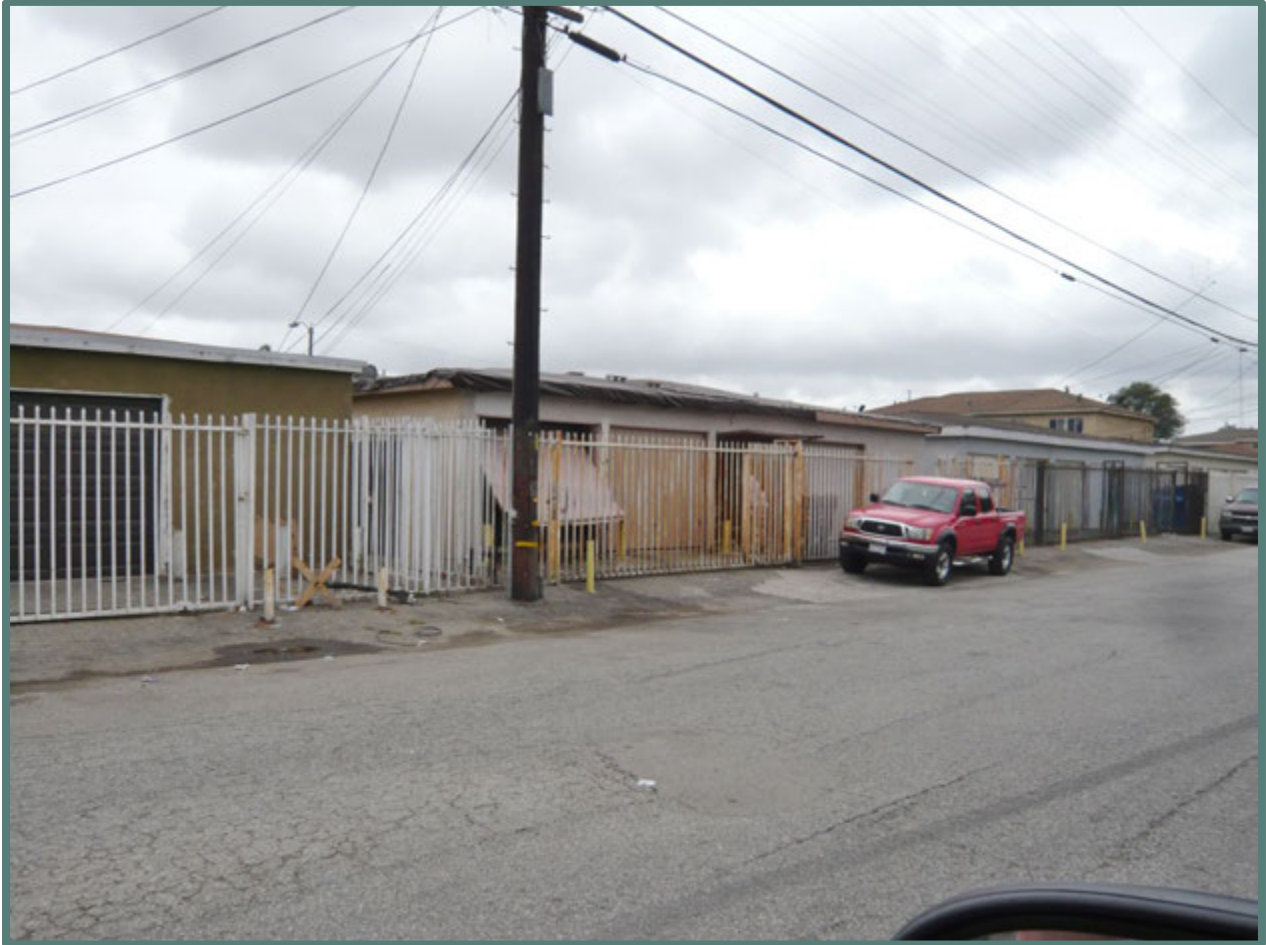
NORTH (REAR) SIDE OF 301 AND 305 FACING THE HIGH SCHOOL CAMPUS

FAILING FENCING, ROOFING AND WOOD
ELEMENTS ARE TYPICAL AT ALL PROPERTIES.

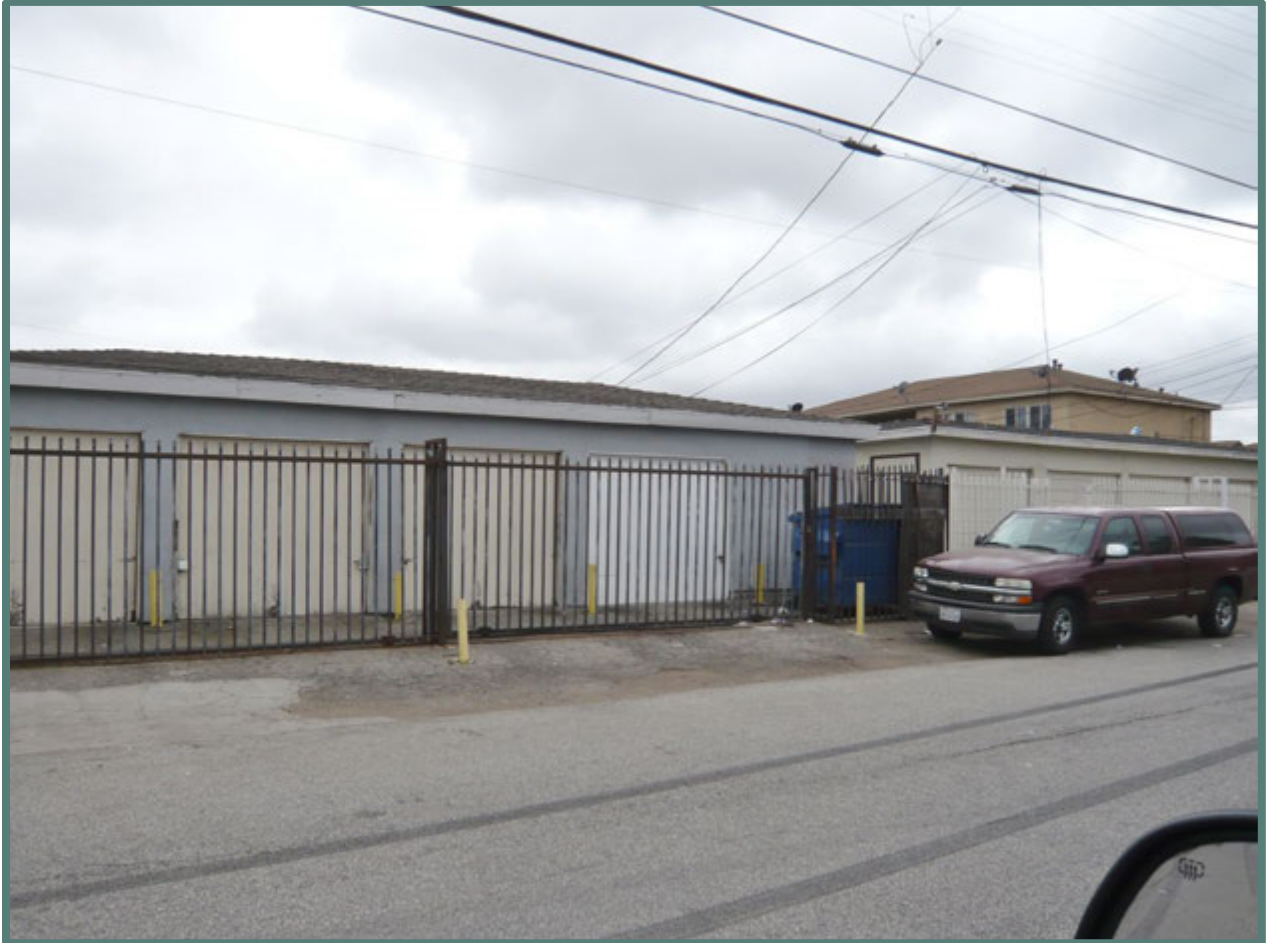
NORTH (REAR) SIDE OF 313 AND 317 FACING CAMPUS

DETERIORATED PAVEMENT AND
FENCING ARE TYPICAL AT ALL PROPERTIES

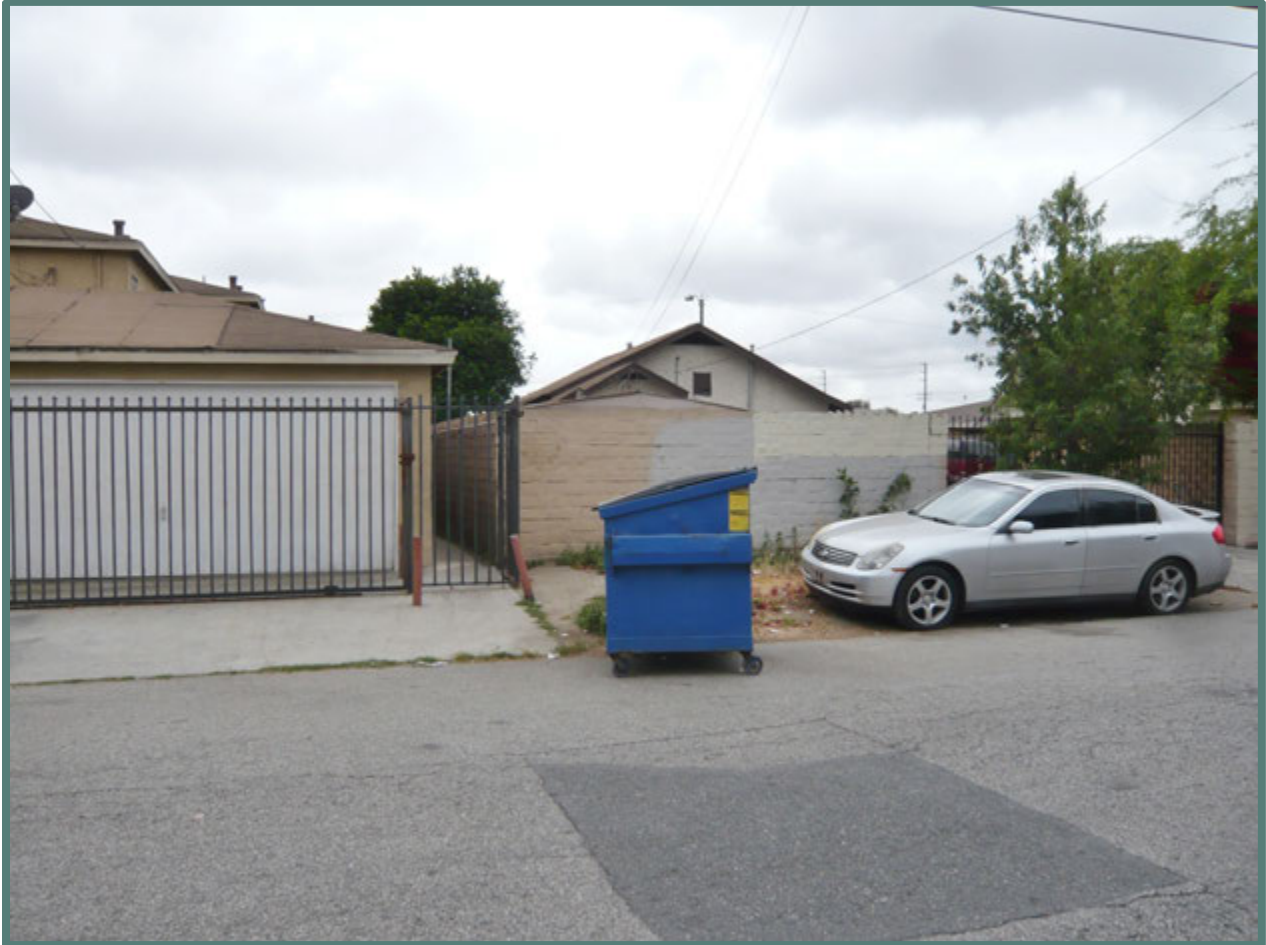
NORTH (REAR) SIDE OF 321 AND 325 FACING CAMPUS

EACH PROPERTY IS POORLY MAINTAINED
AND OVERGROWN WITH WEEDS.
