12338 Mona Blvd., Compton 90220 | <http://bms-compton-ca.schoolloop.com>

A. EXISTING SITE INFORMATION

B. OVERVIEW

C. ASSESSMENT OF SITE

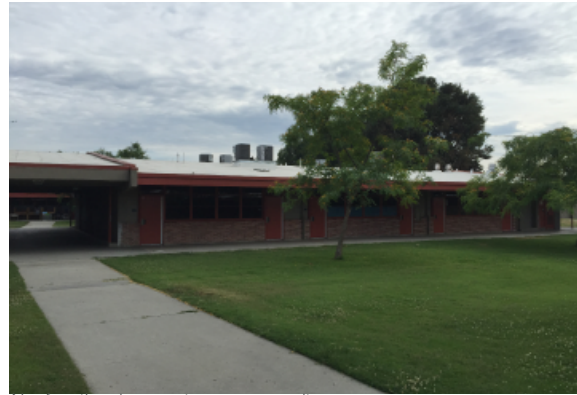
Nonfunctional computer room ac unit

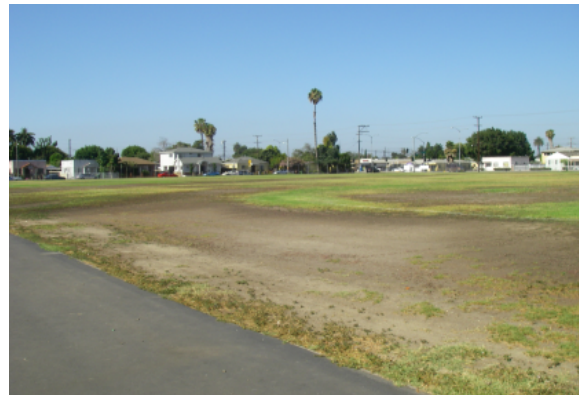
Compacted field, no turf growth

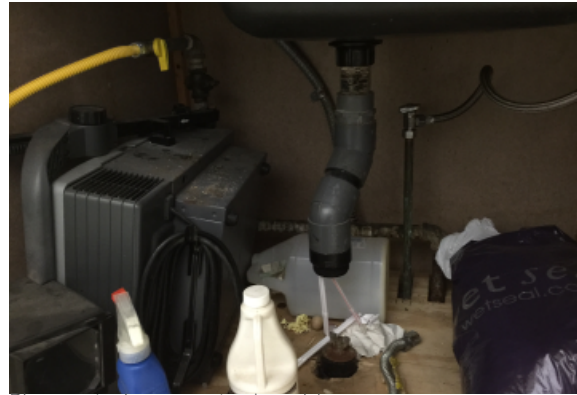
Disconnect science room teachers sink

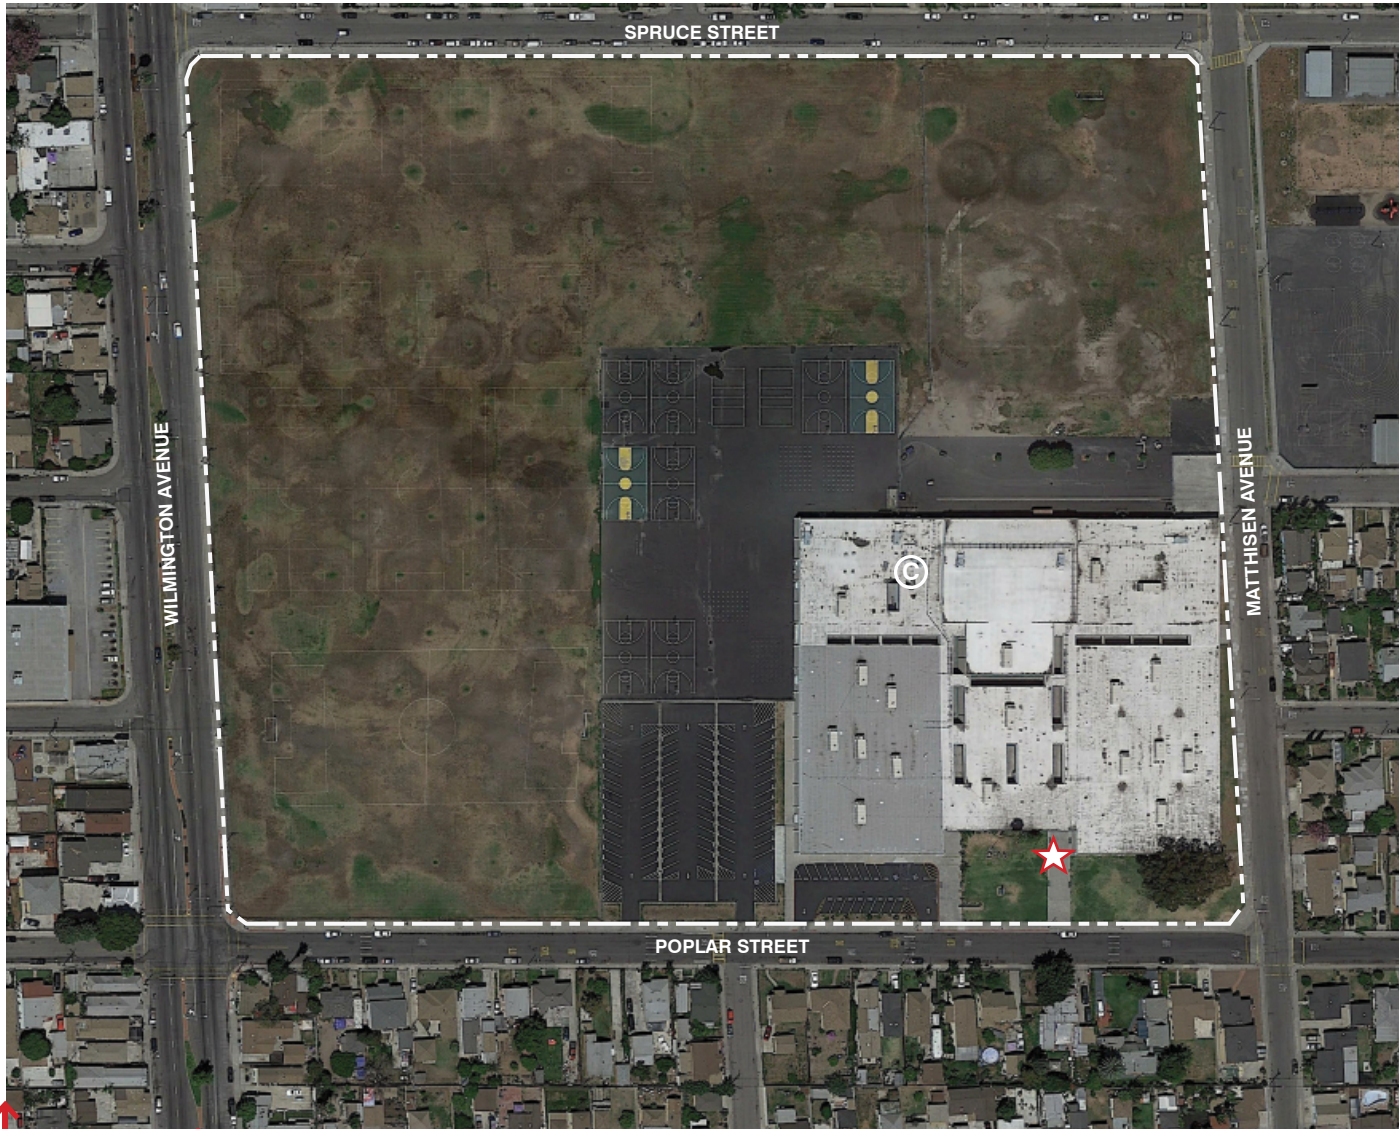
Electrical switchboard

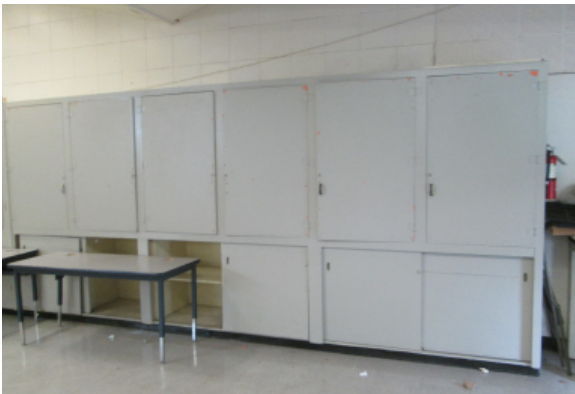
Deteriorating casework

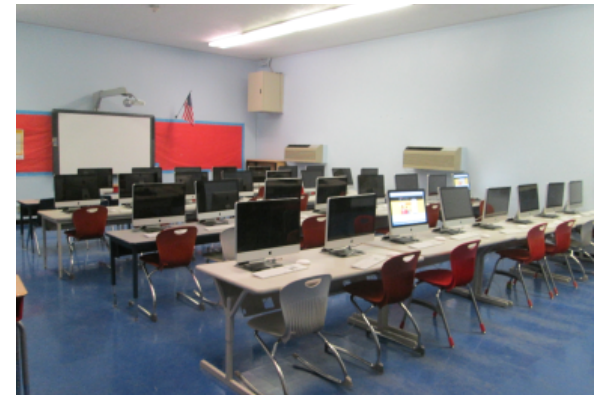
typical computer lab

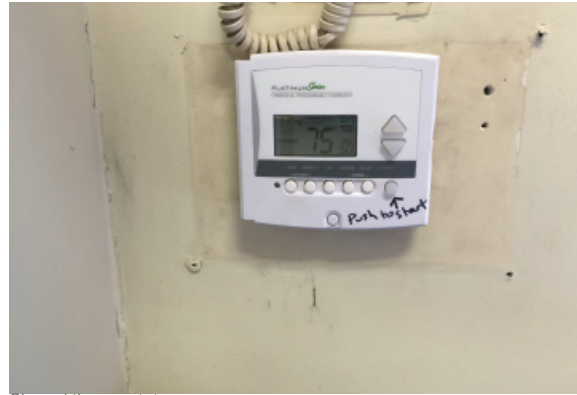
Shared thermostat

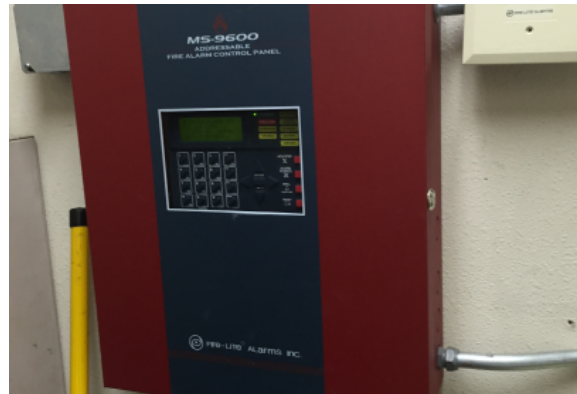
Fire alarm control panel is not up to standards

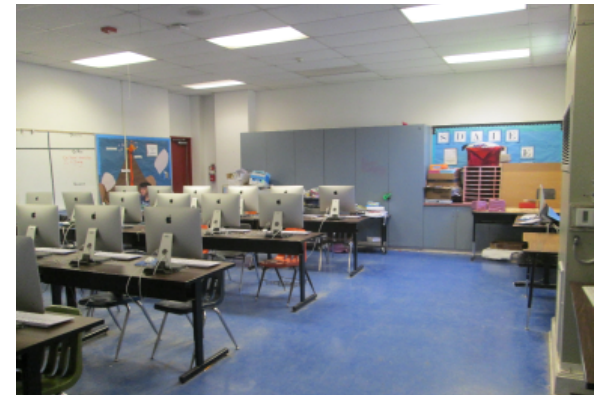
Typical computer lab

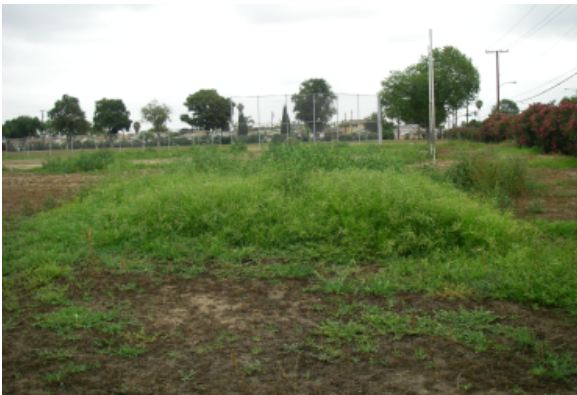
Majority of play field is overrun with weeds

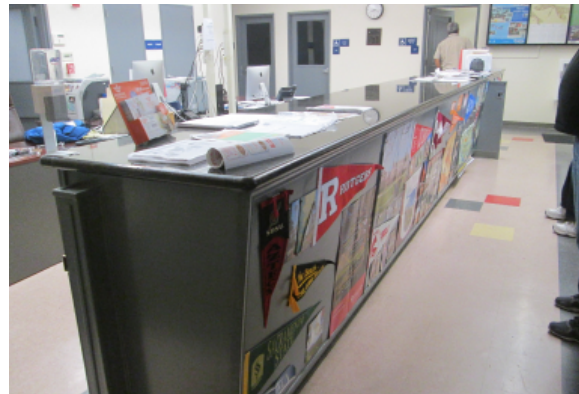
Non accessible counter

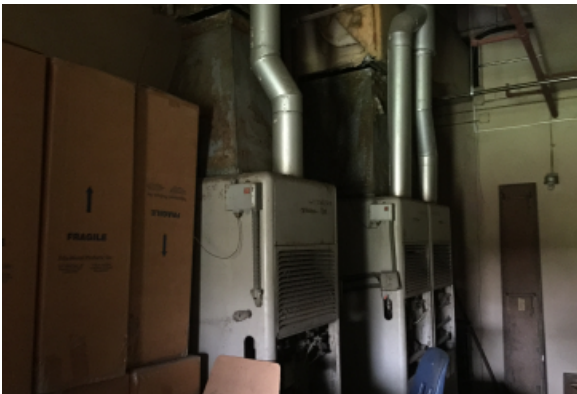
Non operable forced air units

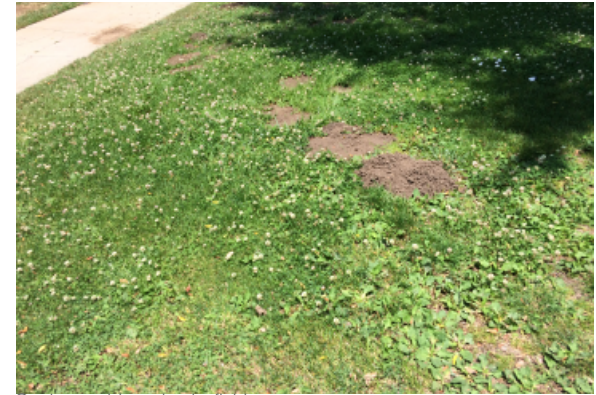
Gopher problems in playfield

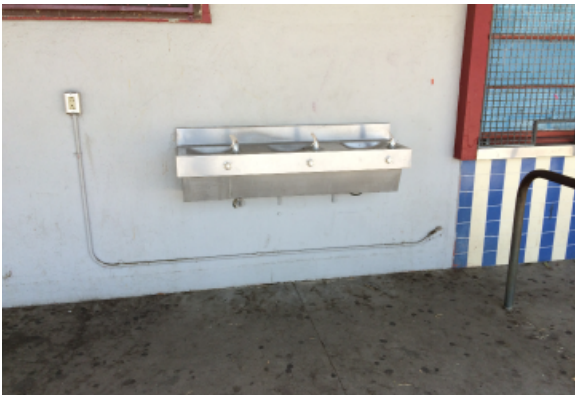
Drinking fountains not up to current code

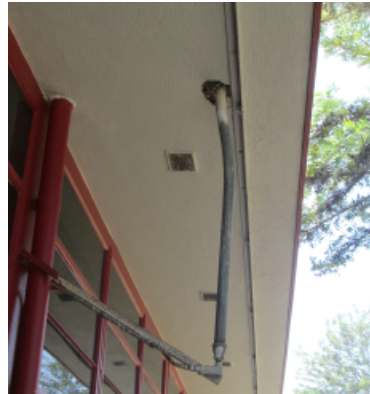
Unsafe installation of light fixture conduit

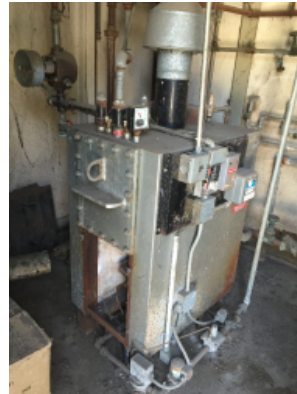
Nonfunctional boiler

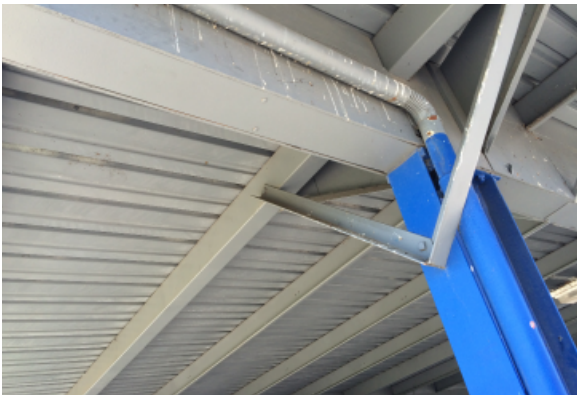
Bird nesting/droppings

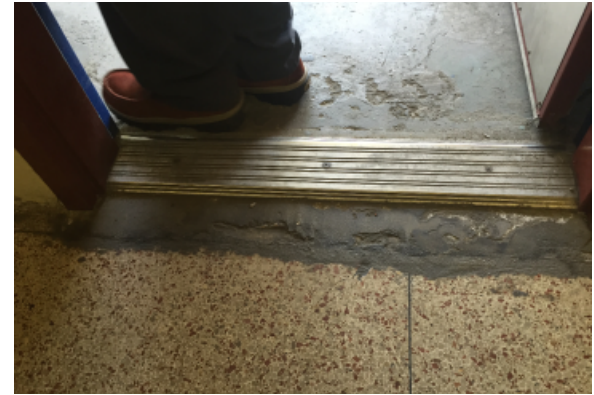
- Campus signs are missing, not legible or damaged.
- Door Thresholds are not ADA compliant.
- Exterior drinking fountains not ADA complain.

Door threshold

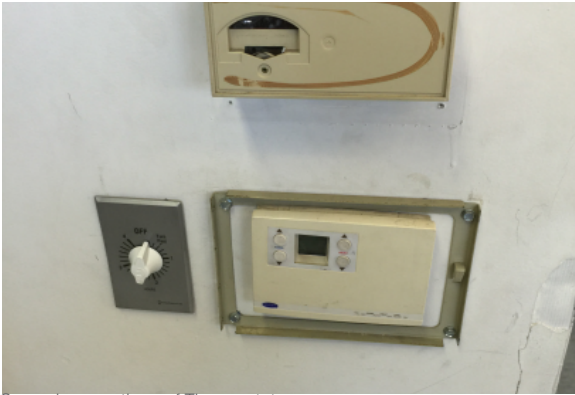
Several generations of Thermostats

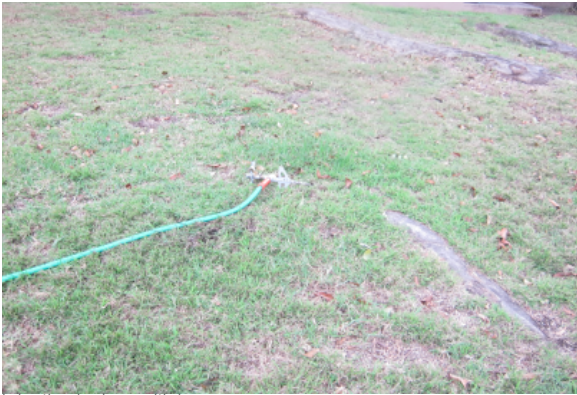
Irrigation is done with hoses

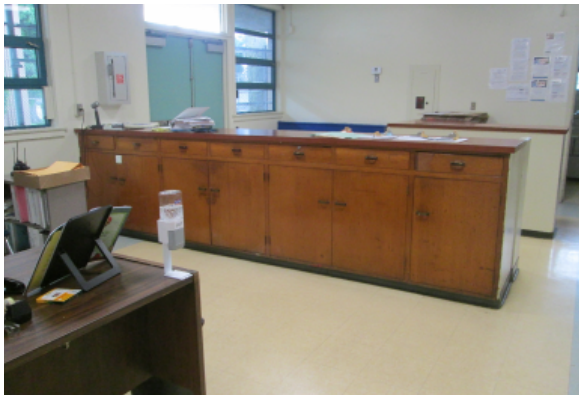
Non accessible counter

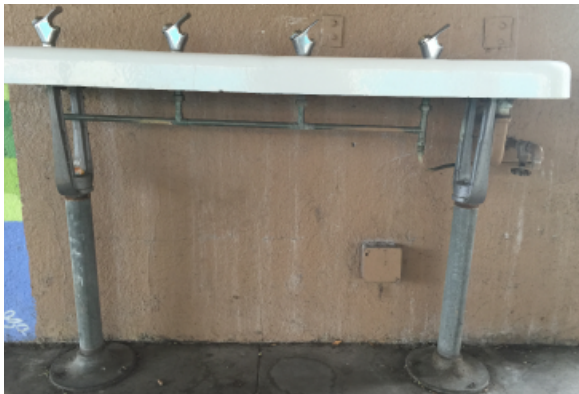
Aged drinking fountain

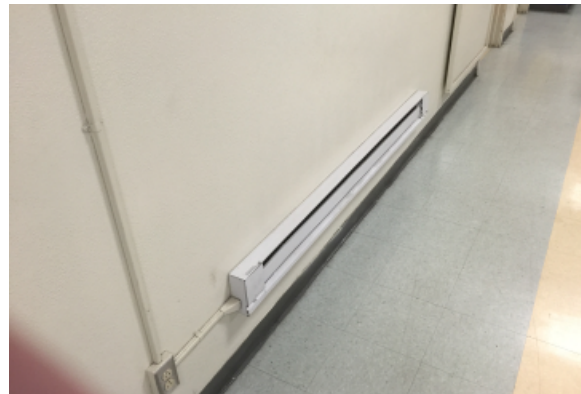
Electric baseboard heater

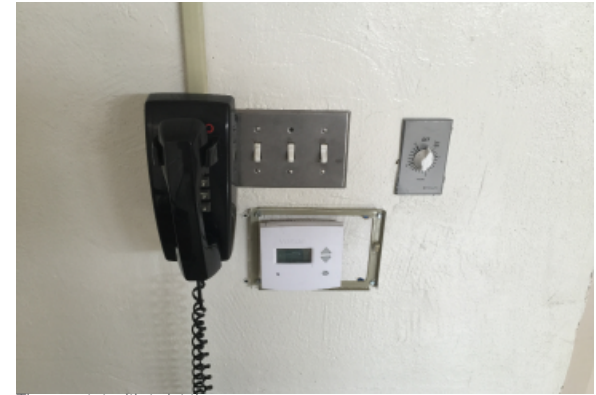
Thermostat with twist timer

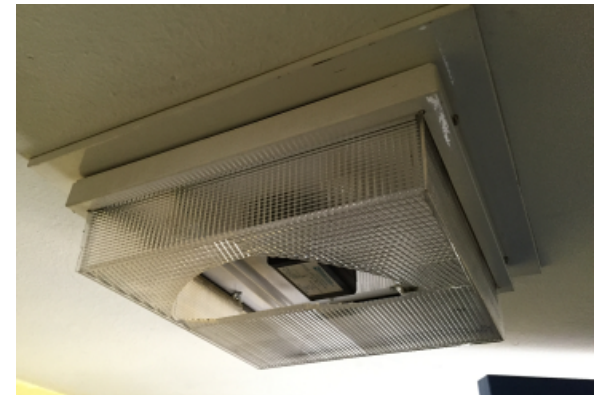
- The Lighting System is approximately 20 years old and is in fair condition and requires little maintenance from the Districts facility staff.
- Light fixtures in the classrooms and the offices are functional and meet the user needs. However, retrofitting the existing lighting with LED will improve efficiency and reduce the school's electrical bill.

Typical condition of exterior surface mounted light fixtures

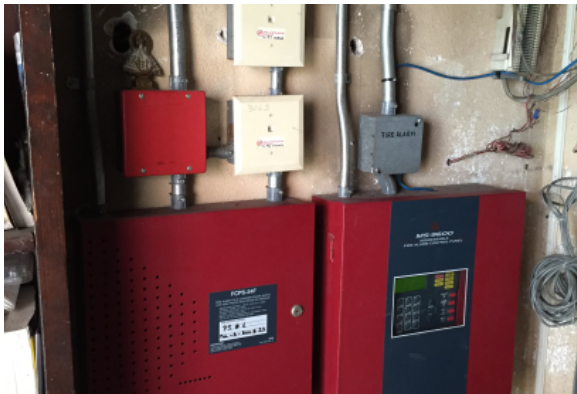
- The Site Fire Alarm System has been upgraded. The System is manufactured by Fire-Lite. The condition of the equipment is poor. There are numerous maintenance issues with the system. The System emits trouble signals and requires constant maintenance from the Vendor's service team.
- The System does not meet the current code. Any renovations to the system will trigger a full System replacement. The current National Fire

Fire alarm control panel is not up to standards
